CSX Train Derailment with Hazardous Materials Release
Hyndman, Pennsylvania
August 2, 2017

NTSB/RAR-20/04
PB2020-101012

Railroad Accident Report

CSX Train Derailment with Hazardous Materials Release

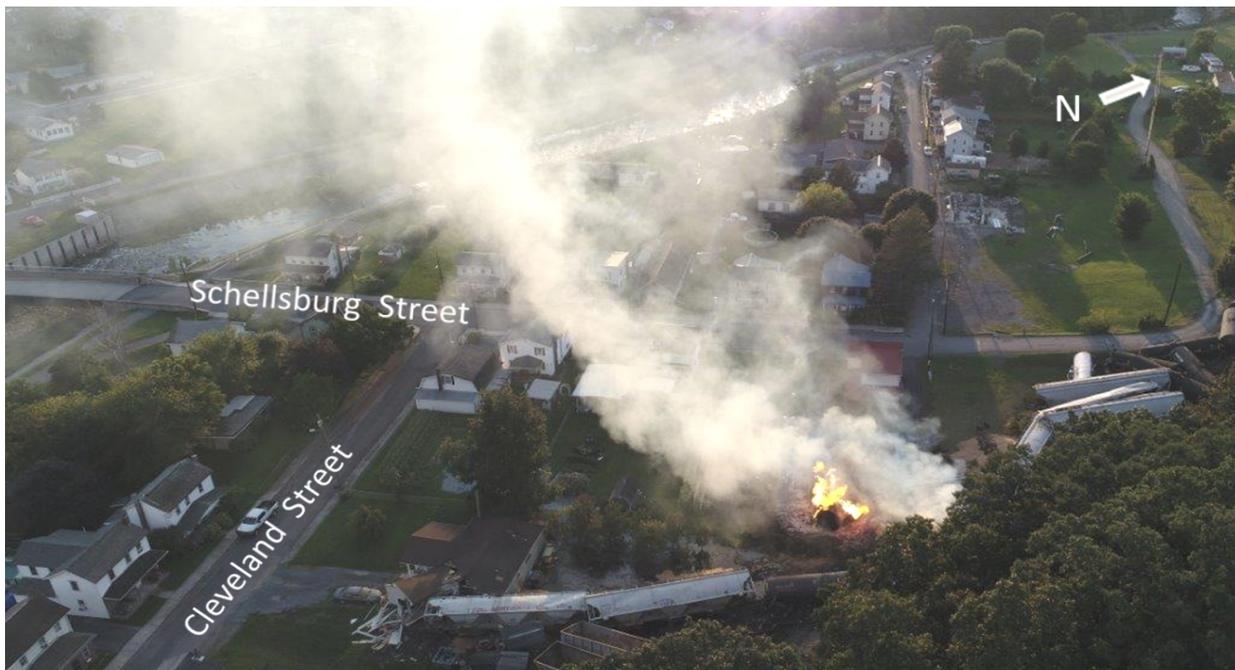
At 9:50 a.m., the CSX operations section chief participated in a state police helicopter overflight of the incident scene and confirmed that molten sulfur and asphalt had been released.¹⁸ Fire was seen issuing from several locations on the propane tank car, giving the appearance of multiple tank punctures. (See figure 3 for accident scene.)

Figure 3. Accident scene August 2, 2017, 7:45 p.m. (Courtesy of CSX.)

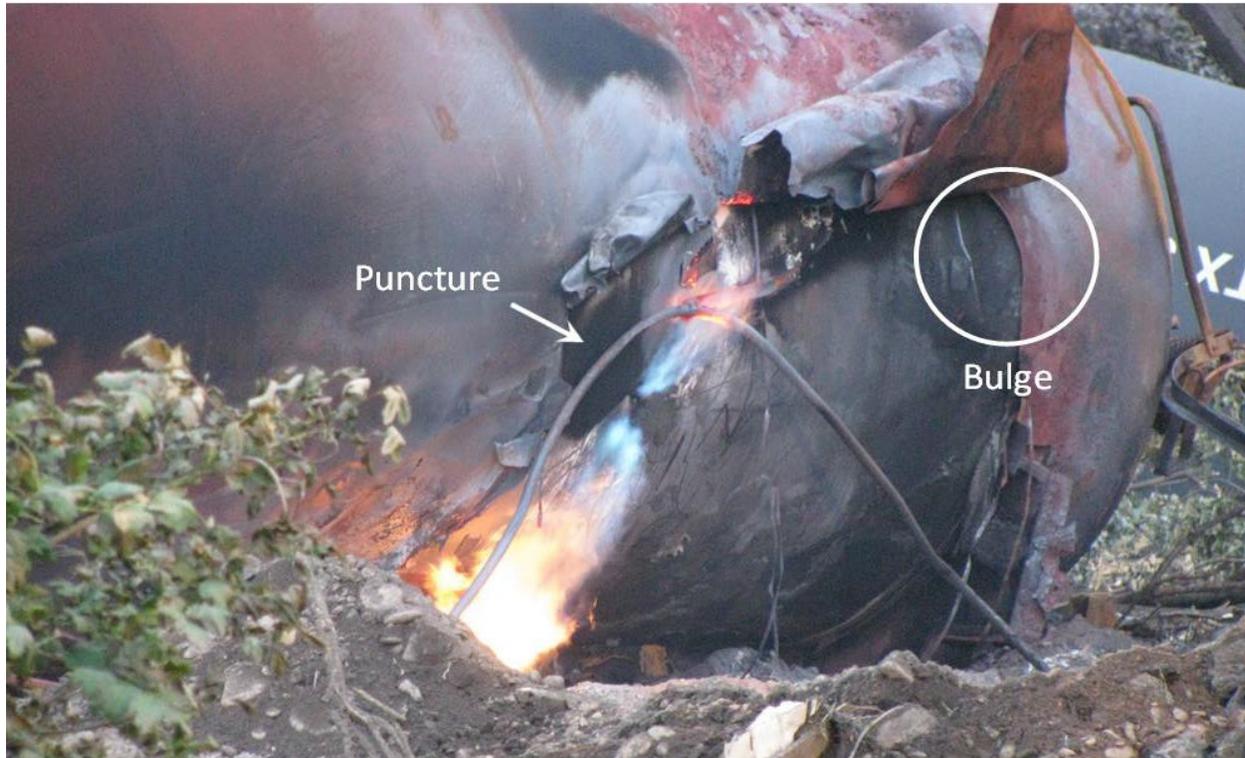
he noticed what appeared to be a bulge in the tank shell adjacent to the puncture. He said that by the time the shell bulge was discovered, there was almost no vapor pressure or product left in the car. Figure 4 shows the puncture covered by a square of magnetic patching material and the visible edge of the shell bulge under the exposed jacket.

Figure 4. The shell bulge and puncture site. (Courtesy of CSX.)

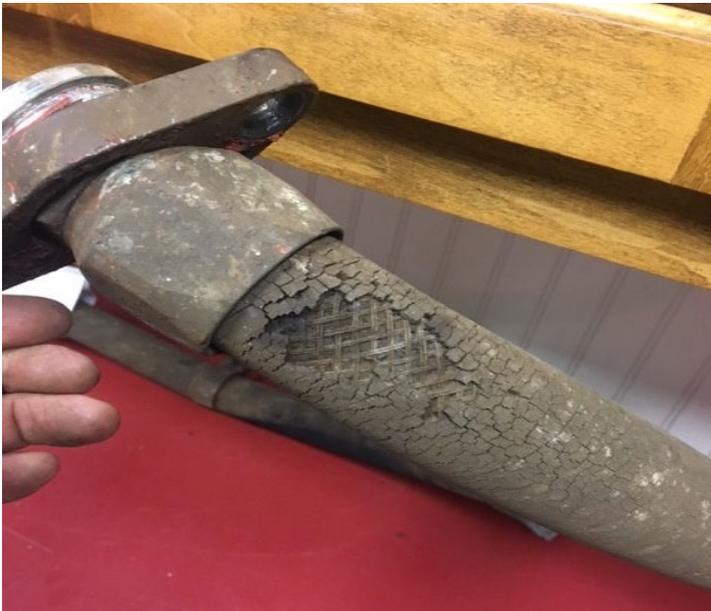
205.6. (See figure 5.) According to one of the mechanics who replaced the defective hose prior to the derailment, the hose that attached from the angle behind the angle cock to the train line was kinked and leaking.²⁹ The mechanic stated that the hose was “basically falling apart. You could see the internal threads.... I guess it was an older hose.”

Investigators inspected the damaged hose that was removed and found no visible signs of kinking. The hose was fitted with a coupling on one end and a pipe nipple and cap on the other. The hose was then pressurized to identify the location of the leak. The hose leaked at one end just behind the hose clamp and flange fitting. After returning the damaged hose to the Cumberland, Maryland, terminal for further testing, investigators attached the hose to the rear of a 67-car freight train. Leakage, measured by a pressure drop over time, on the train before attaching the hose at the rear was 2 psi over a span of 3 minutes in compliance with FRA minimum safety standards. After attaching and aligning air into the leaking hose, the pressure drop increased by 1 psi (to a 3-psi drop) within 3 minutes, which was within the federal threshold.³⁰

Figure 5. Close-up view of defective intermediate air brake hose removed from car LW 62114.

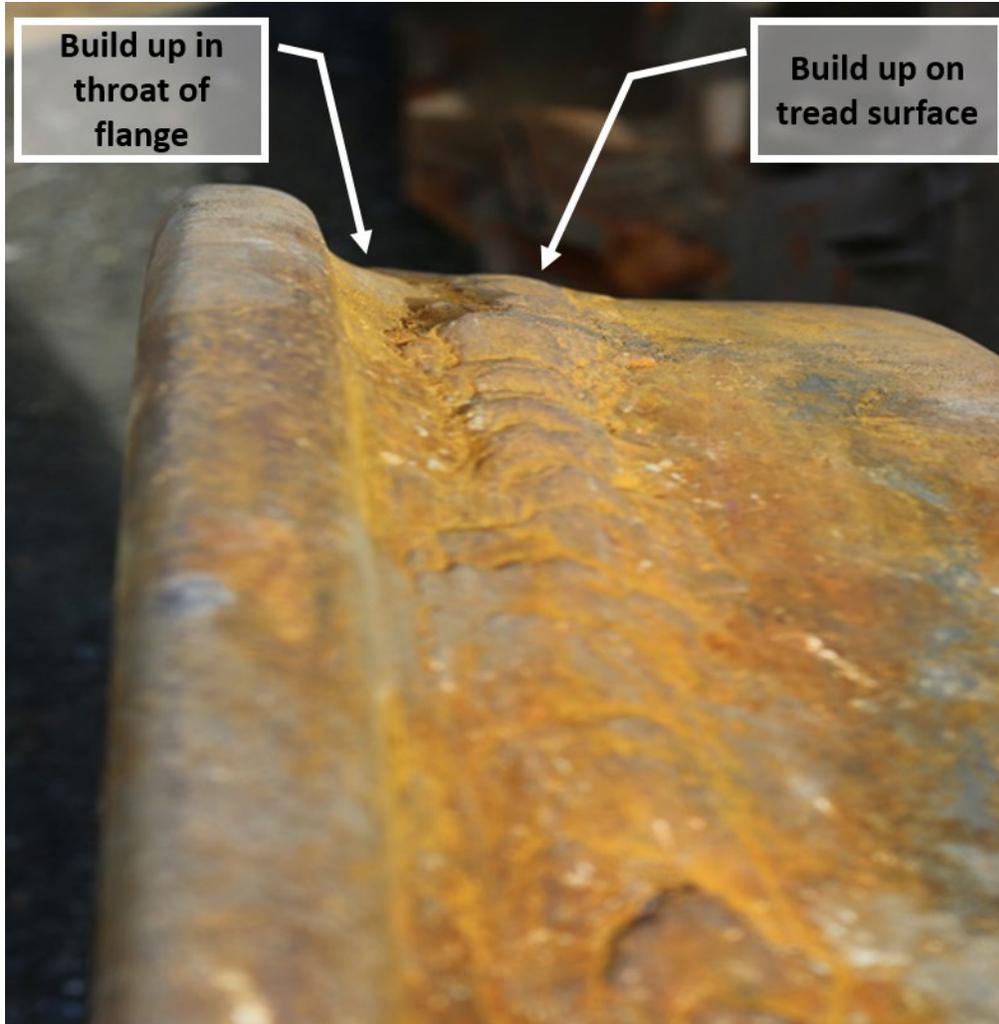
- [The application of hand brakes on empty rail cars toward the front of the consist caused the wheels of those cars to overheat and build up tread.](#)

A rail car truck assembly with damage consistent with being derailed was discovered between the point of derailment (POD) and the location of the general pile-up. It was identified as the truck assembly from FWTX 620111 (35th car). The truck assembly was discovered 600 feet away from the resting location of FWTX 620111. There were several indications that this truck assembly had derailed prior to the general pileup. These included gouges on the bottom of the side frame (consistent with impact with the rails), damage to the inside vertical surfaces of the side frame (where the wheel made contact) and damage to the tread of the wheels (consistent with contact with the roadbed). This truck assembly was from the leading end (in the direction of movement) of FWTX 620111 on the train at the time of derailment. All the wheels of FWTX 620111 showed signs of overheating. The 1st and 3rd axles (in the direction of movement) had a reddish-brown discoloration on both the front and back of the rim, which extended more than 4 inches into the plate. These wheels also had extensive tread buildup, especially along the throat of the flange as can be seen in figure 6.

Figure 6. Closeup of wheel tread surface showing tread buildup on wheel of the 35th car.

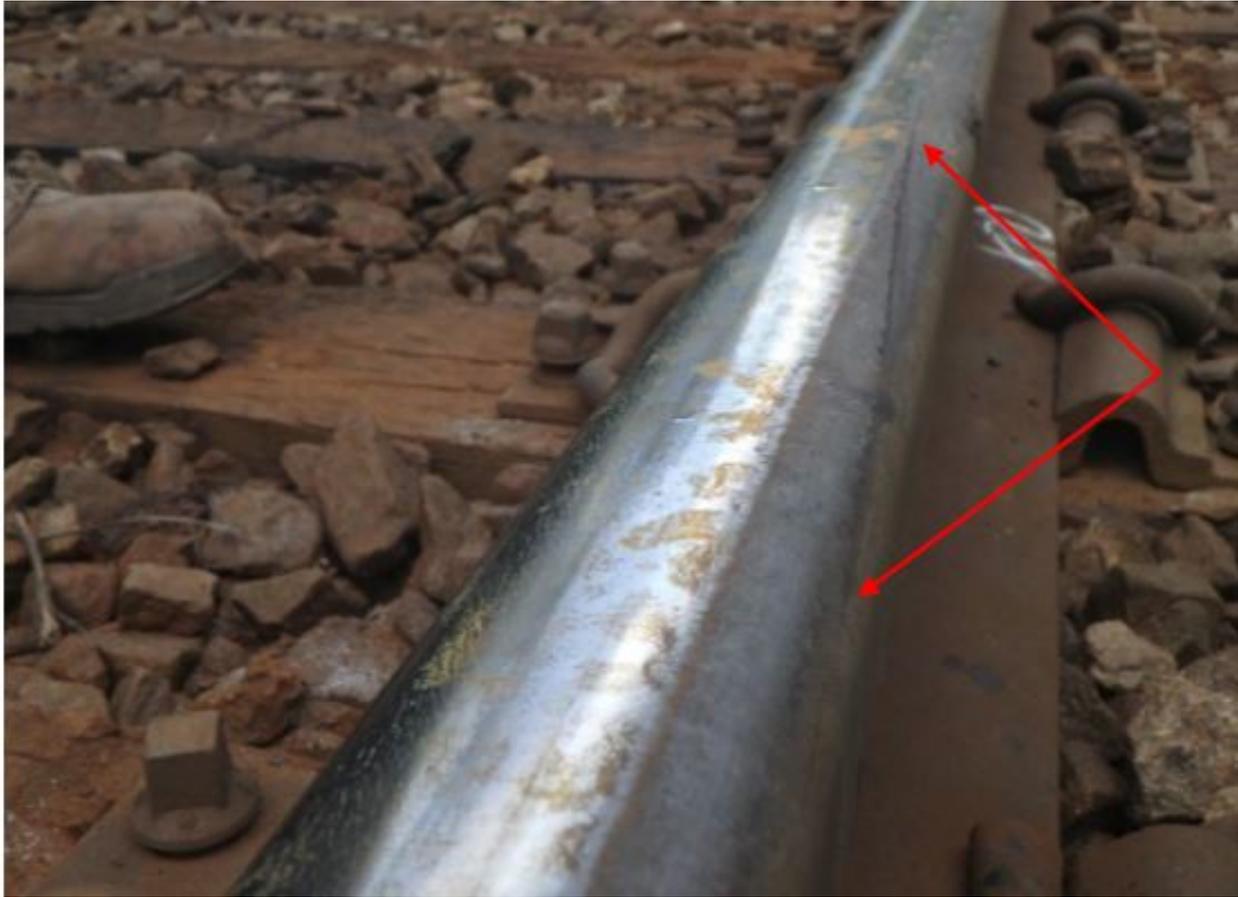
Figure 8. Flange mark at point of departure of FWTX 620111 (35th car).

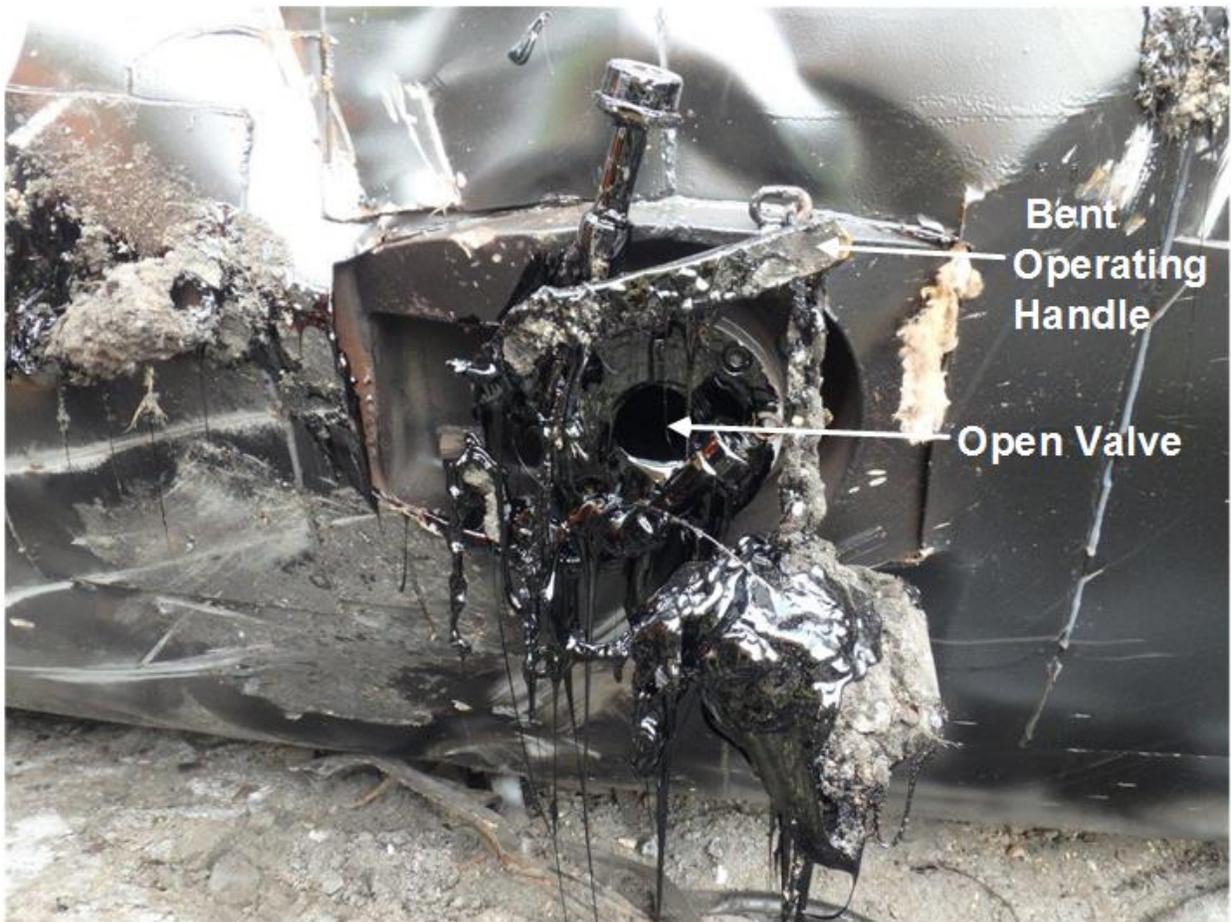
The derailment left the tank car with a missing bottom outlet valve nozzle, a bent operating handle, and the ball valve in the completely open position as shown in figure 10. Most of the asphalt released through this open ball valve. The left side of the shell was also crushed with significant loss in tank volume. The entire load of about 23,000 gallons of asphalt released and pooled on the two residential properties north of Cleveland Street in Hyndman.

Figure 10. UTLX643949 open bottom outlet valve.

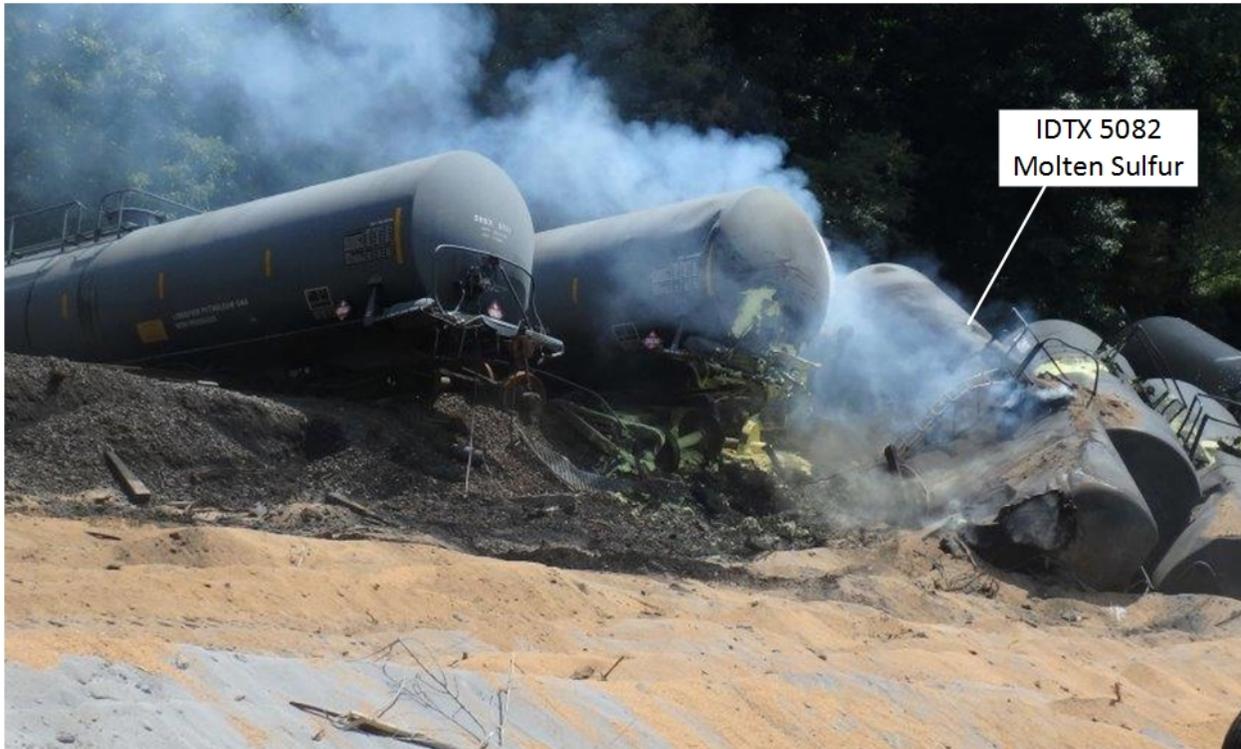
Most of the 13,000 gallons of molten sulfur product contained in tank car IDTX5082 released and ignited. (See figure 11.) The tank car sustained a 7-foot transverse shell tear in the right center of the car. The bottom of the car sustained a 32 x 18-inch puncture midway between the bottom outlet valve and the A end.

Figure 11. Burning molten sulfur released from tank car IDTX5082.

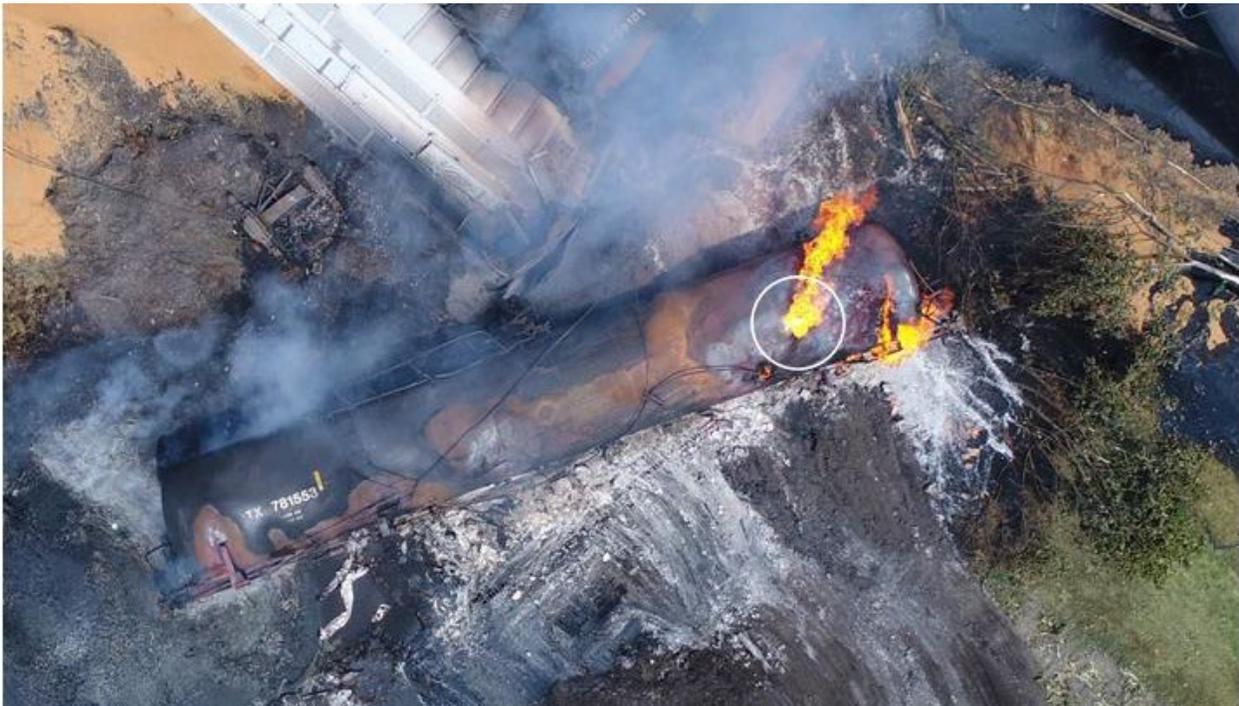
The A end of CBTX 781553 was leading in the eastbound train consist. The car came to rest with the A end facing east, parallel to and about 2 car lengths south of the track. The bottom of the car was in contact with a pool of burning molten sulfur released from tank car ITDX5082. The car was punctured and released burning propane, with torch fires escaping from holes and gaps in the jacket at several locations the length of the car. The most vigorous flame was observed at the right A end. (See figure 13.) As the postaccident emergency response actions progressed, the fire became restricted to the A end of the car. Aerial video and visual examination of the pressure relief device did not show any evidence that it had activated.

Figure 13. CBTX 781553 with puncture location circled, August 3, 2017, 2:46 p.m.

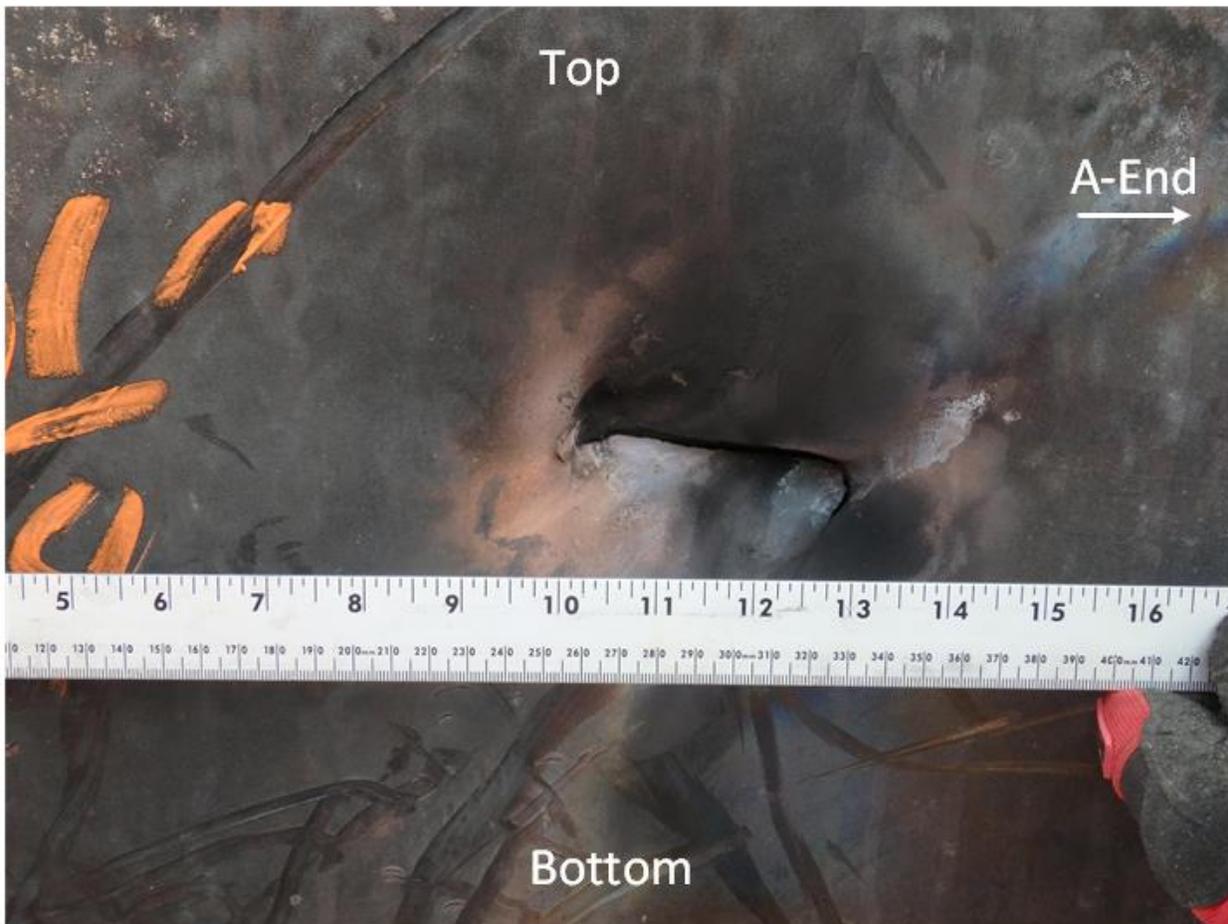
Investigators found a shell puncture at about the 3 o'clock position on the right side of the A end in the first barrel section. (See figures 14 and 15.) The puncture measured about 3.25 inches

in length and was oriented longitudinally. The puncture was within a dent measuring about 3.5 inches deep, with evidence of sliding contact in an upward direction. The shell fracture was isolated to the impact area and did not show any visual evidence of brittle propagation. Ultrasonic gauge thickness measurements of the tank shell in this region found thinning from 0.630 inch in a nearby unaffected area to 0.537 inch at the top edge of the puncture.

Figure 14. Tank Car CBTX 781553 puncture in exterior surface, August 4, 2017.

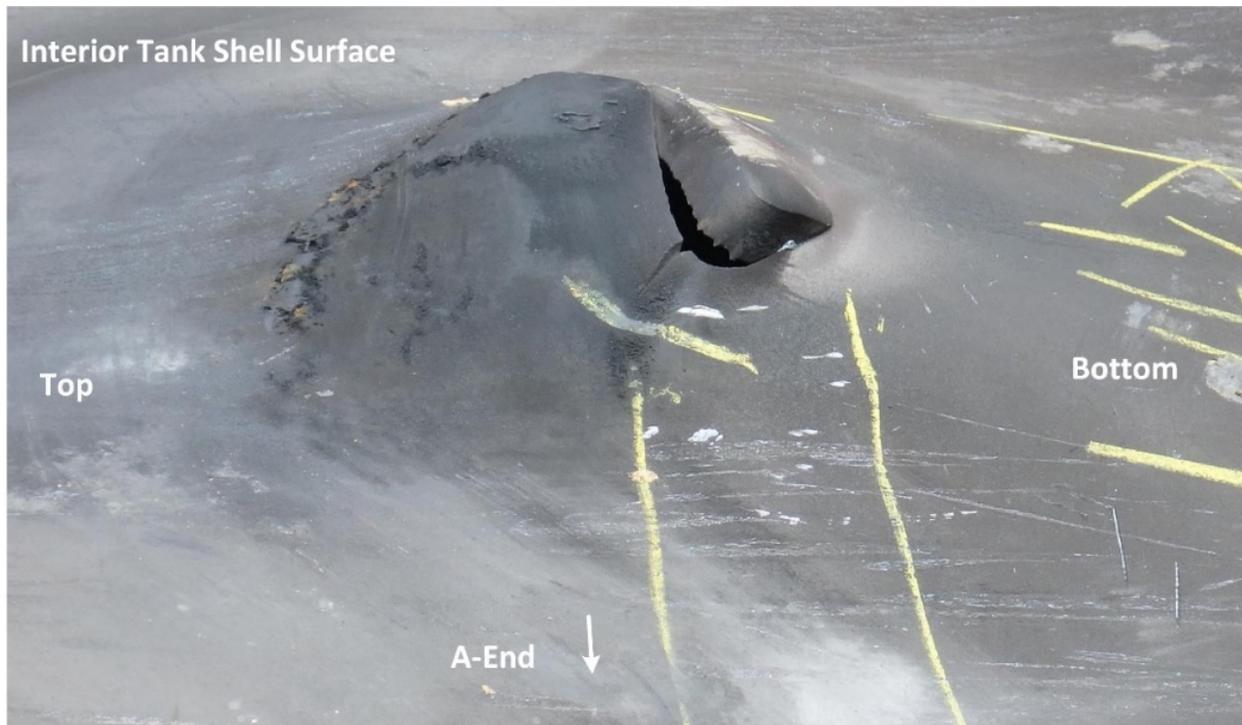
Investigators removed a section of the punctured tank shell plate 1 to examine the interior surface of the puncture as shown in figure 15. Penetration into the shell became deeper toward the A end. At the A-end side of the puncture, the crack turned downward about 1/2 inch in the circumferential direction. Carbon was deposited on the interior shell surface above the breach.

Figure 15. CTBX 781553 interior surface of shell puncture, August 5, 2017.

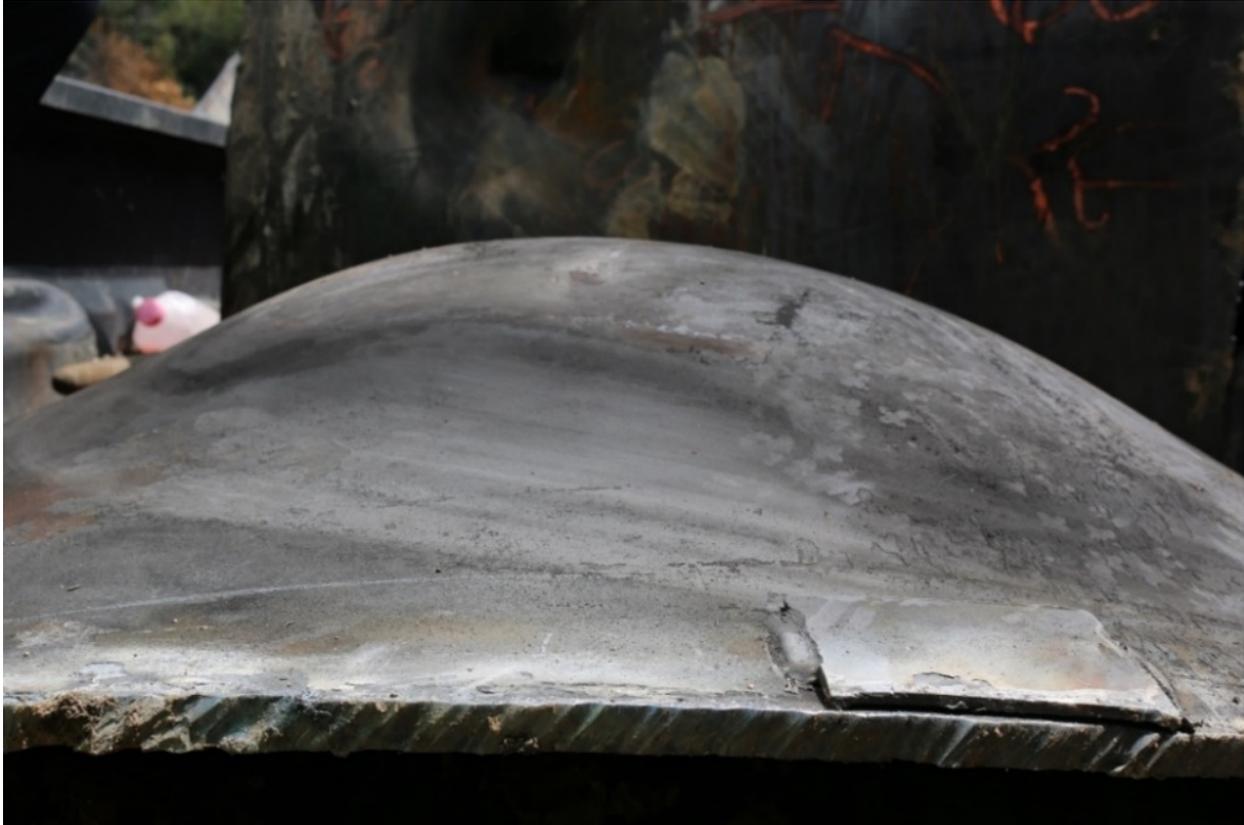
A shell bulge was observed closer to the A end, above the right-side body bolster in ring 1 of the tank shell. The bulge measured 27 inches in the longitudinal direction and 56 inches in the circumferential direction and protruded outward about 5 inches. (See figure 16.) Ultrasonic thickness measurements taken at about 2-inch intervals across the center of the bulge found that the shell thinned from 0.630 inches in a nearby unaffected area, to 0.436 inches at the thinnest location near the edge of the bulge. The Certificate of Construction reported a nominal shell thickness of 0.608 inches.⁴¹

Figure 16. CBTX 781553 tank shell coupon showing bulge profile, August 5, 2017.
