Amtrak Roadway Worker Fatality
Bowie, Maryland
April 24, 2018

NTSB/RAR-21/02
PB2021-100935

Railroad Accident Report

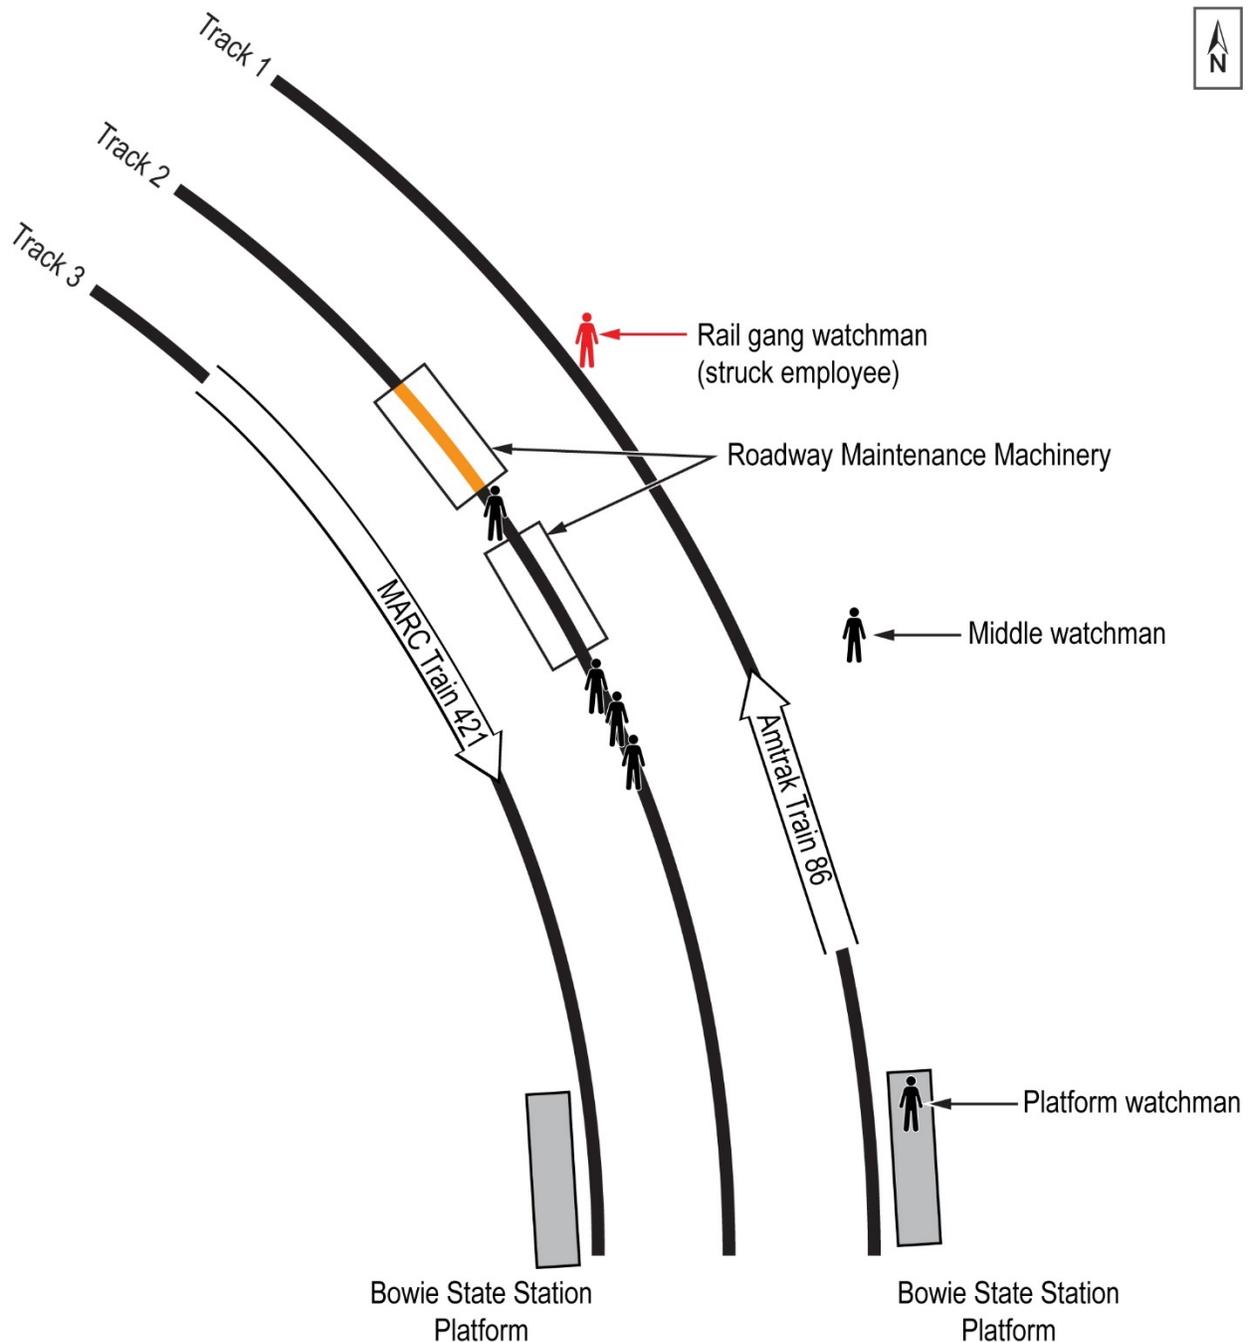
Figure 1. Graphic of accident site.

to the equipment and the watchman would be in a better position to get the attention of the welders.⁶ At this location he was about 660 feet north of the middle watchman.

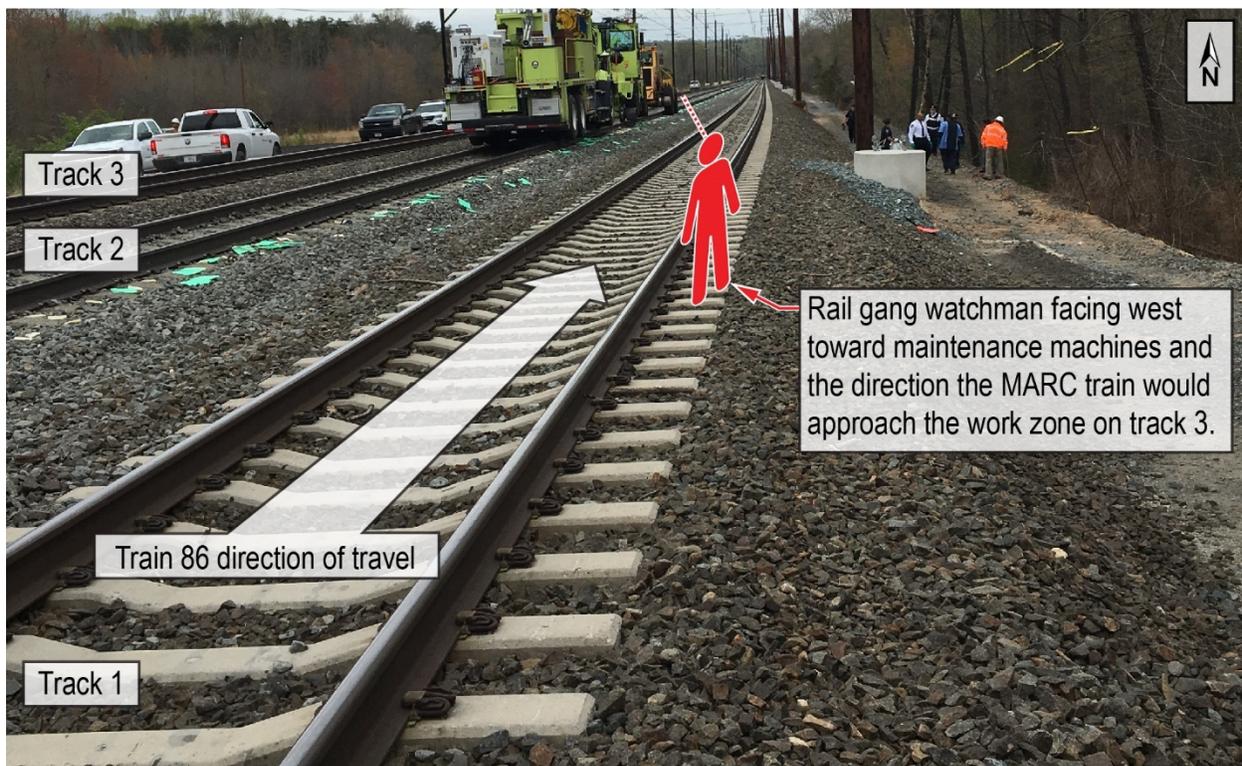
Figure 2. Photograph of the accident area, facing north.

During an examination of the accident scene, the NTSB noted that the ballast shoulder was steep at the location where the rail gang watchman was posted and did not provide stable footing.¹⁷ Figure 2 shows the work environment. The NTSB asked the platform watchman about the rail gang watchman's position on the steep ballast. The platform watchman indicated that, in general, it was difficult to find stable footing anywhere along the steep ballast shoulder throughout the work zone.

The middle watchman indicated that the steep ballast shoulder was uncomfortable to stand on while watching for trains. The slope was steep enough that standing on the rocks that made up the ballast caused unstable footing.

because the steep ballast slope made it too difficult to safely stand and properly watch for trains. He also suggested to the NTSB that watchman platforms be built to reduce the safety hazards of unstable footing. Another employee stated that when watching for trains, he often found it necessary to move and pack the ballast around with his feet to make “step like” indentations in the steep ballast slope. He stated that when a train approached, he usually would go behind a catenary pole for added protection due to the flying debris and dust that the train kicked up.¹⁸
