RAILROAD

PIPELINE

# Passenger Railcar Wheelset Alert

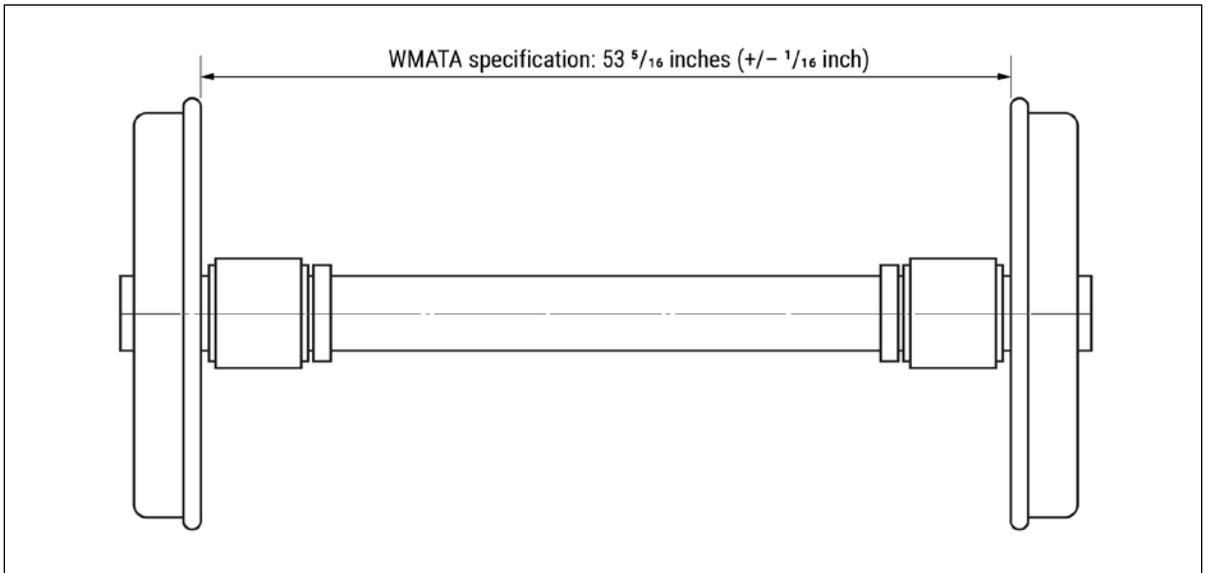
The 7000-series cars were manufactured by Kawasaki Rail Car Inc. (Kawasaki). For their contract with WMATA, Kawasaki subcontracted with Sumitomo Metals to supply the wheels and axles and with ORX to assemble the wheelset by pressing the wheels onto the axles.<sup>3</sup> WMATA's design specification specified the linear distance between the wheels on the axle (the gage) is 53-5/16 inches  $\pm$ 1/16 inch. (See figure.)

**Figure 1: Illustration depicting WMATA's design specification showing the linear distance between the wheels on the axle.**

The NTSB examined car 7200 and found that both wheels had moved outboard from their seats, increasing the gage 2-inches, which exceeded the design specifications. The NTSB also observed increased wear of the wheels.

- Assess your fleets for wheelsets not meeting your gage specifications and take immediate action to correct the problem.

The NTSB encourages rail transit agencies and commuter railroads to assess your fleets for wheelsets not meeting your gage specifications and take immediate action to correct the problem.
