The Washington Metrorail Safety Commission

Safety Audit

Audit of Communications Systems

Final Report:
September 29, 2022

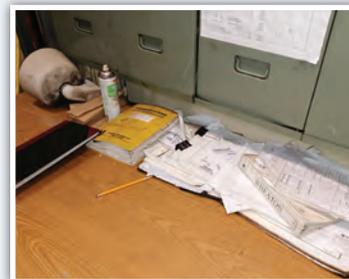
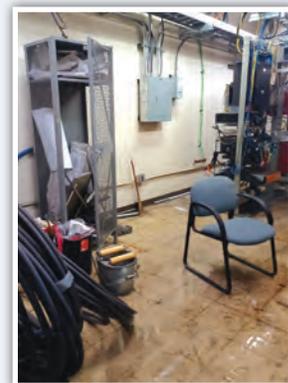
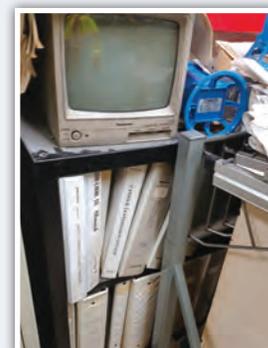
In Communications Room 124 at Fort Totten Station, the WMSC encountered standing water, used rags, a bucket, and a squeegee tool used to redirect water.

regards to dirt and materials not stored in accordance with Metrorail policy were observed at all communications rooms visited during this audit.

Minimum Corrective Action: WMATA must conduct a special inspection of all communications rooms to check for water intrusion or signs of water intrusion. Metrorail must prioritize and address all identified hazards and safety deficiencies in a timely fashion. Metrorail must provide the records of these inspections and this prioritization and schedule for addressing each issue on at least a quarterly basis along with documentation of all implemented mitigations. Metrorail must then institute a process that ensures water intrusion is identified and addressed on an ongoing basis going forward. WMATA must develop processes to ensure all equipment and documents in communications rooms are kept clean, organized and protected, including routine verification inspections conducted and documented by supervisors.
