Railroad Investigation Report RIR-23-13

Watco Dock and Rail, L.L.C.

Employee Fatality

Houston, Texas

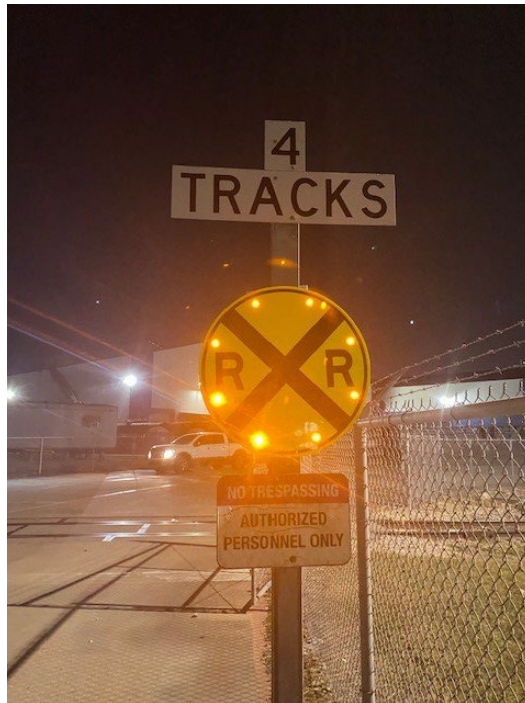
Figure 5. Highway-railroad grade crossing signage with LED lights.

WDRL also equipped the private highway-railroad grade crossing's advance warning signage with LED (light-emitting diode) lights. (See figure 5.) The intent was to make the signage more visible to truck drivers who enter the driveway that intersects with the private highway-railroad grade crossing. Further, WDRL conducted assessments to identify other crossings within the Greens Port Industrial Park that could benefit from this added protection.
