National Transportation Safety Board

TANK CAR DERAILMENT DAMAGE FACTUAL REPORT

**March 30, 2023, Derailment of BNSF Railway Freight Train
L-TWI8801-29 and Subsequent Hazardous Materials Release**

Raymond, Minnesota

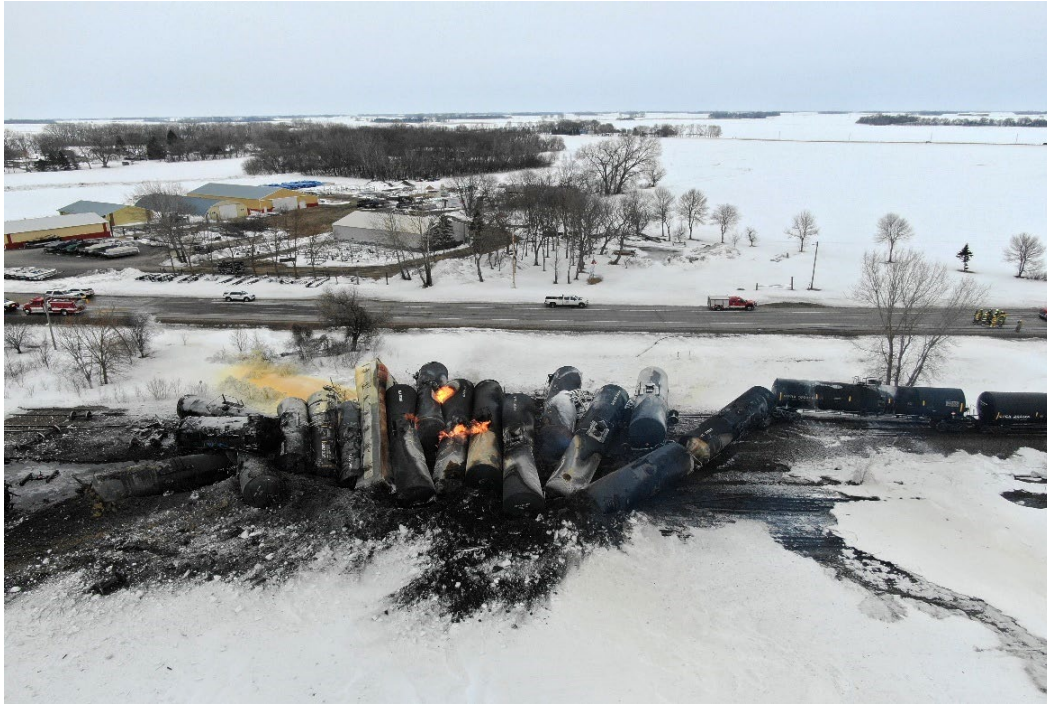
Figure 1. Photo of derailed train (courtesy of BNSF)

Post-accident inspections revealed that a catastrophic broken rail event occurred along the straight main rail portion of the switch.

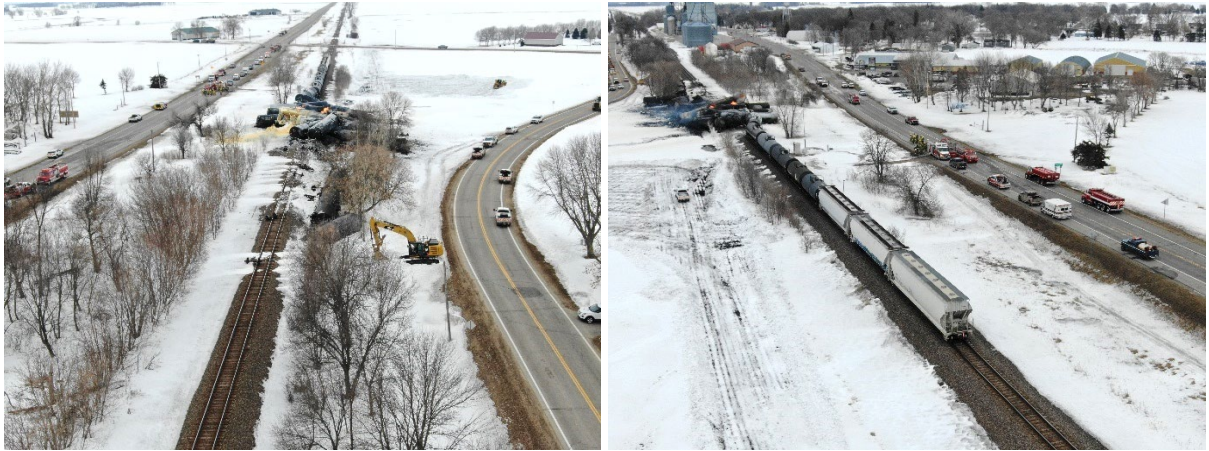
Figures 3 and 4. UAS still photographs of derailment as shown in-situ (Courtesy of BNSF)

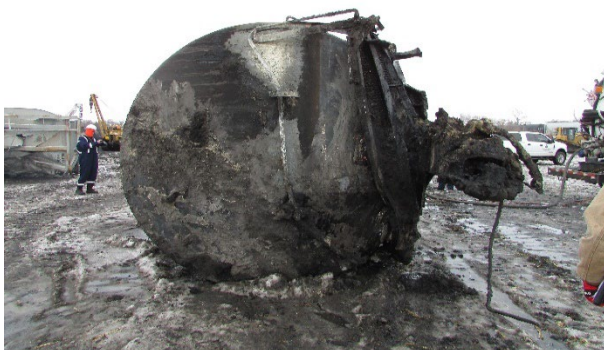
1(c) A-end head, minor damage to head at approx. 6 o'clock position

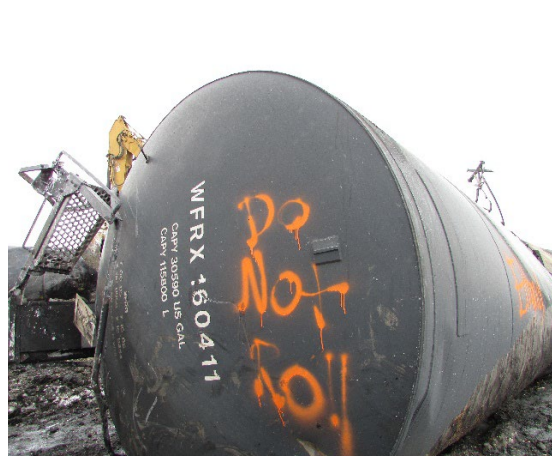
2(a) A-end head.

Consist order	23
Orientation in the consist	Unknown
Derailed resting position	Unknown, car was in staging yard for inspection.
Heads	Various dents to upper-right B-end head. B end head shield missing (possibly during post derailment handling).
Shell	Multiple impact damages. About 65% of the shell/jacket surface was thermally damaged.
Bottom outlet valve	No damage.
Top fittings, PRD and Manway	Protective housing was impacted by rollover and contact. No breaching damage to top fittings or manway.
Stub sills and couplers	Stub sills remained attached to head pad.

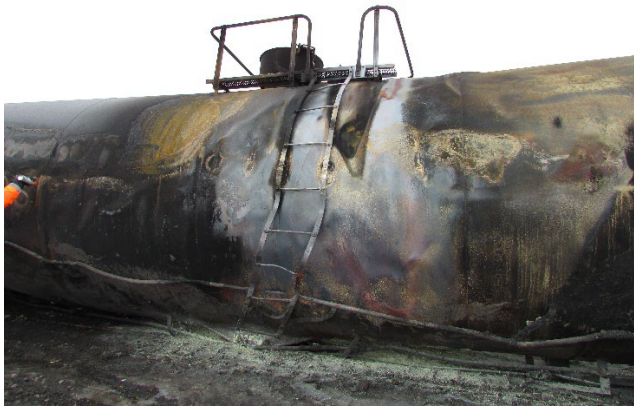
4 (e) Right side, thermal damage.
