Transportation
Safety Board
of Canada

RAIL TRANSPORTATION SAFETY INVESTIGATION REPORT R19T0107

MAIN-TRACK TRAIN DERAILMENT

Canadian National Railway Company
Freight train M38331-27
Mile 60.55, Strathroy Subdivision
Sarnia, Ontario
28 June 2019

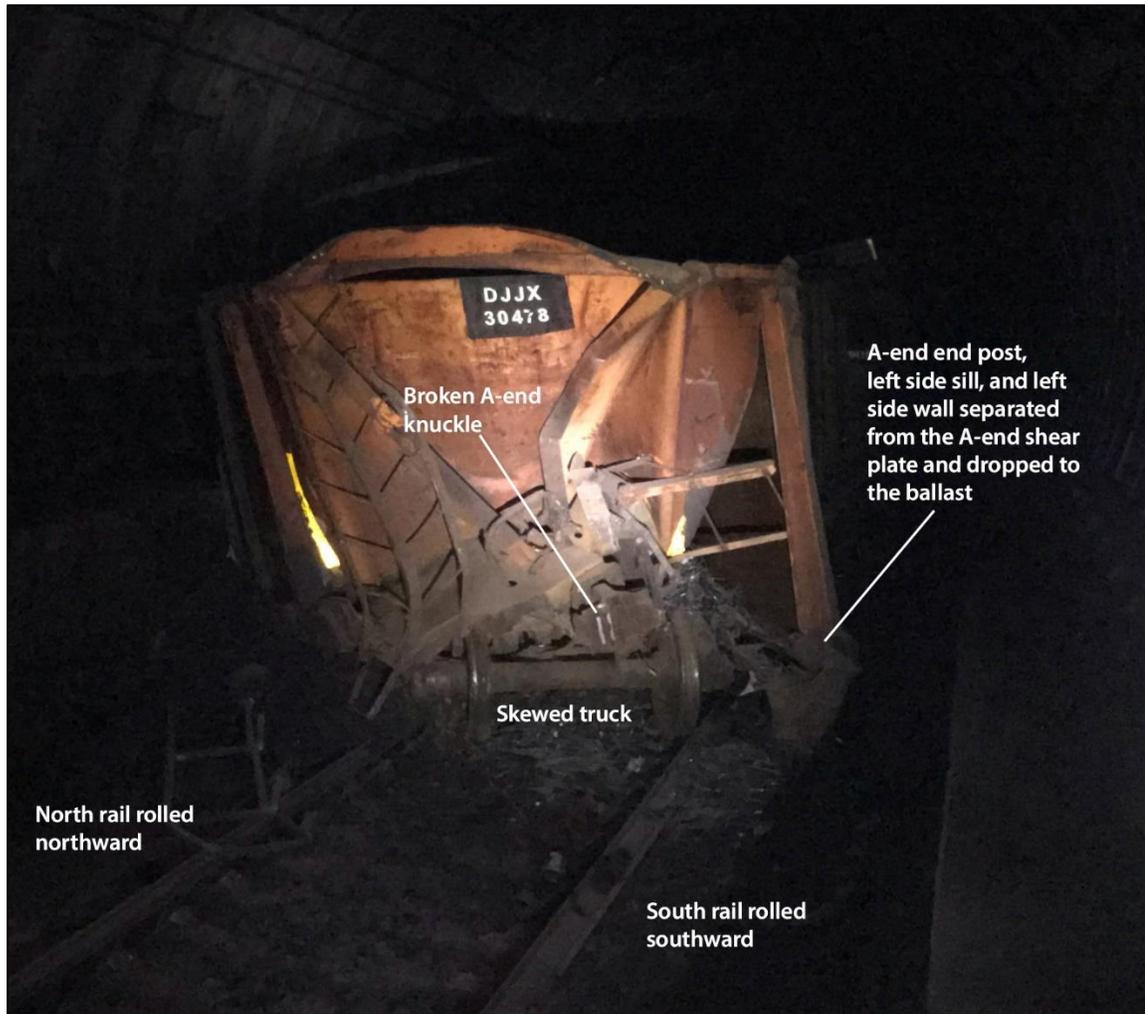
Figure 6. Bathtub gondola car DJJX 30478 (line 53) A-end in situ, showing extensive car damage, broken knuckle, skewed truck, and rolled rail (Source: Federal Railroad Administration, with TSB annotations)

The broken A-end knuckle fracture surface on DJJX 30478 (line 53) exhibited brittle fracture characteristics with no visible defects (Figure 7). The A-end of the car also exhibited a number of pre-existing car body conditions that suggested its structural integrity may have been compromised. There were no visible impact marks on the adjacent tunnel's reinforcement walls in this area.

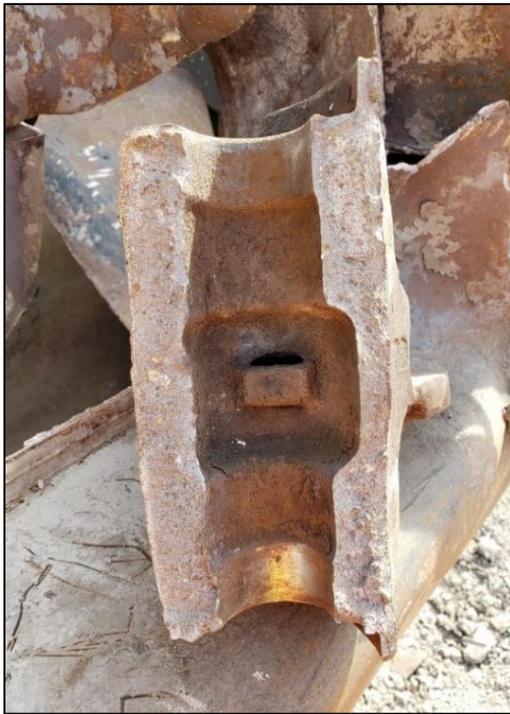
Figure 7. Fracture surface of the broken A-end knuckle on car DJJX 30478 (line 53) (Source: TSB)

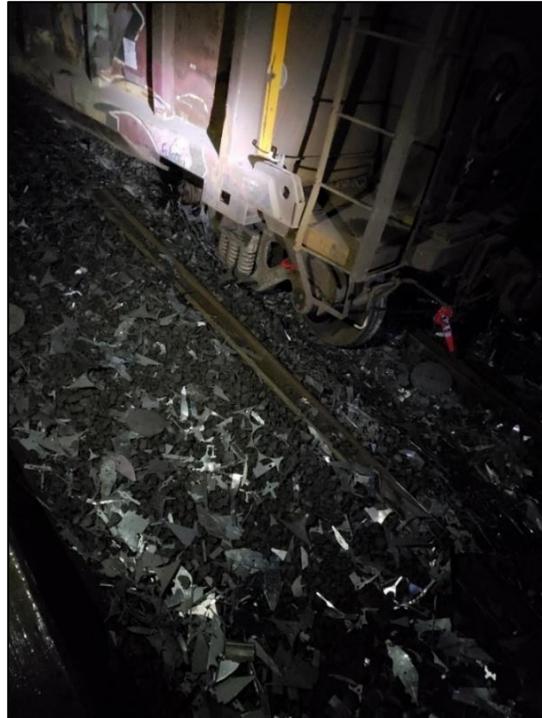
The B-end of car DJJX 30478 (line 53) was relatively intact but was surrounded by scrap steel lading from the car, which had been released to the track surface (Figure 8).

Figure 8. Picture of B-end of car DJJX 30478 (line 53), showing scrap steel on the ballast (Source: TSB)

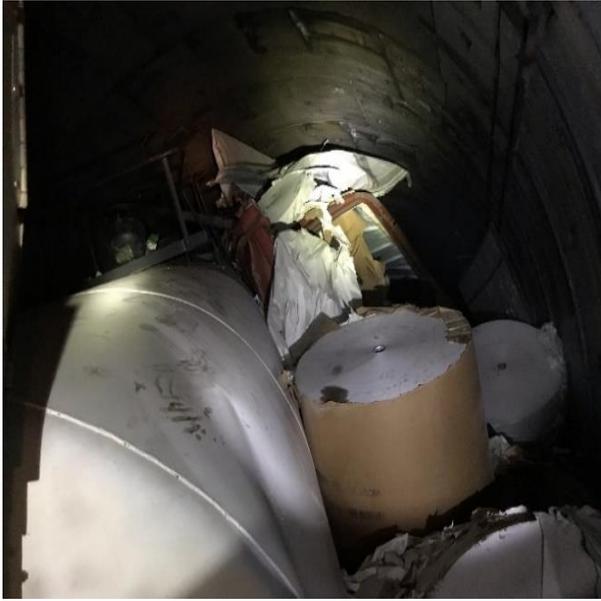
Most of the trailing cars behind car DJJX 30478 (line 53) had jackknifed and come to rest in various positions, blocking the tunnel and rendering it impassable by equipment or on foot in several locations (figures 10 and 11).

Figure 10. Example of derailed cars and lading blocking the tunnel on the U.S. side (Source: Federal Railroad Administration)

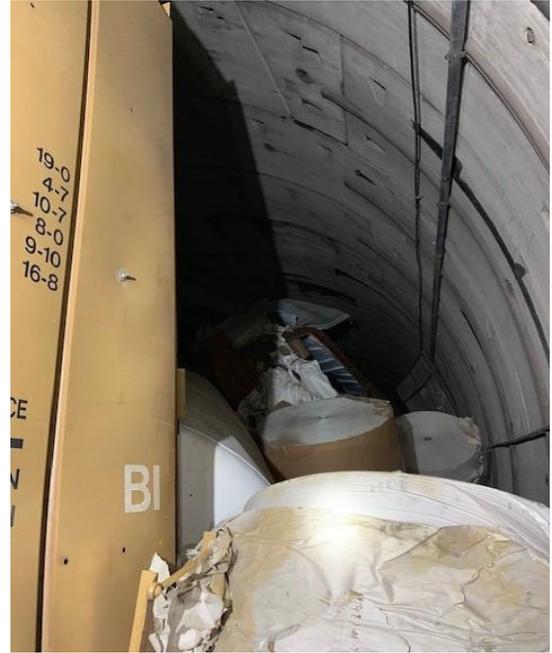
Figure 11. Second example of blocked tunnel on the U.S. side (Source: Environmental Protection Agency)

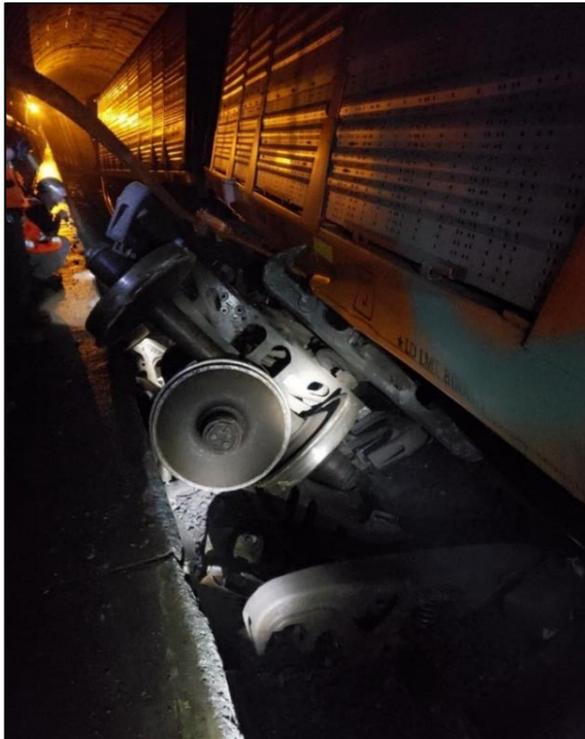
Similar to the situation on the U.S. side, many of the derailed cars had jackknifed and came to rest between the tunnel’s reinforcement walls in various positions (Figure 13).

Figure 13. Displaced wheel sets, trucks, and derailed cars on the Canadian side (Source: TSB)

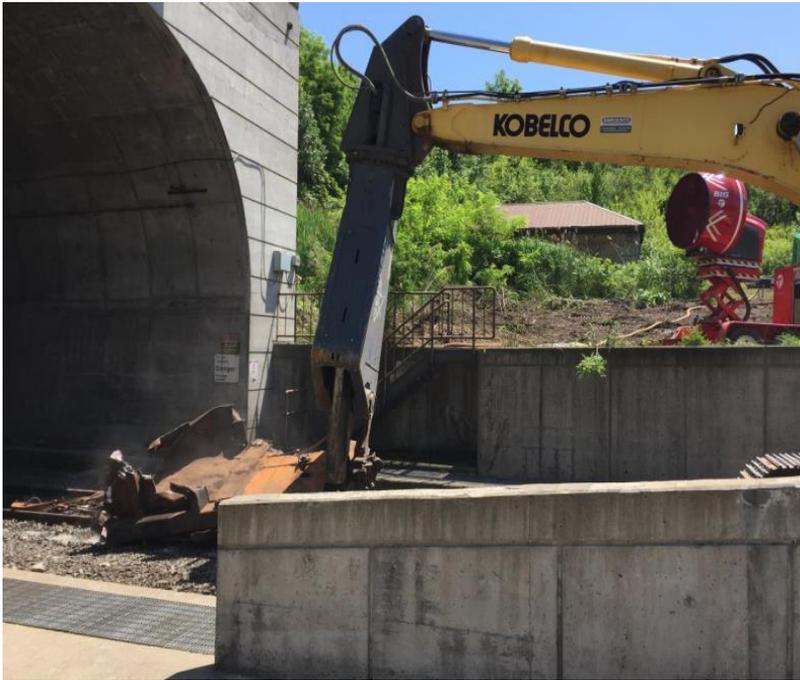
Figure 14. Car DJJX 30478 A-end shear plate and stub sill were removed from the tunnel (Source: Environmental Protection Agency)

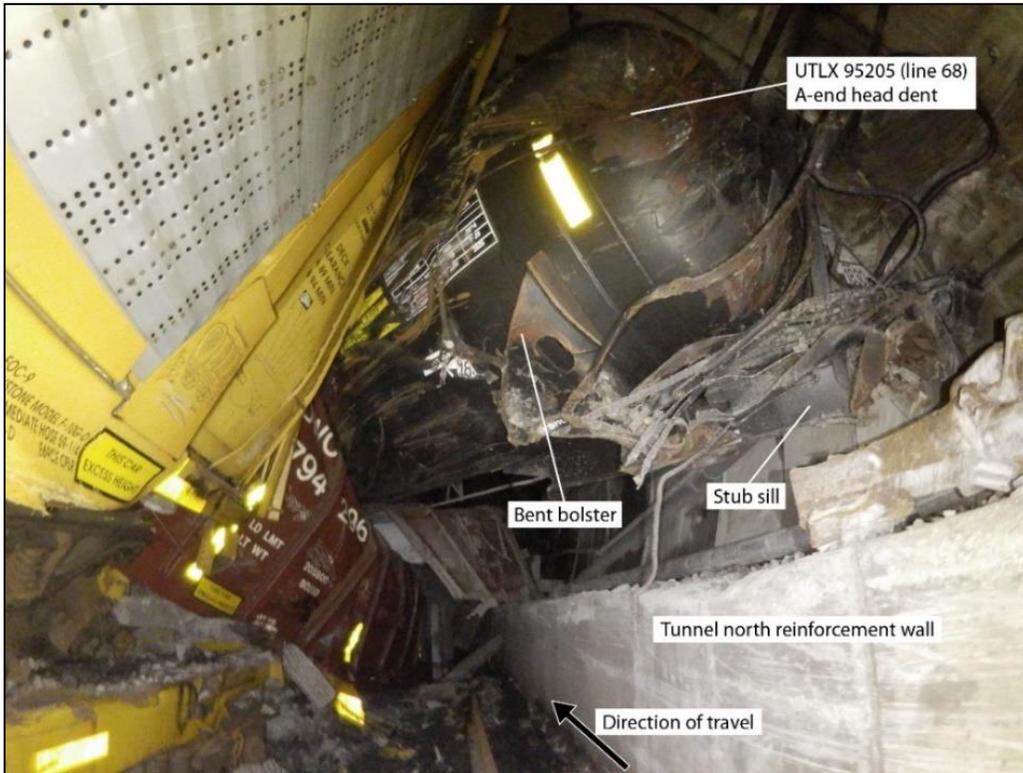
Figure 16. Aerial view of UTLX 95205 trailing A-end situated diagonally across the tunnel, near the tunnel north wall (Source: Canadian National Railway Company and Exelon Corporation, with TSB annotations)

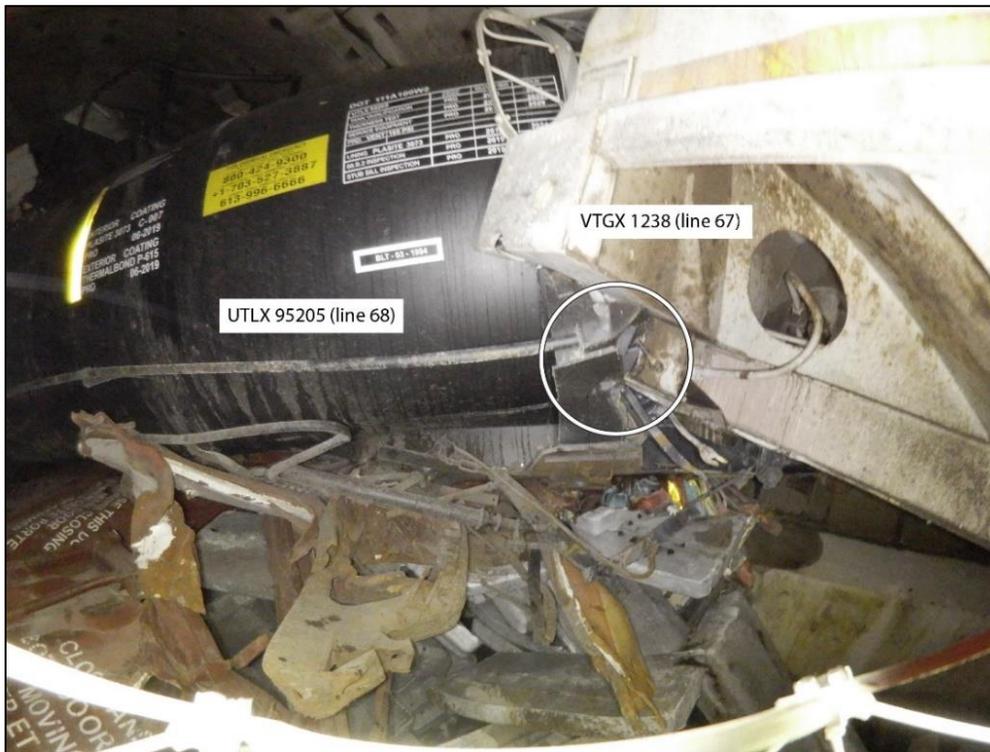
Figure 17. Aerial view of UTLX 95205 (line 68) leading B-end tank head, which had been punctured by the coupler and stub sill of VTGX 1238 (line 67) (Source: CN and Exelon Corporation, with TSB annotations)

After tank car UTLX 95205 was removed from the tunnel, a follow-up examination confirmed that all tank damage observed was related to the derailment.

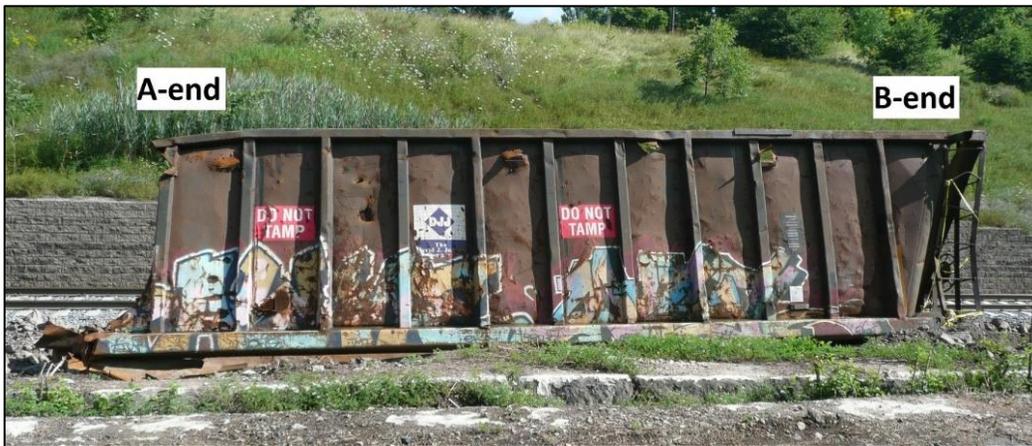
Figure 25. DJJX 30478 car body, as recovered in CN's Port Huron Yard (Source: TSB)

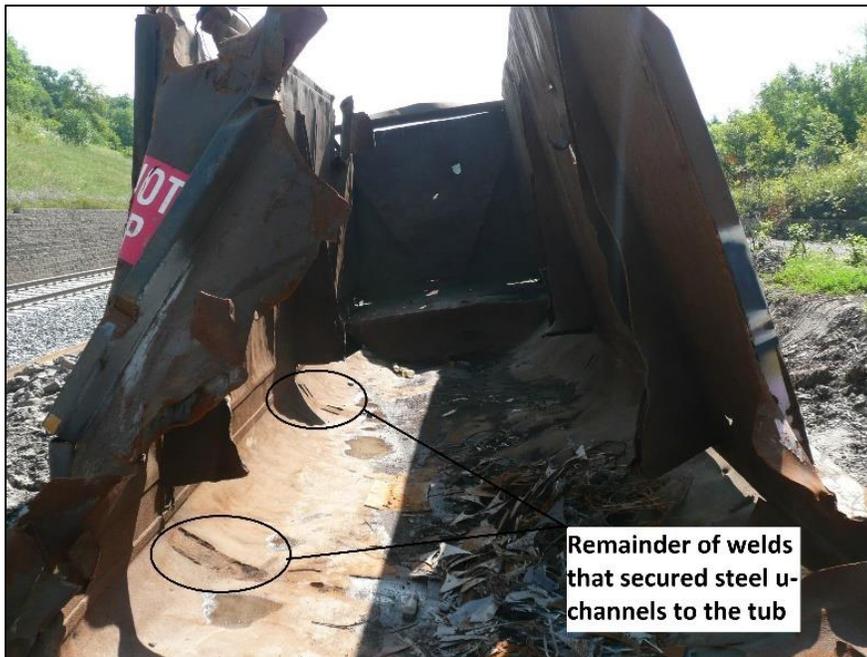
From the A-end, looking inside the car, extensive deterioration was observed throughout (Figure 26). The steel reinforcements that had replaced the crossbars were extensively corroded, and the bottom portions that reinforced the tub were missing. The welds that had secured the reinforcements to the tub were severely corroded, indicating that this condition had likely existed for some time prior to the accident.

Figure 26. Car DJJX 30478, view inside the car from the A-end (Source: TSB)

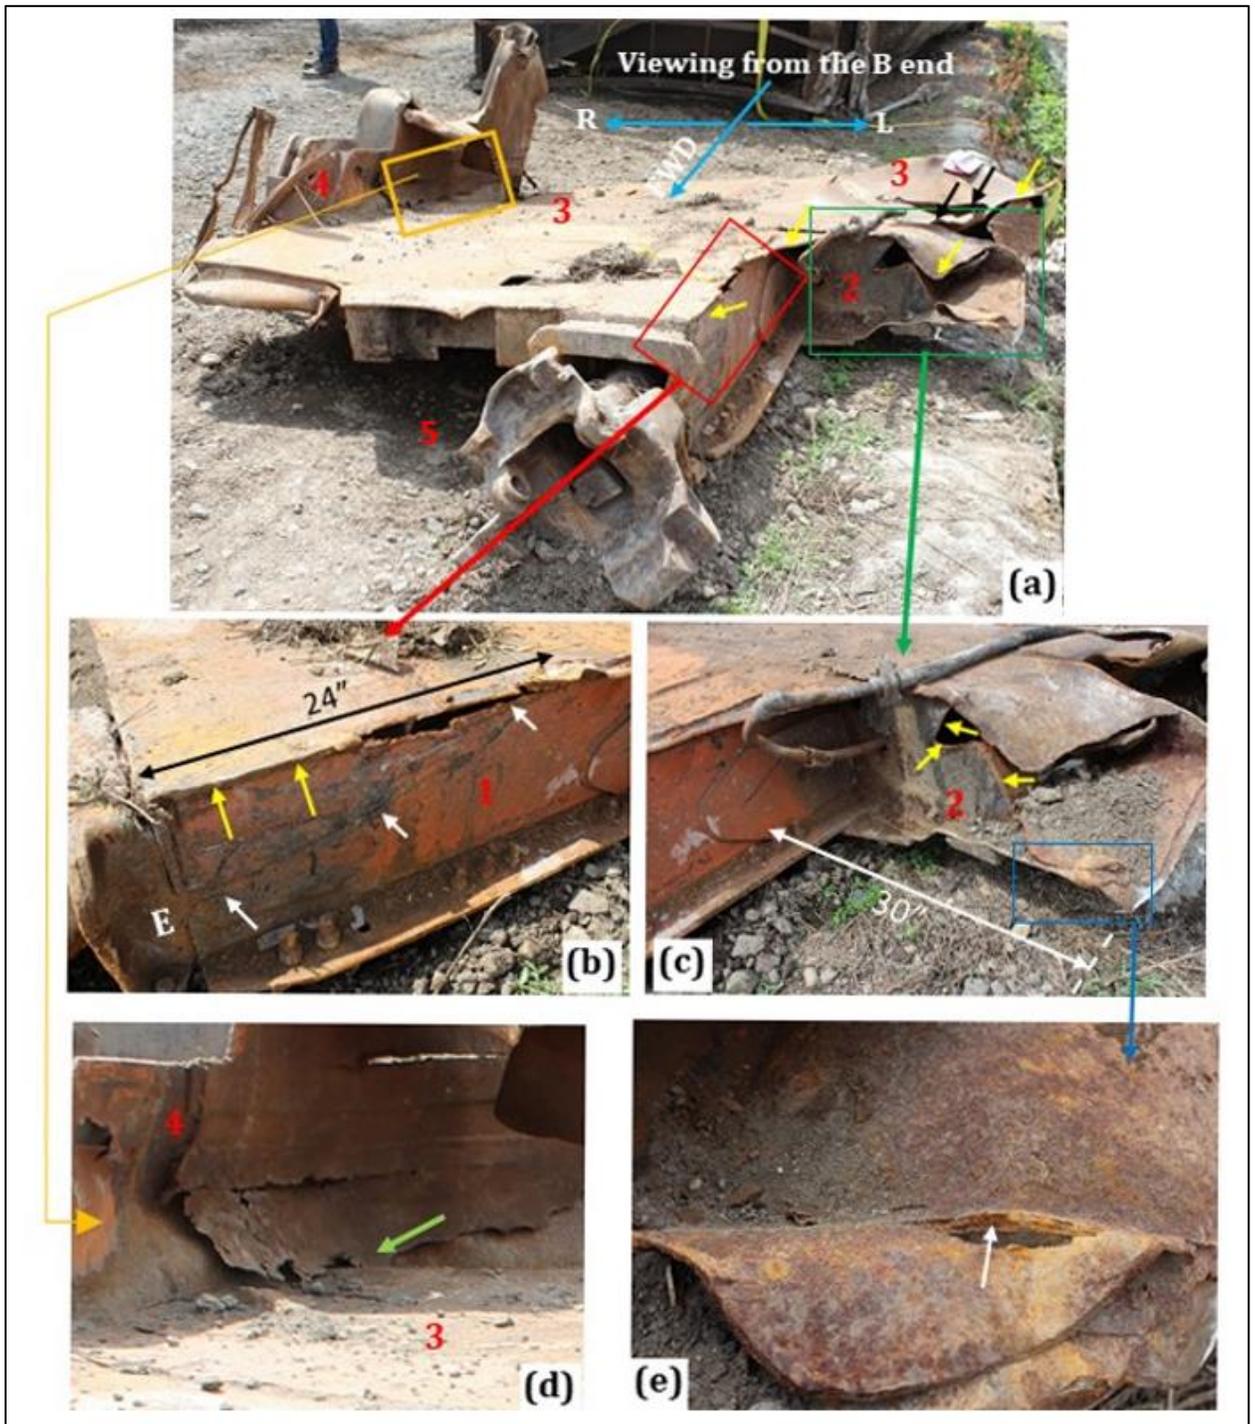
The car had a number of pre-existing defects, was heavily corroded, and exhibited numerous cracks in the welds that secured the A-end shear plate to the stub sill, car body bolster, and side sills. The left-side sill, part of the body bolster, and a portion of the shear plate were torn off (Figure 27).

Figure 27. Car DJJX 30478 A-end wreckage in upright position. Photo (a) is an overview; photos (b), (c), and (d) are the close-up views of the red, green, and yellow boxes in (a), respectively; photo (e) is a close-up view of the blue box in (c). (Source: TSB)

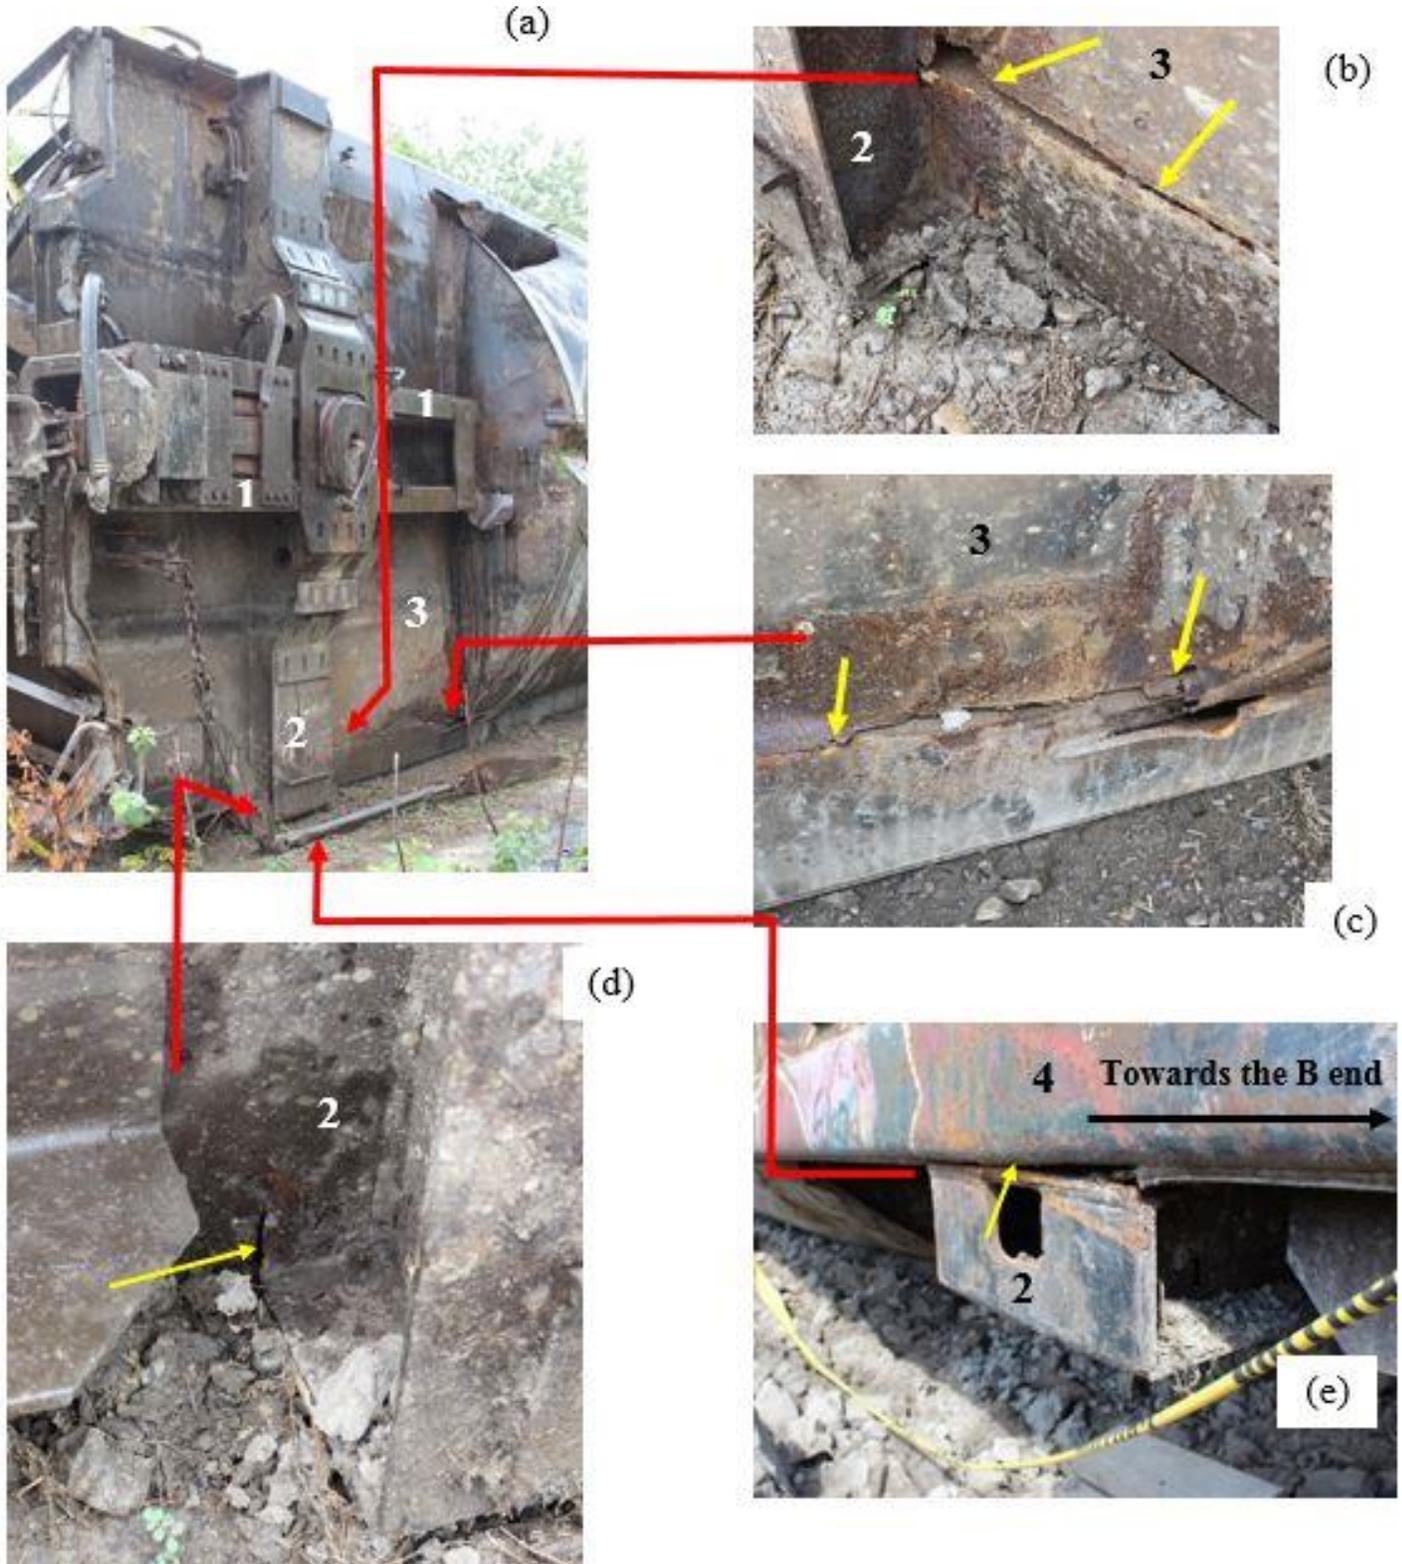
Figure 28. Car DJJX 30478 B-end underframe . Photo (a) shows the bottom of B-end, including the stub sill and car body bolster; photos (b) and (c) are close-up views of cracks found on the shear plate (yellow arrows) in photo (a); photos (d) and (e) show cracks found in the joint between the car body bolster and side sill in photo (a) (Source: TSB)

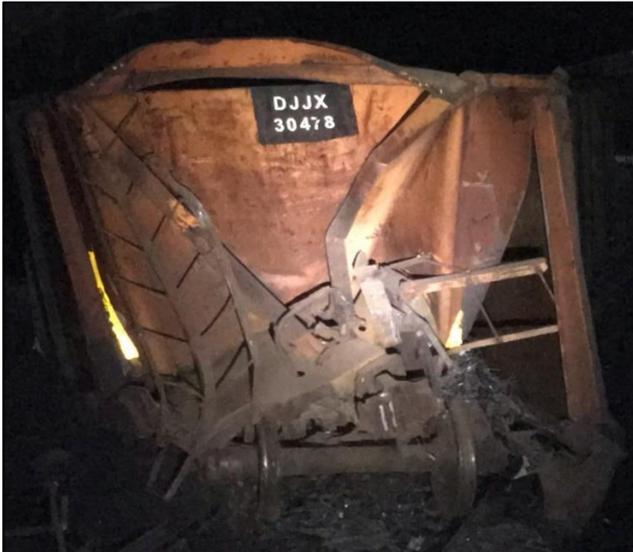
Figure 30. DJJX 30478 AL failure in tunnel (Source: Federal Railroad Administration)

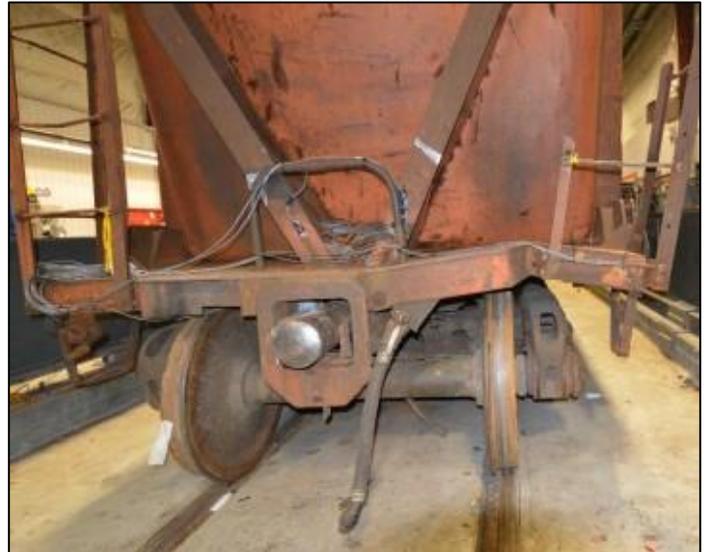
Figure 31. DJJX 30156 AL failure during testing (Source: National Research Council Canada)

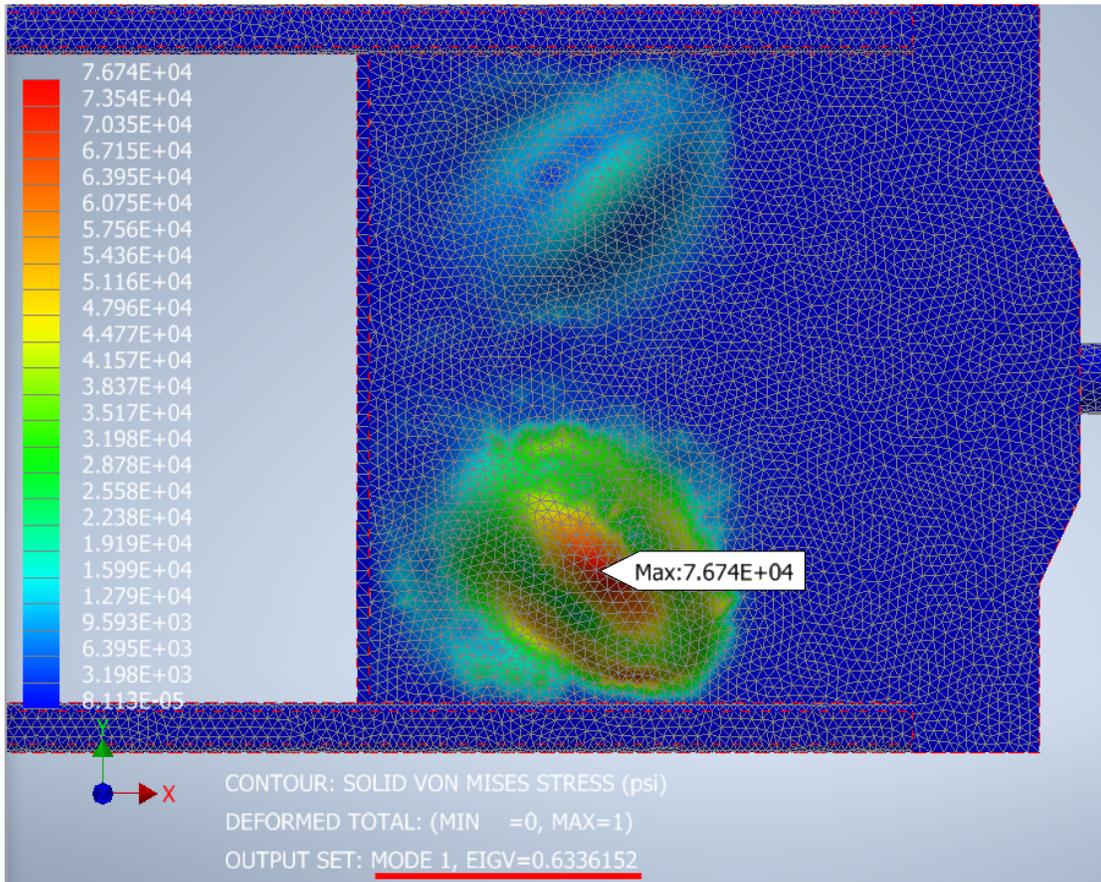
The model for the A-end of car DJJX 30156, which was of the same design as failed car DJJX 30478, was then built by introducing the observed defects into the intact model. Specifically, the thickness of the shear plate was reduced from 0.31 inches to 0.24 inches, and identified cracks in the shear plate and between the body bolster and shear plate were introduced into the model.

Figure E3. Linear buckling analysis of the platform structure of the A-end of DJJX 30156 (Source: TSB)

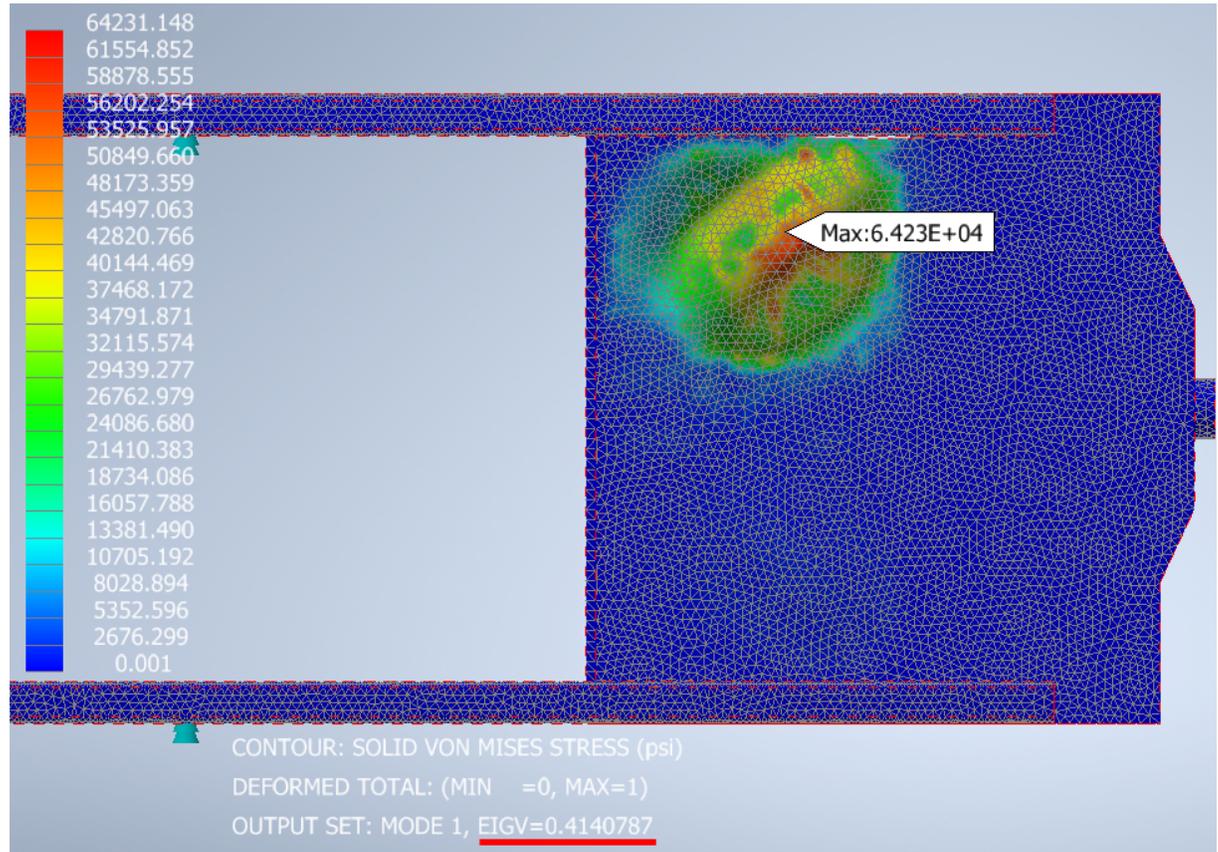
A model for the B-end of the subject car DJJX 30478 was subsequently built using the same procedure by introducing identified defects into the intact model. The thickness of the shear plate was reduced from 0.31 inches to 0.19 inches, and an identified long crack in the shear plate at the location where it joins with the side sill was introduced. Analysis indicated that the output EIGV value was approximately 0.41 (Figure E4), indicating that the critical buckling load of the car was reduced to 410 000 pounds force ($0.41 \times 1\,000\,000$) and the subject car DJJX 30478 B-end could fail when buff loads reached approximately 410 000 pounds of force.

Figure E4. Linear buckling analysis of the platform structure of the B-end of subject car DJJX 30478 (Source: TSB)
