Re: Talgo, Inc. Petition for Reconsideration of National Transportation Safety Board  
Investigation No. RRD18MR001, Accident Report NTSB/RAR-19/01

In accordance with 49 C.F.R. § 845.32, Talgo, Inc. petitions the National Transportation Safety Board to reconsider several of its findings and safety recommendations and its statement of the probable cause of the injuries and fatalities sustained in the high-speed derailment of Amtrak train 501 near DuPont, Washington, on December 18, 2017.

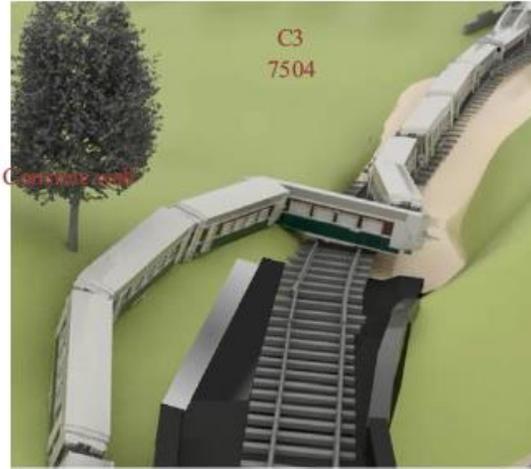
Figure 79 C3 7504. Moment prior to impact

- After the impact against the concrete wall, C3 7504 came to rest on top of C2 7554 and dining car 7804. The truck that belonged to C6 7422, three cars to the rear, was found under and next to C3. Part of the concrete wall was also found there. . . .

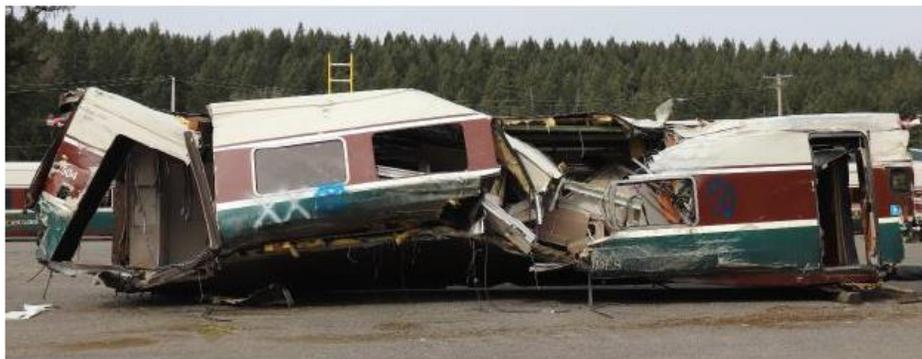
Figure 82 C3 C7504 damage, left side

As can be clearly seen in Figure 82 through 85 of Talgo’s Party Submission, the damage to C3 7504 was produced by an impact with a large rigid body at high speed. The damage was extensive and clearly the result of the collision with the overpass retaining wall.<sup>20</sup>

Analysis of the derailment sequence, the final positions of the railcars, and the physical evidence of damage to Amtrak C3 7504 support Talgo’s conclusion that the breach of C3 7504’s sidewall was from the violent impact with bridge, which tore open the car, and that the rolling assembly from Amtrak C6 7422 only ended up partially in C3 7504 after the bridge damage had occurred.

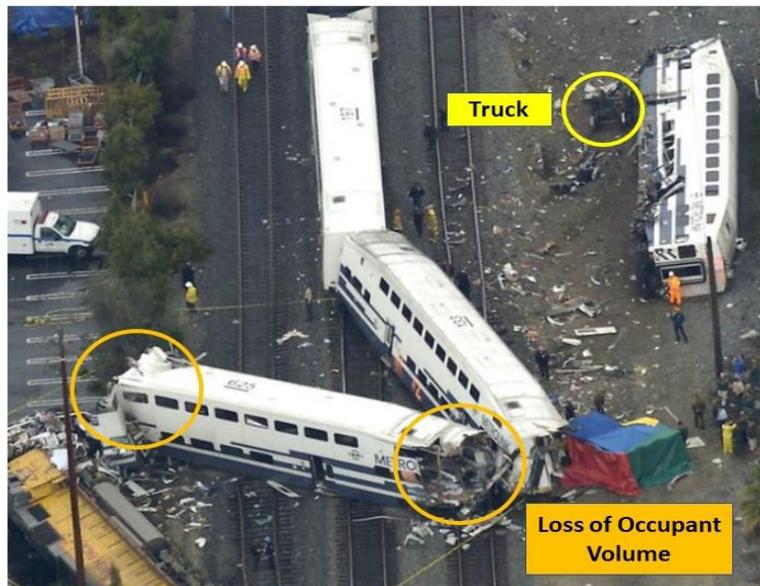
#### **Metrolink Collision with SUV, Glendale, CA (January 26, 2005)**

Train impact with an obstacle and a freight train at 63 mph—11 fatalities, >100 injured.<sup>34</sup>

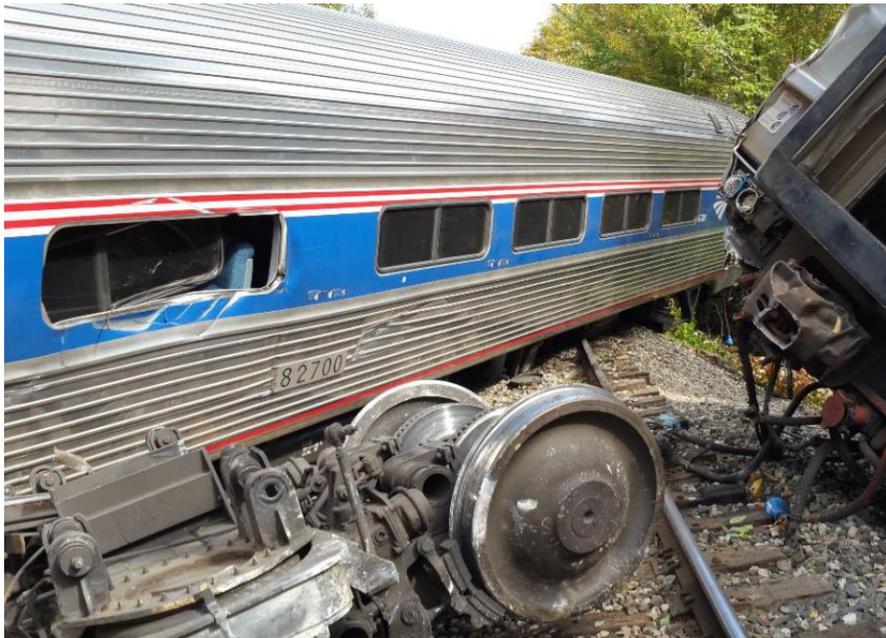
**Amtrak Train 55, Northfield, VT (October 5, 2015)**

Train derailed at 59 mph after striking an obstruction--7 injuries.<sup>36</sup>

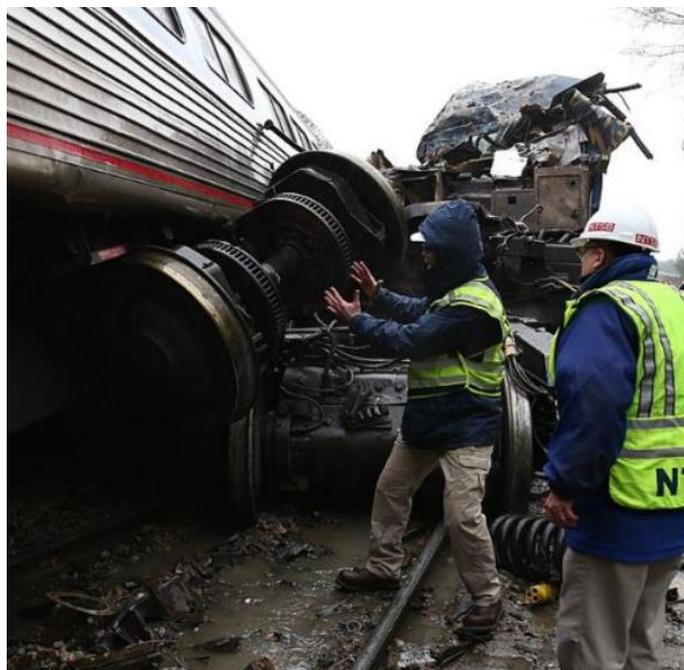
### Amtrak-CSX Collision, Cayce, SC (February 4, 2018)

A southbound train diverted from the main track into a siding and collided head-on with a stationary freight train while traveling 53 m.p.h.—2 fatalities, 92 injuries.<sup>37</sup>

These real-life scenarios also support the argument above that structural features of Talgo’s Series VI trainset actually enhance passenger safety, as evidenced by the number of fatalities and injuries that have happened in the above accidents under similar (or better) speeds and conditions. The reasons the Talgo equipment behaves better than conventional equipment in high-speed accidents stem from the lightweight material of the structural elements, the low center of gravity of the consist, and the articulated connections between the railcars. Those features reduce the energy to be dissipated, and prevent overriding and telescoping, which are key effects involved in the severity of accidents to passengers. The NTSB’s final accident report fails to identify the advantages of the design, and chooses to stress effects (truck detachment) that are erroneously attributed exclusively to the Talgo Series VI equipment, which in this instance occurred at one of the highest accident speeds investigated in recent memory by the NTSB.

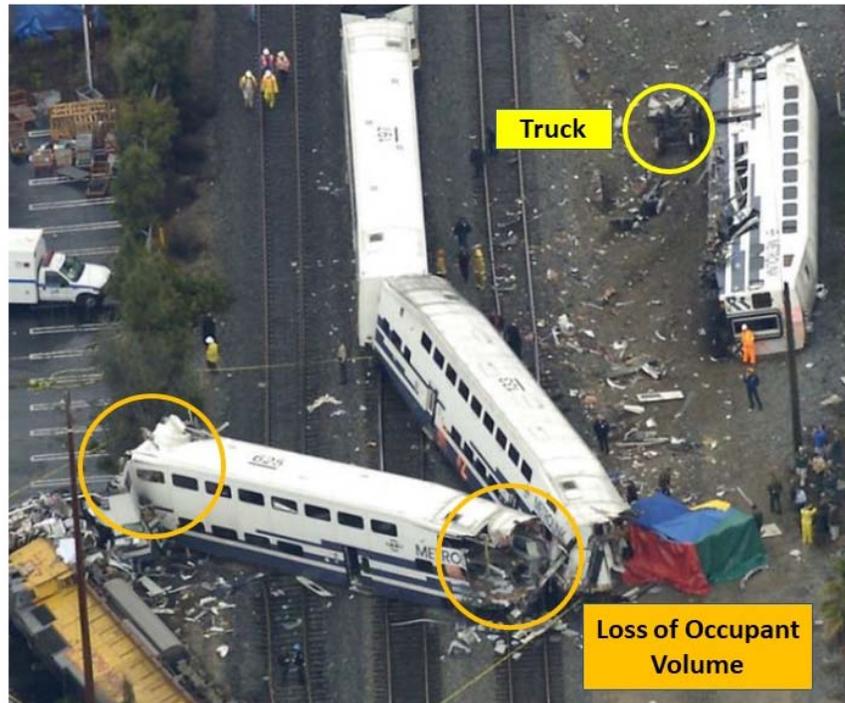
Train impact with an obstacle and a freight train at 63 mph. These rail cars satisfied the 800,000 lb buff strength and 250,000 truck-to-carbody strength requirements.

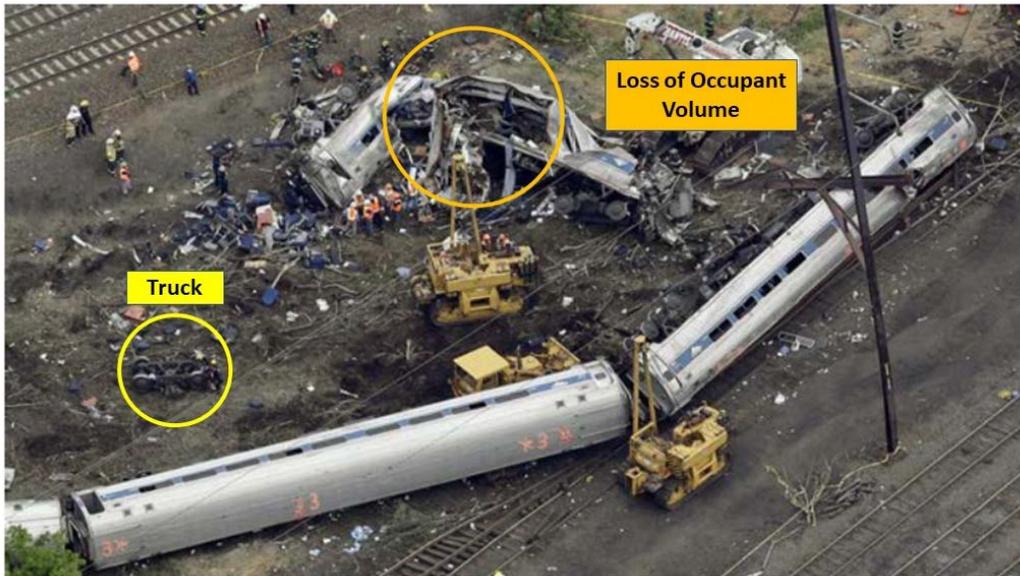
**Frankford Junction, Pennsylvania, 12 May 2015**

Train derailed at 106 mph in a curve with speed restriction of 50 mph. These rail cars satisfied the 800,000 lb buff strength and 250,000 truck-to-carbody strength requirements.

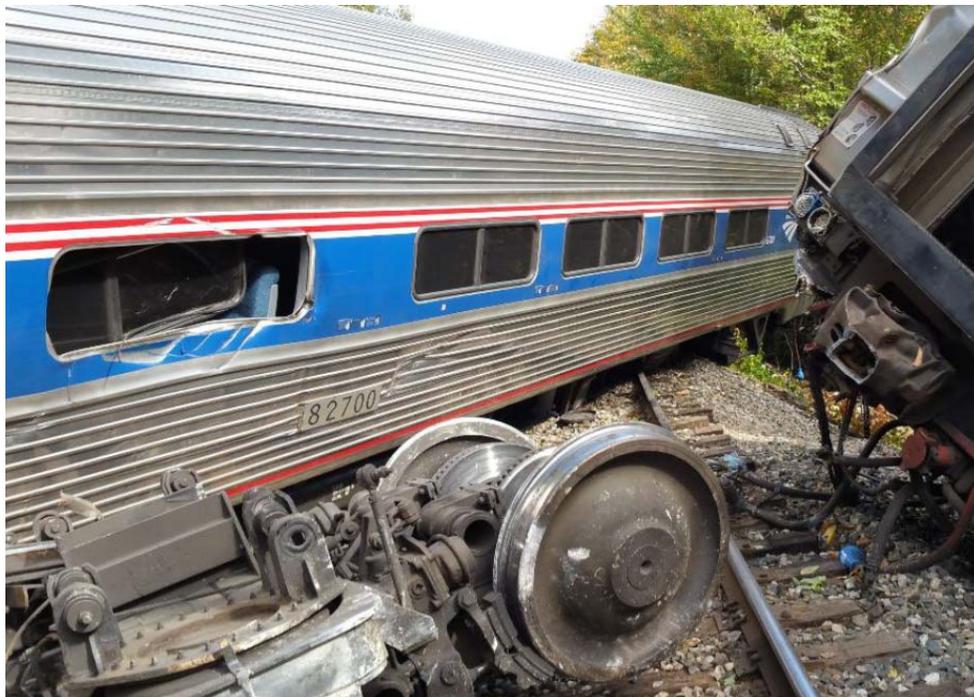
**Northfield, Vermont, 5 October 2015**

Train derailed at 59 mph after striking an obstruction. These rail cars satisfied the 800,000 lb buff strength and 250,000 truck-to-carbody strength requirements.

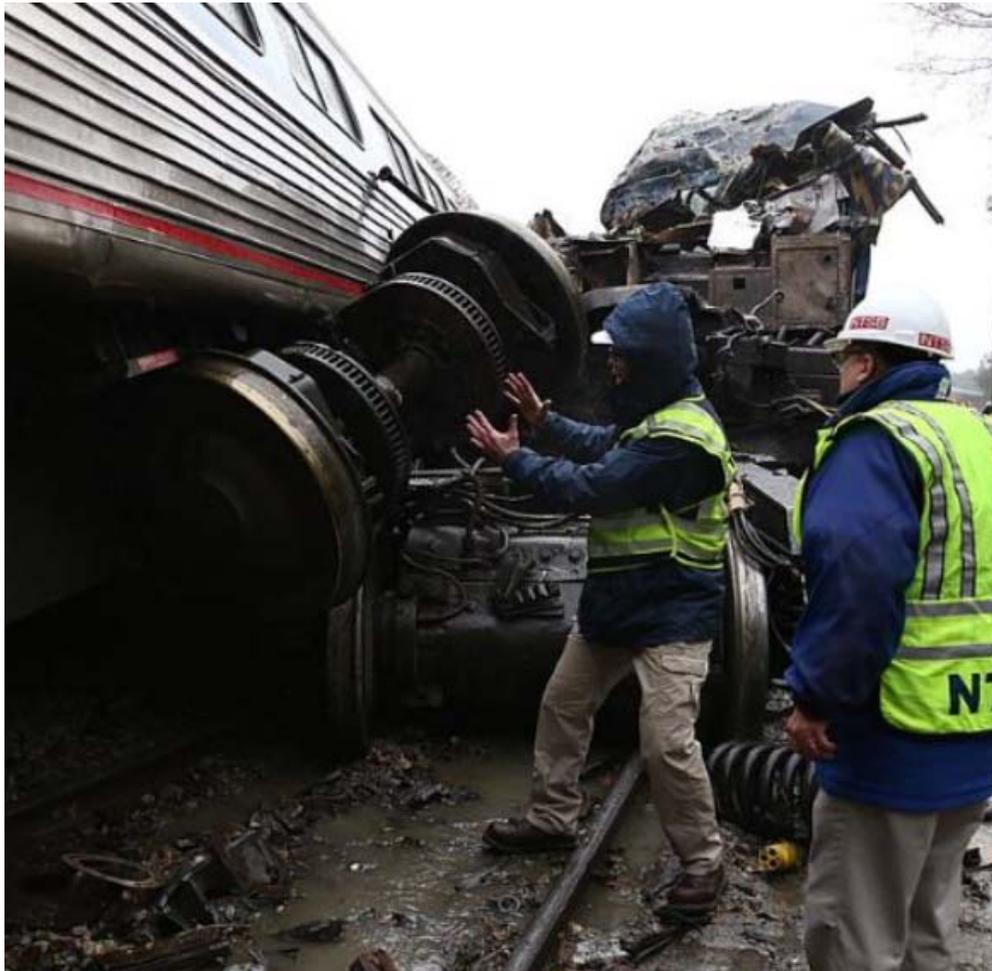
### **Cayce, South Carolina, 4 February 2018**

A southbound train diverted from the main track into a siding and collided head-on with stationary freight train. These rail cars satisfied the 800,000 lb buff strength and 250,000 truck-to-carbody strength requirements.

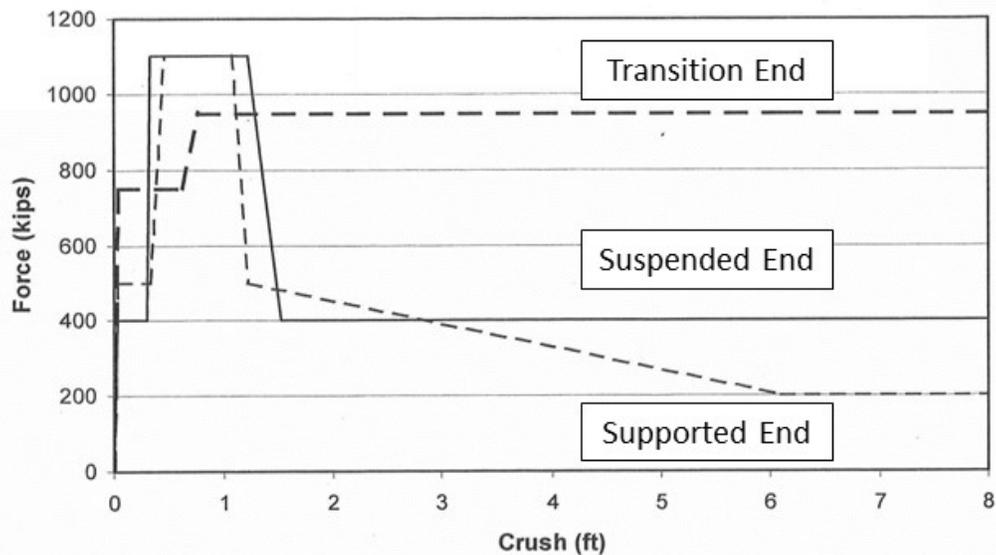
**Figure 2.1 – Talgo VI Car End Crush Responses**

ADL conducted train collision analyses for a simulated closing speed of 50 mph. In this case, ADL found that the maximum crush in the first passenger car of the Talgo VI train was 7 ft, compared to 19 ft in the first passenger car of a conventional train.

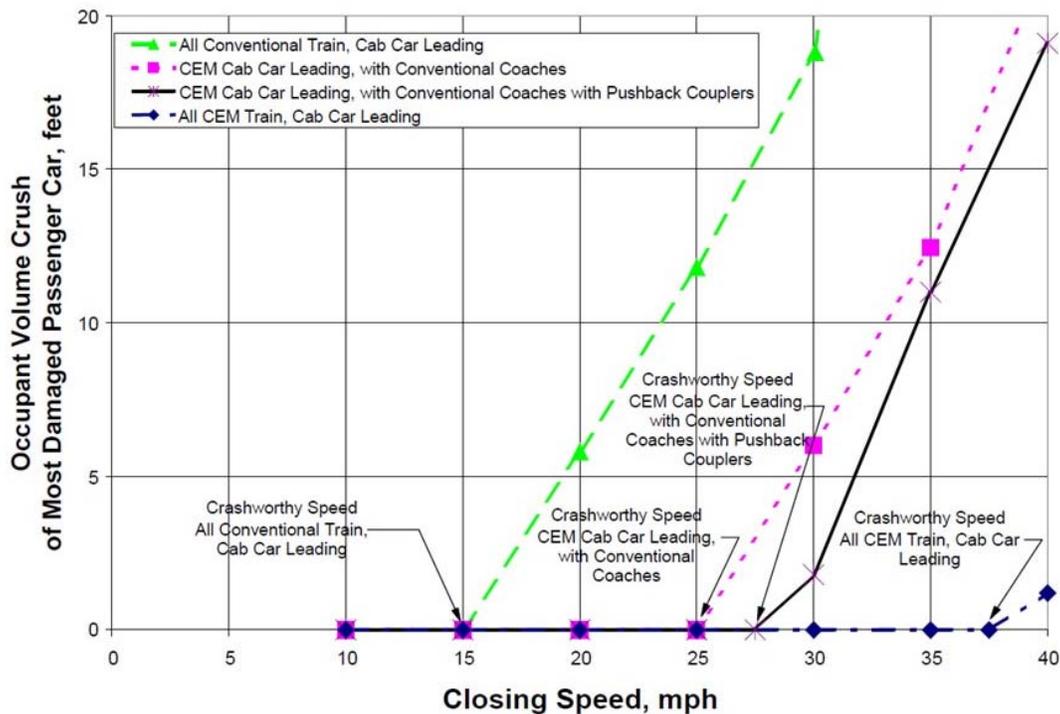
**Figure 2.2 – Plot of Crush vs. Closing Speed for Various Train Types, Including Conventional Trains (from Tyrell and Tsai, 2006)**

This paper includes an evaluation of the safe closing speed for conventional trains that meet the CFR crashworthiness requirements. It is based upon research conducted at the Volpe National Transportation Systems Center (Volpe Center). Figure 2 from this report, reproduced in Figure 2.2 below, shows that the safe closing speed is only approximately 15 mph for a cab car leading consist of convention cars, while trains utilizing CEM are safe at or above 25 mph.

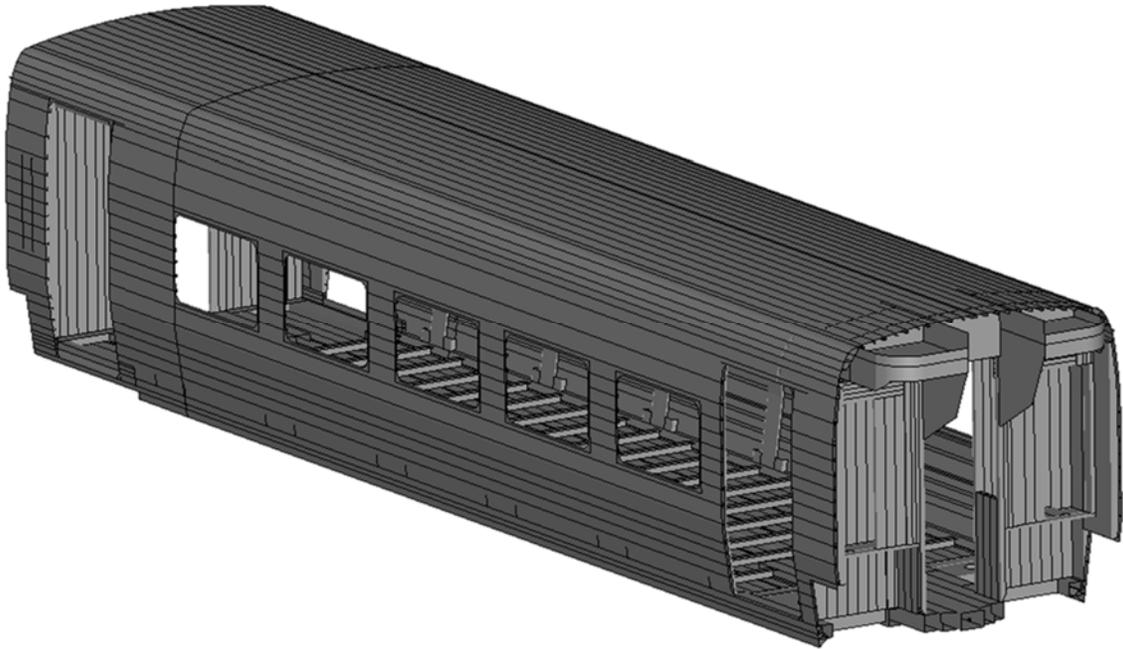
Figure 3.1 – Illustration of the Talgo Series VI Carbody

The Talgo Series VI cars in train consists that have a locomotive or locomotive-like cab car (Amtrak NPCU) and an unoccupied vehicle at each end, with the passenger cars between these vehicles. The locomotive on one end of the consist includes a CEM system on both its lead and trailing ends.

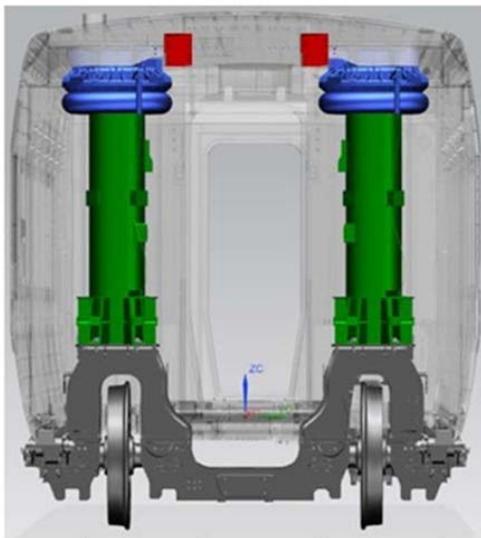
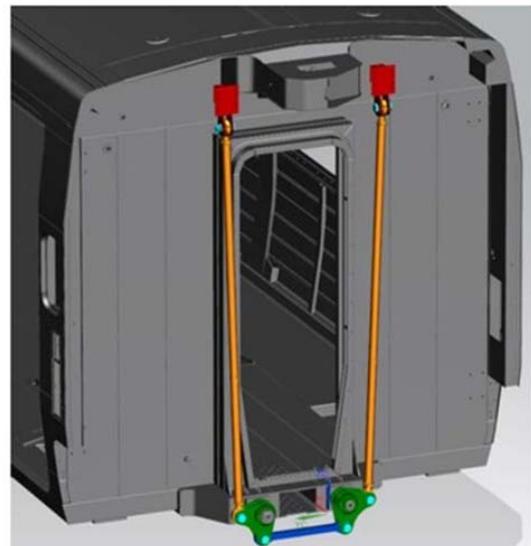
Figure 3.2 – Illustrations of the Supported and Suspended Ends of the Talgo Series VI Cars

Supported end

Suspended end

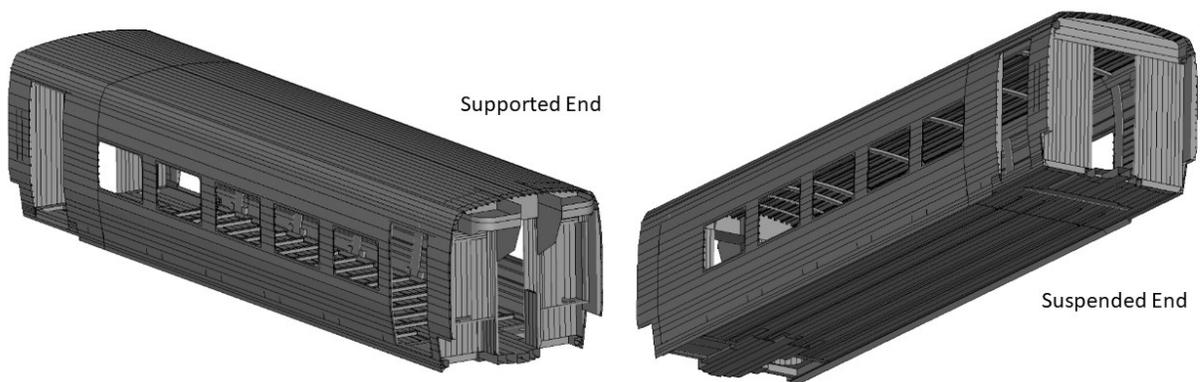
**Figure 4.3 – LS-DYNA Finite Element Model of Talgo Series VI Carbody**

The resulting model, shown in Figure 4.3, consists of 827,179 elements and 789,952 nodes. The model is made entirely of shell elements with a uniform mesh. The characteristic element length is 20 mm. The uniformly meshed carbody is illustrated in Figure 4.4. We used the same material properties as used in the ADL study for the carbody construction material, 6005A T6 aluminum. Table 4.2 and Figure 4.5 summarize the properties.

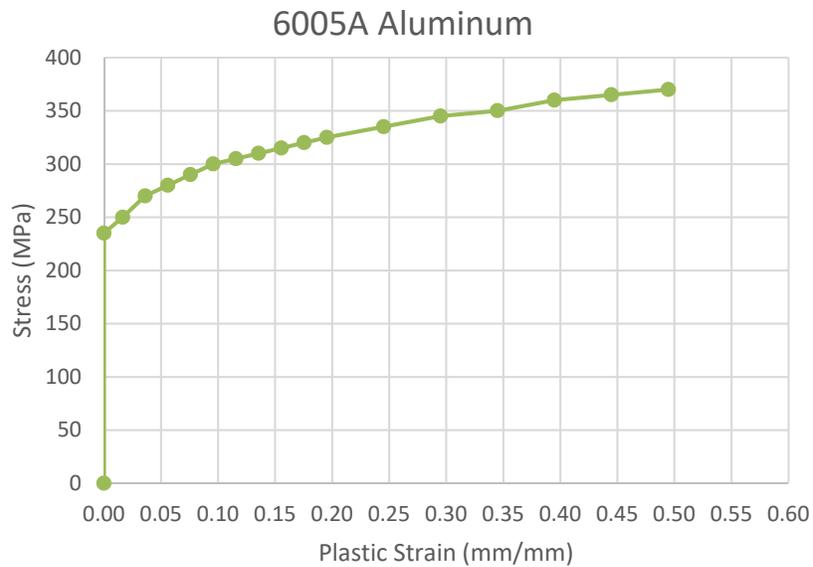
**Figure 4.5 – True Stress vs. True Plastic Strain Curve Used in LS-DYNA Analysis**

**Table 4.2 – Material Properties of 6005A T6 Aluminum**

Property	Value	Unit
Yield Stress	235	MPa
Young's Modulus	69	GPa
Poisson's Ratio	0.33	
Density	2,700	kg/m <sup>3</sup>

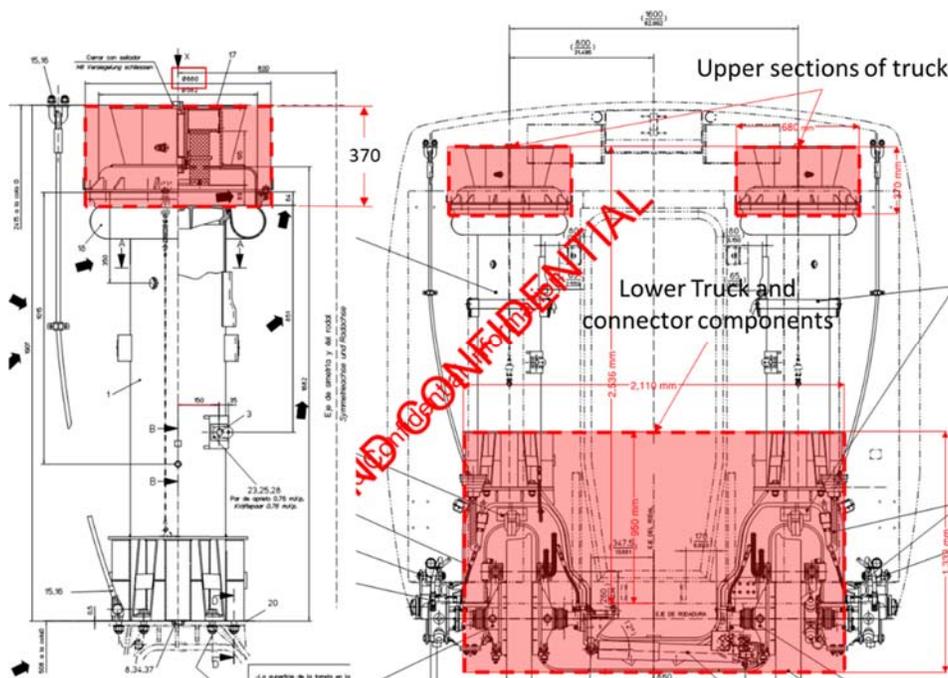
Figure 4.6 – Loaded End Wall Areas in the Occupant Volume Strength Analysis

We applied a prescribed displacement history to the suspended end through rigid blocks over areas to represent the collision load path and we constrained the corresponding areas through blocks at the supported end. The areas are (Figure 4.6):

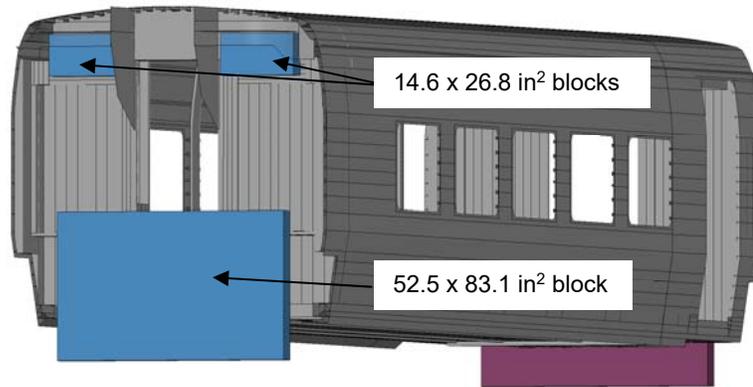
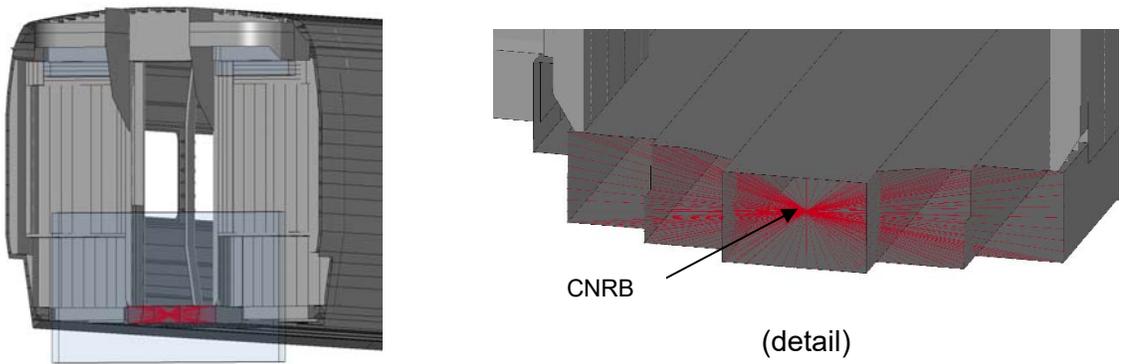
**Figure 4.7 – Supported End Boundary Constraints Applied to LS-DYNA Model**

For the fixed (constrained) area blocks, longitudinal motion is constrained through contact between the carbody structure and the blocks (Figure 4.7). The constraint at the articulated connector is applied through a constrained nodal rigid body (CNRB), which rigidly connects the nodes shown in the figure. A central node is used to control the motion of the overall CNRB. In this model, the CNRB on the supported end is fully fixed—no linear or rotational motion is permitted at the CNRB nodes. We applied a prescribed velocity condition on the same areas but at the suspended end, as shown in Figure 4.8. We used the normalized curve shown in Figure 4.9 to apply the velocity in the longitudinal direction. With this curve, we increased the velocity slowly and smoothly to produce a quasi-static loading history with minimal dynamic response. The steady state velocity magnitude was 0.5 m/sec (1.6 ft/sec).

a. Constraining blocks on supported end

b. Constraint at supported end articulated connection anchor

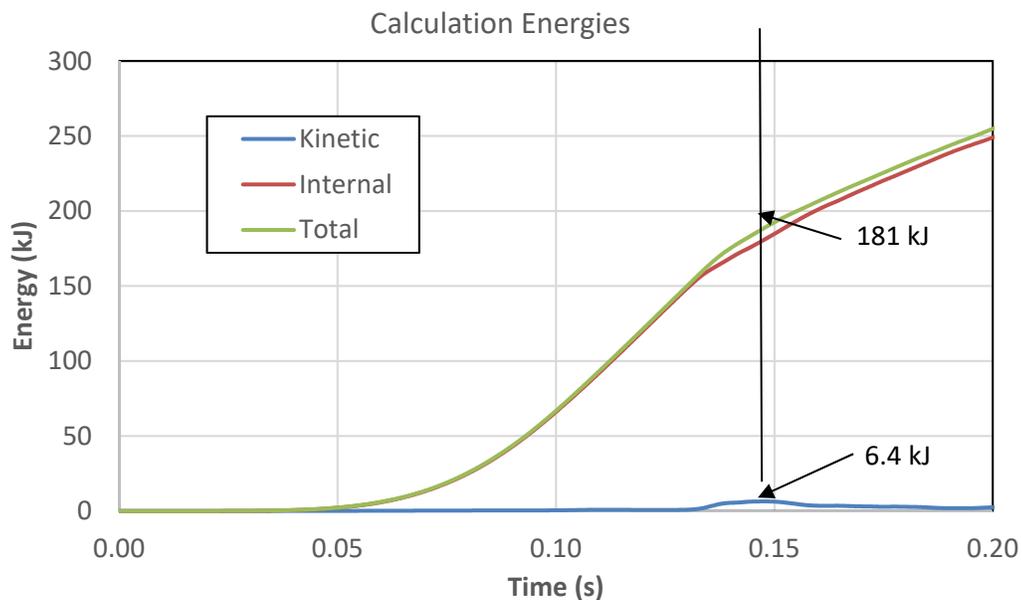
**Figure 4.10 – Calculation Energy Shows that the Simulation is Quasi-Static (6.4 kJ Kinetic /181 kJ Internal = 3.5% at Point of Peak Kinetic Energy)**

Figure 4.10 shows plots of internal energy and kinetic energy vs. time. The kinetic energy is less than 5% of the internal energy, including when the carbody cripples and kinetic energy is maximum, which shows that the calculation is quasi-static (see Section 4.4.2 of DOT/FRA/ORD-11/22). The resulting load-displacement curve and the deformed shape at 1,200 kips are shown in Figures 4.1 and 4.2, respectively.

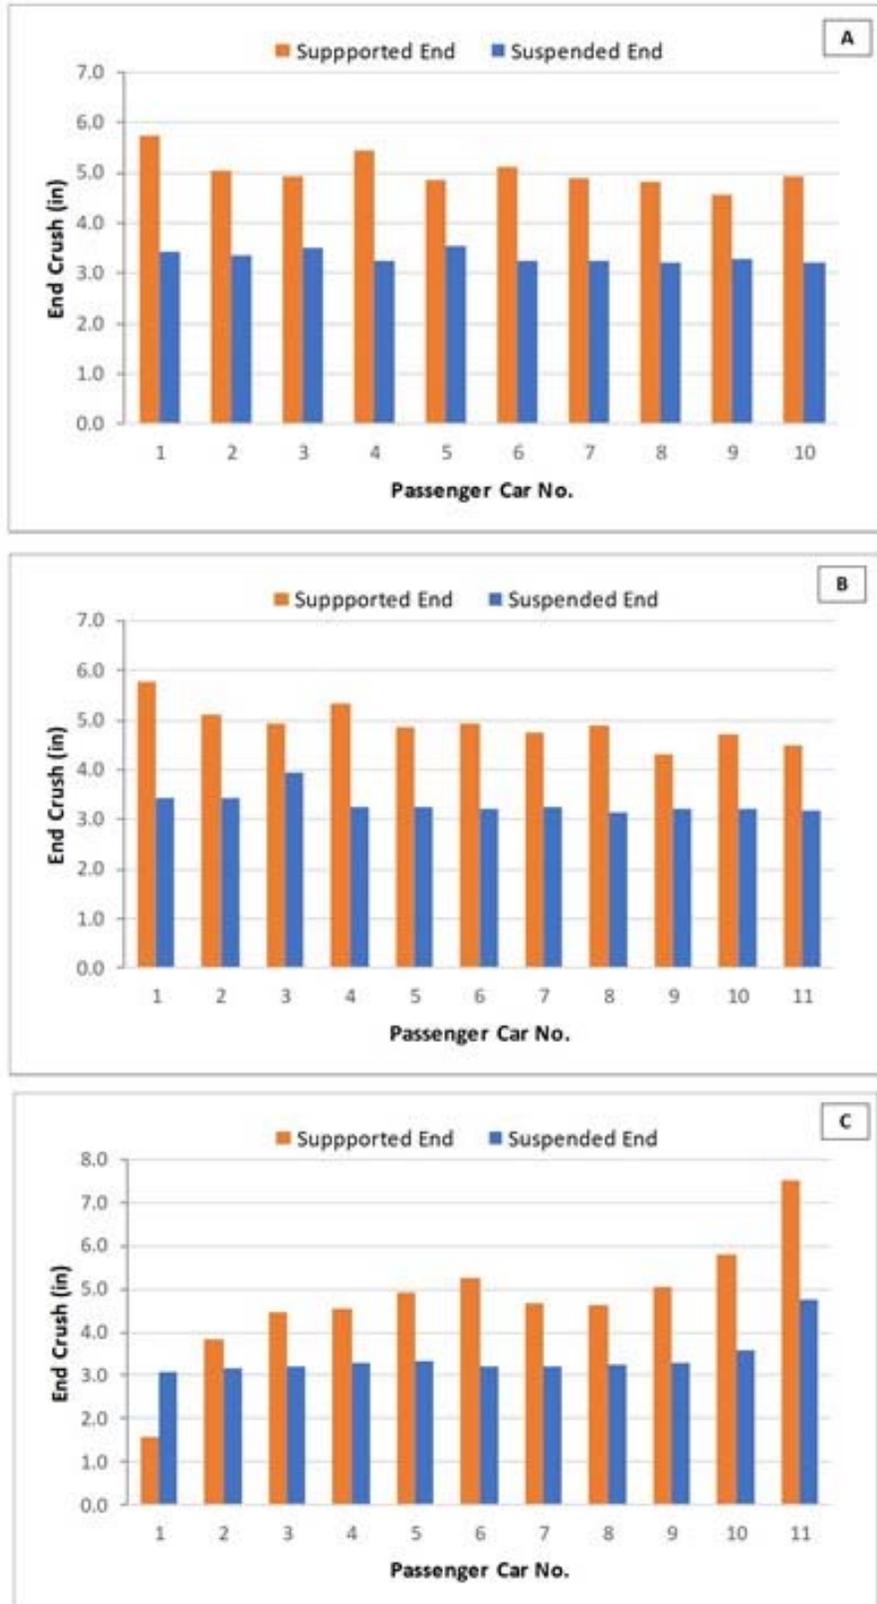
Figure 4.11 – Summary of Talgo Series VI Carbody End Crush Results for Three Collision Scenarios

The maximum deceleration of a simulated Talgo VI car mass in this simulation is 21 g. This is used in evaluation of the truck-to-carbody attachment strength, Section 4.7.

The crush results of the simulations are shown in Figure 4.11. The maximum acceleration of a simulated Talgo VI car mass in this simulation is 21 g.

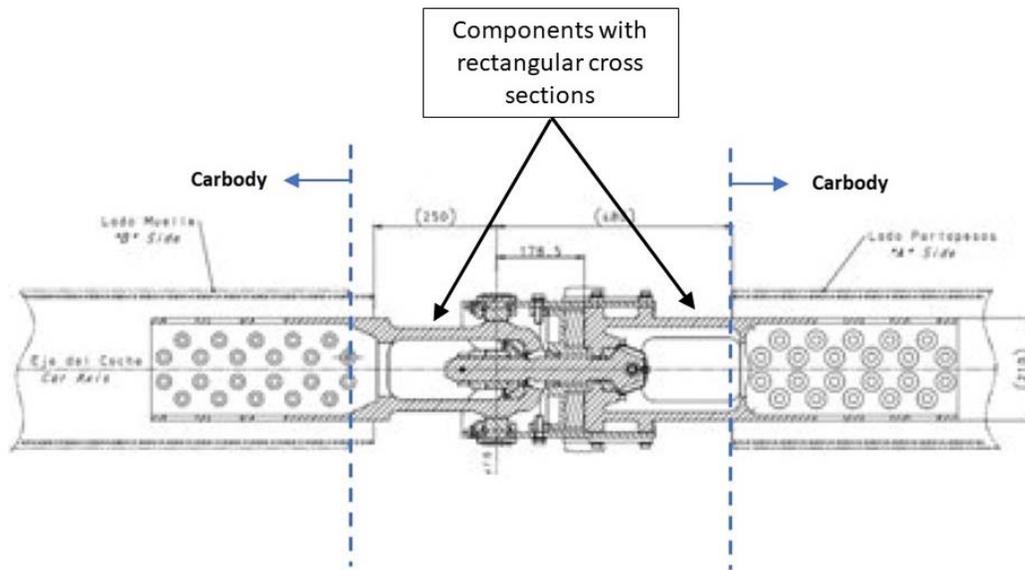
**Figure 4.14 – The Articulated Connection Showing the Components with Rectangular Cross-Sections**

The shear yield strength is governed by the yield strength of the pin and is equal to 82.1 kips.

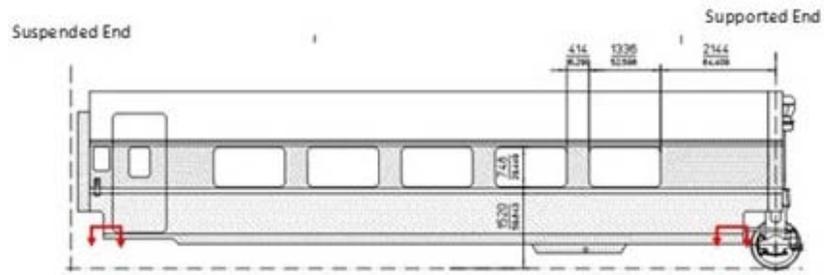
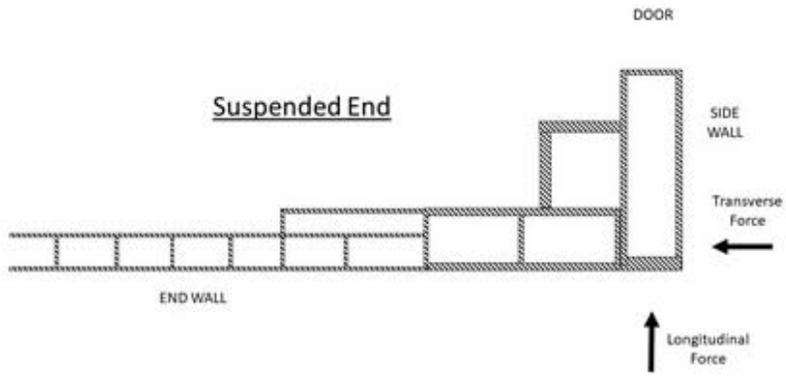
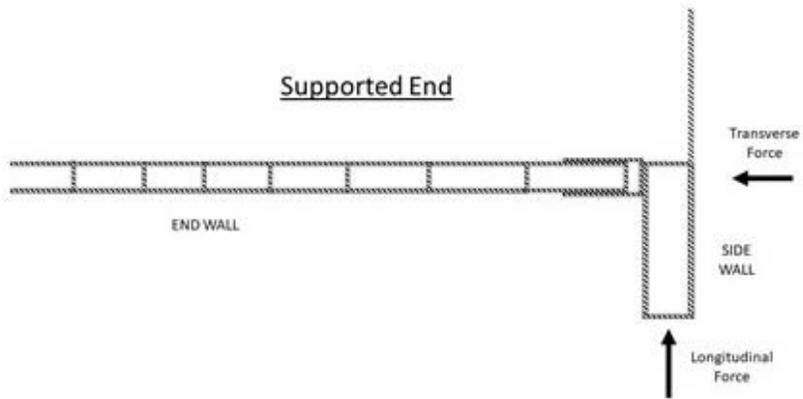
Figure 4.15 – Underframe Corner Structures Considered in Strength Evaluation

Location	Longitudinal (kips)	Transverse (kips)
Suspended End	21	28
Supported End	21	24

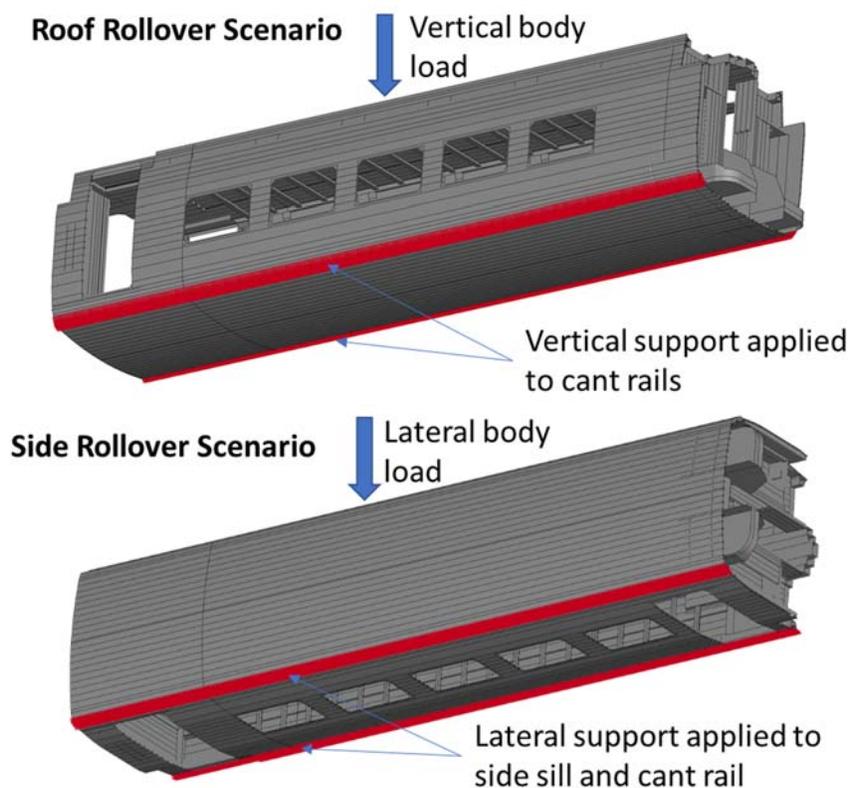
Figure 4.16 – Rollover Strength Assessment Model Loads and Boundary Conditions

We used the finite element model described in Section 4.1.1 to assess the carbody rollover strength compared to 49 CFR §238.215. The regulation requires investigation of two scenarios: one with the carbody resting on its side, supported at the side and cant rail, and one resting on its roof, supported by both cant rails. The model setup for both scenarios is shown in Figure 4.16 below.

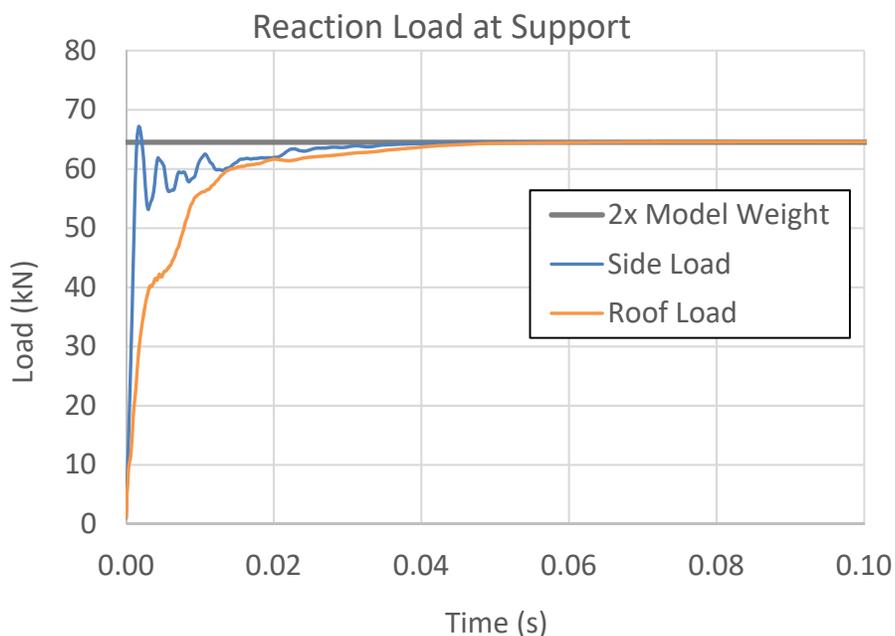
**Figure 4.17 – Reaction Loads Illustrating Static Load Convergence**

To optimize the load initialization process, we used a combination of instantaneously applied gravity and global damping to minimize dynamics and to simulate a resting condition. We ran short dynamic test calculations to determine appropriate damping constants for the system in both the side and roof supported configurations. Ideally, the damping constant should result in near critical damping. The reaction load histories measured at the supports for both scenarios are provided in Figure 4.17, which shows that both simulations quickly converged on the expected full load.

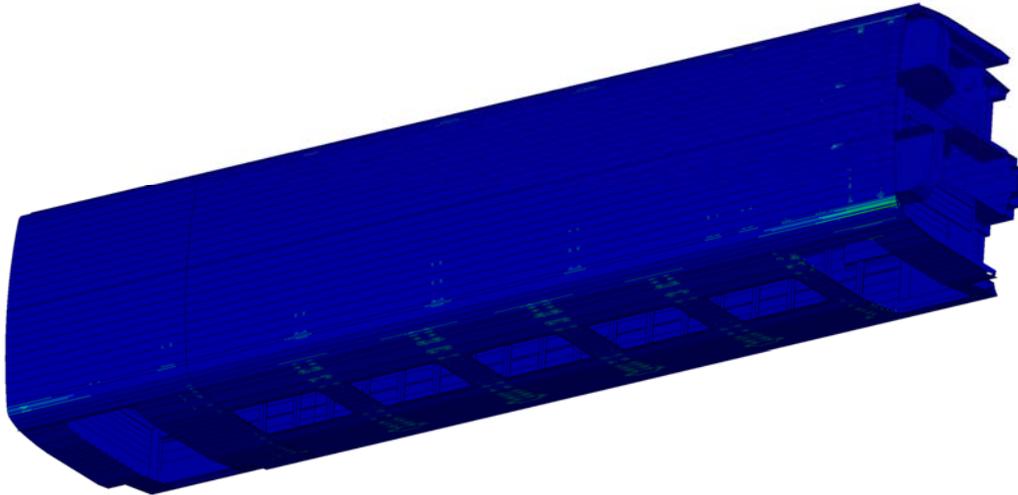
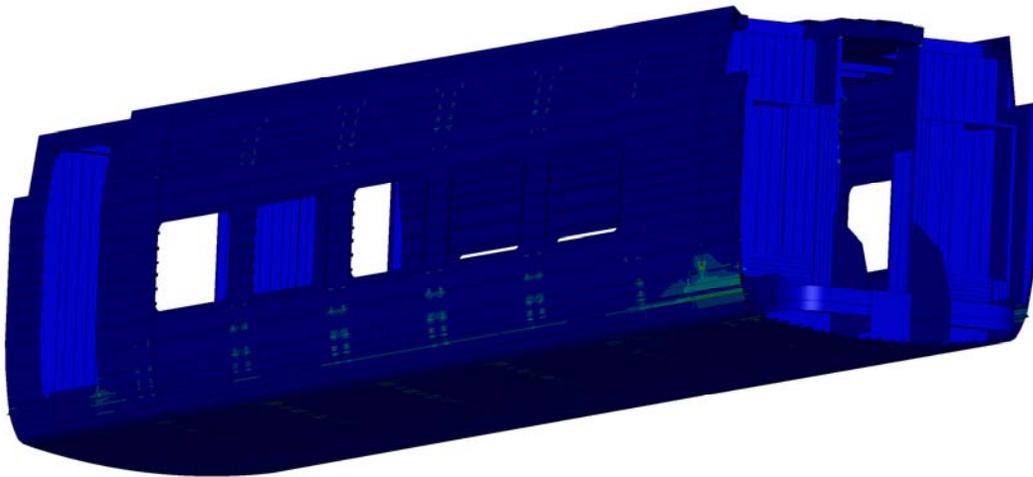
Figure 4.18 – Rollover Analysis Scenarios, Resultant Stress

a) Side loading (Maximum stress: 40 MPa (5.8 ksi))

b) Roof loading (Maximum stress: 55 MPa (8.0 ksi))

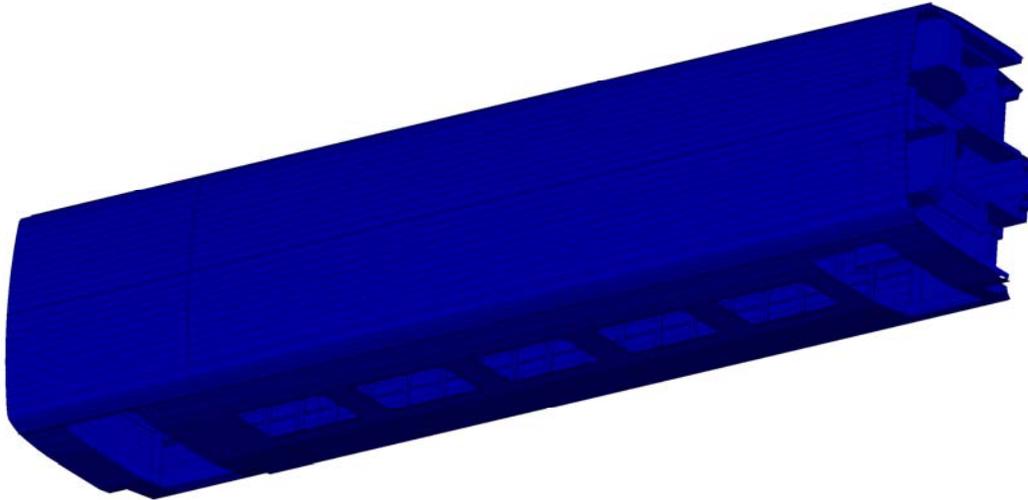
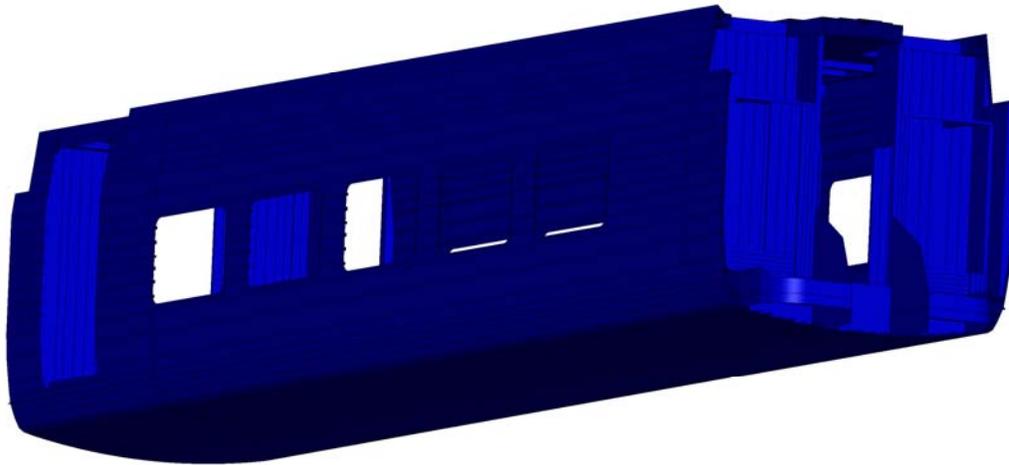
Figure 4.19 – Rollover Analysis Scenarios, Plastic Strain

a) Side loading (no plasticity)

b) Roof loading (no plasticity)

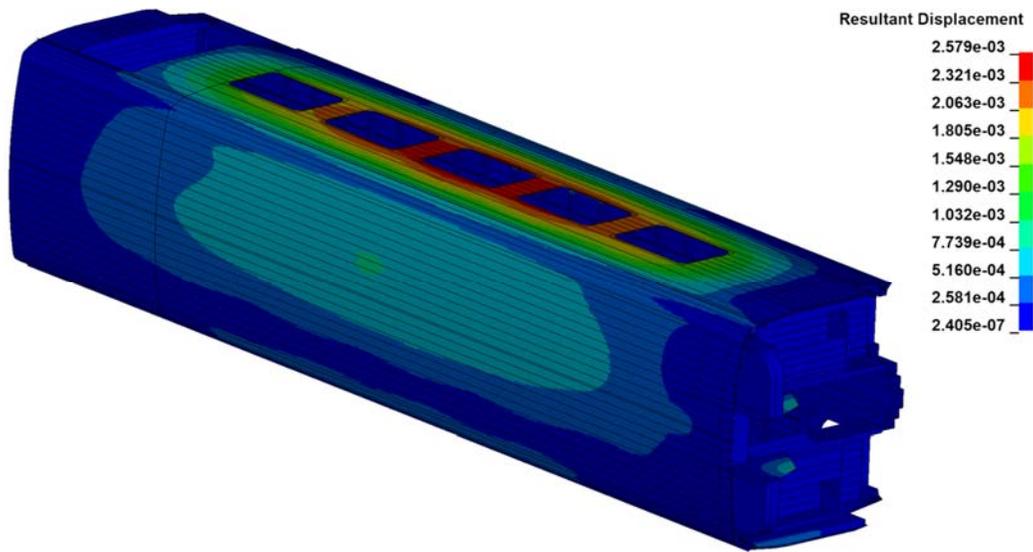
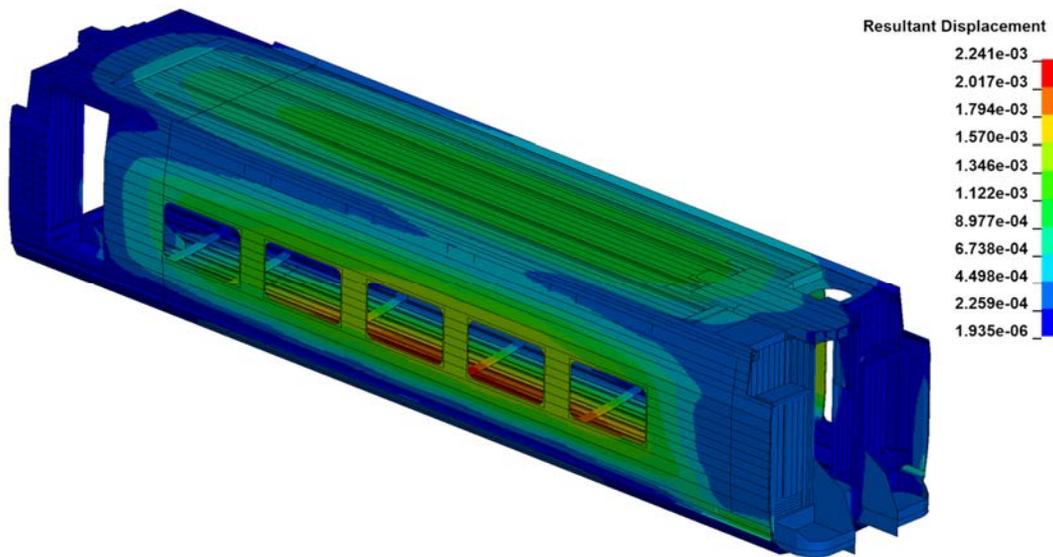
**Figure 4.20 – Rollover Analysis Scenarios, Resultant Displacement**

a) Side loading (Maximum displacement: 2.6 mm (0.10 in.))

b) Roof loading (Maximum displacement: 2.2 mm (0.09 in.))
