# The Washington Metrorail Safety Commission

## Safety Audit

## Audit of Revenue Vehicle (Railcar) Programs

Final Report:  
September 14, 2021

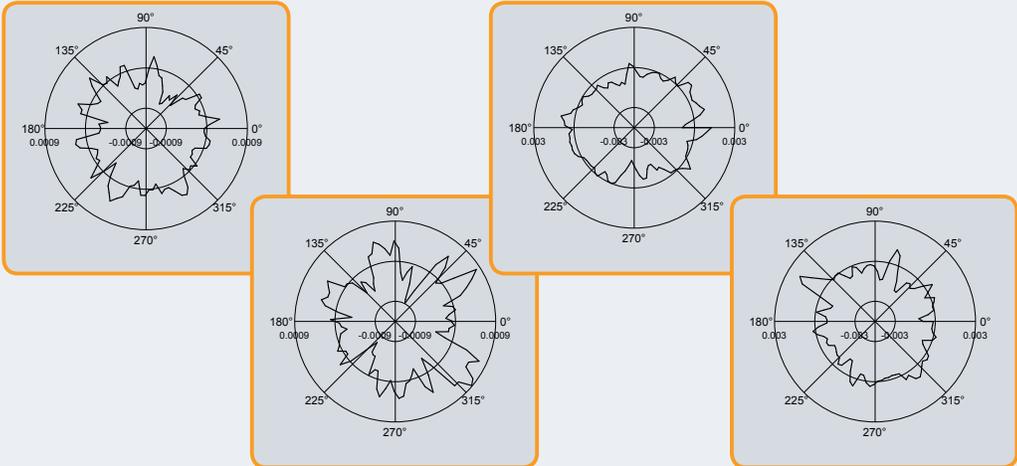
Those interviewed for this audit stated that Metrorail defines an out-of-round wheel as a wheel with a difference greater than 0.015" between the highest and lowest radius measured on a wheel. Once a wheel is out-of-round, it can be cut to return it to the proper shape. However, there was mixed understanding during interviews of this standard and whether that meant that Car Maintenance personnel were not permitted to cut the wheels before the wheels reach that threshold. It was noted in interviews that an out-of-round wheel can be identified and addressed at lower thresholds, but that some managers are limiting cuts to occurring only at 0.015" while others are allowing cuts earlier when the issue is detected and reported with the wheel out-of-round 0.008" or 0.009".

**Measurements used to determine the degree to which wheels are out of round.**

Even using the 0.015" threshold, different shops and wheel lathe operators are cutting the wheels differently because there is no documented standard on how best to address this issue. More experienced operators appear to be cutting the wheels more deeply to ensure that defects are fully removed, but that guidance is not documented and communicated to others.

**Minimum Corrective Action:** Metrorail must implement a consistent procedure for reporting and addressing wheels out-of-round, including processes to identify and mitigate root causes and to prevent cars with wheels out-of-round from operating, and must train personnel appropriately, including any relevant guidance for wheel lathe operators and their supervisors on the depth of cuts.
