CSX Train Derailment with Hazardous Materials Release
Hyndman, Pennsylvania
August 2, 2017

NTSB/RAR-20/04
PB2020-101012

Railroad Accident Report

CSX Train Derailment with Hazardous Materials Release

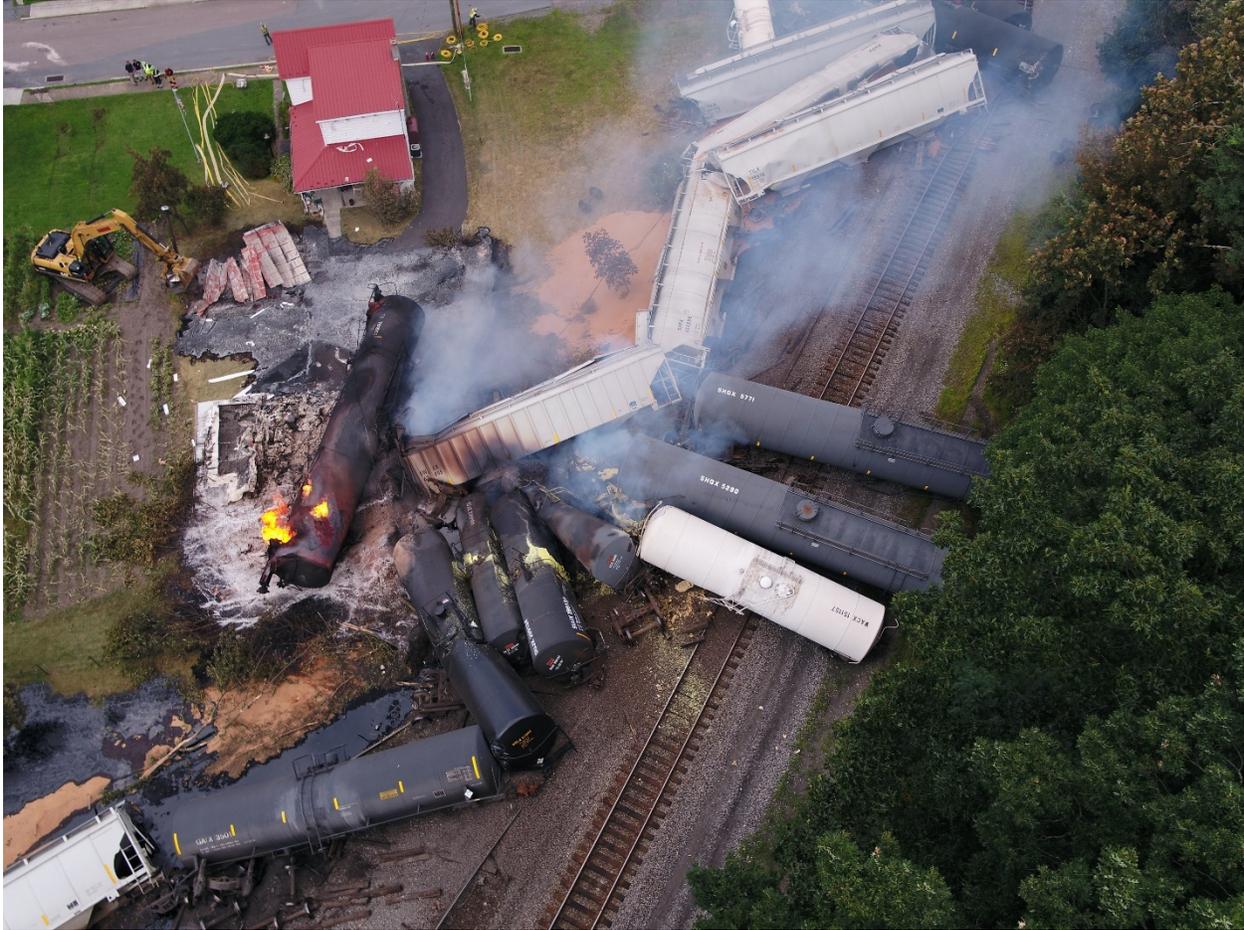
Figure 2. Overhead view of derailment of CSX freight train Q38831. (Courtesy of CSX.)

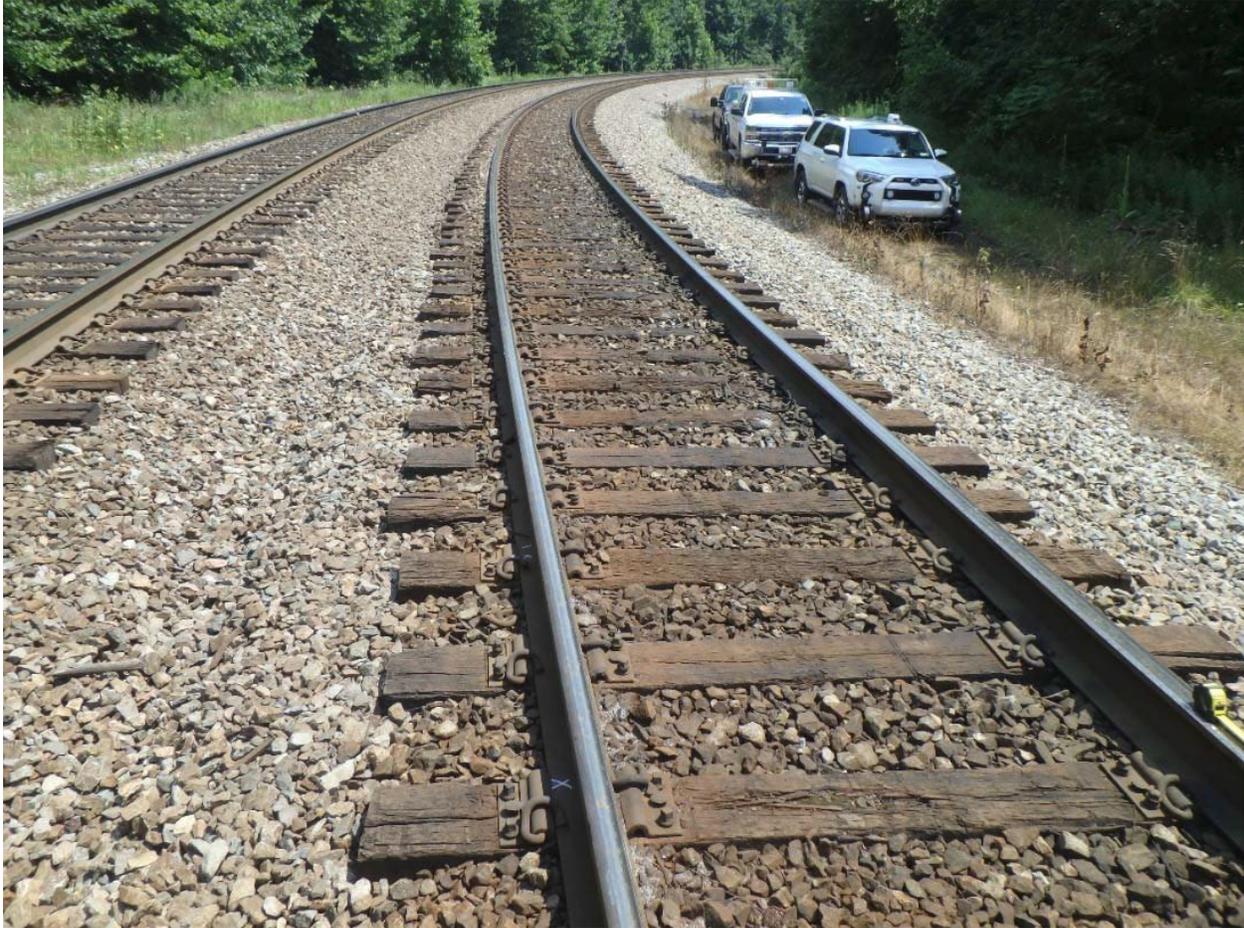
Traveling on main track 2, the train moved through a descending grade beginning at MP 209.8 (top of grade) to MP 192.3 (train resting location). The grade is one of the steepest grades in the CSX system. At the POD (MP 193.8), the train was moving through a right-hand curve that has a permanent speed restriction of 30 mph for freight trains. (See figure 7.) As stated previously, the train had been traveling at 29 mph at the time of derailment.

Figure 7. Accident curve facing east toward direction of accident train travel.
