Transportation
Safety Board
of Canada

RAIL TRANSPORTATION SAFETY INVESTIGATION REPORT R19T0107

MAIN-TRACK TRAIN DERAILMENT

Canadian National Railway Company
Freight train M38331-27
Mile 60.55, Strathroy Subdivision
Sarnia, Ontario
28 June 2019

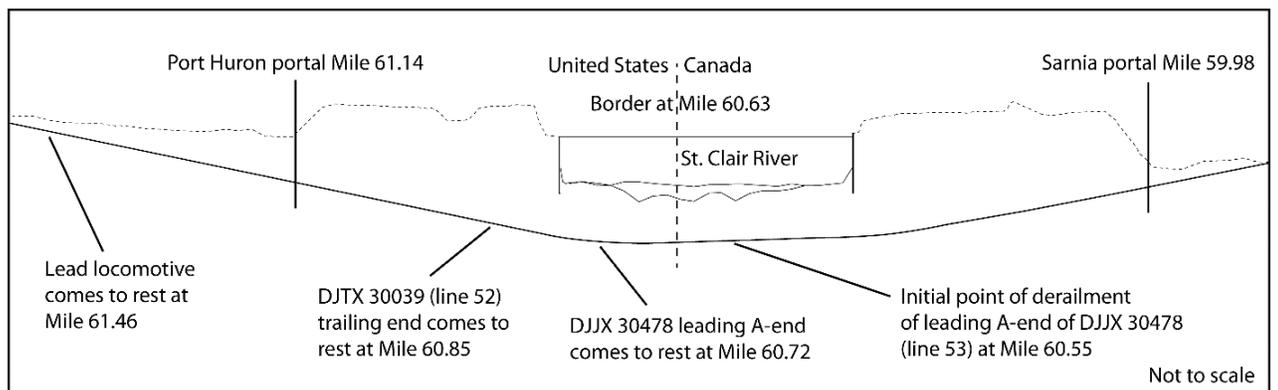
Figure 9. Diagram showing initial point of derailment and mileage of relevant car locations (Source: TSB)

Eastward from the B-end of car DJJX 30478 (line 53), scrap steel was sporadically observed on the ballast along the south side of the tunnel, extending back to about Mile 60.55. A schematic diagram of the tunnel illustrating the initial POD and the mileage for the location of various relevant rolling stock are presented in Figure 9.

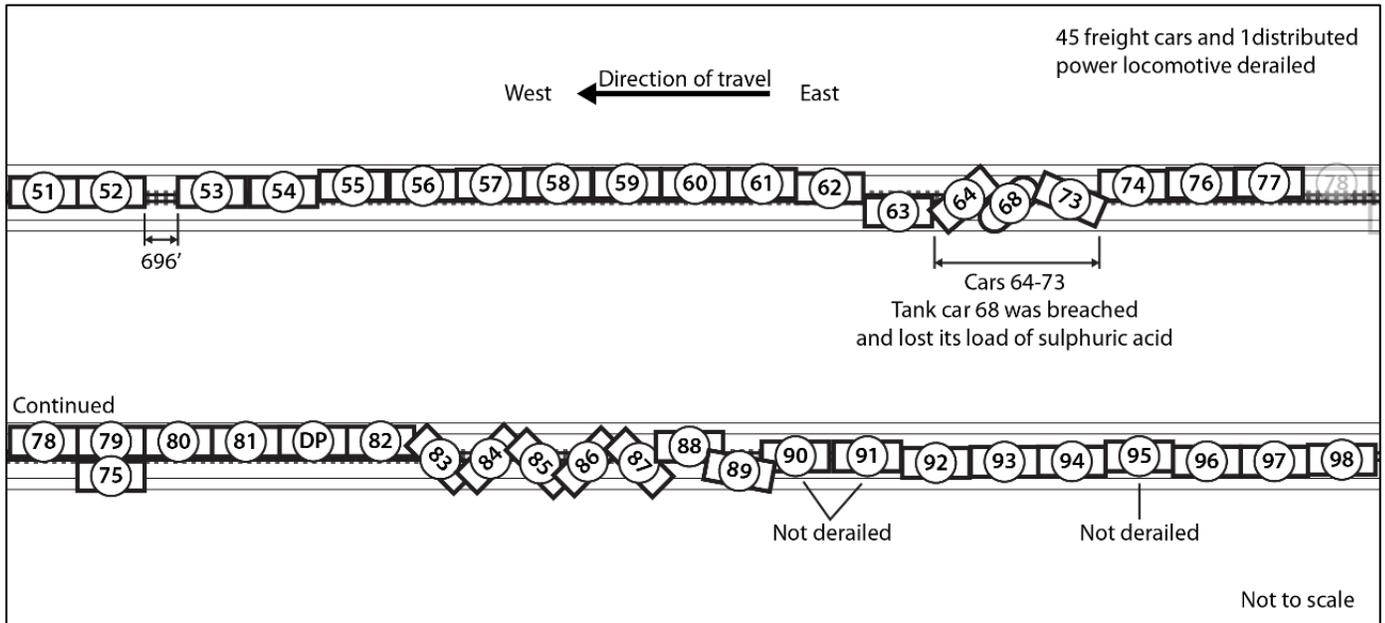
Figure 12. Diagram of derailed cars in the tunnel (Source: TSB)

During the afternoon of 29 June 2019, CN personnel accompanied TSB and NTSB investigators as they entered the tunnel on the Canadian side and made their way along the walkway on top of the tunnel's north reinforcement wall up to the point where the route was impassable due to the derailed cars (Figure 12).

Similar to the situation on the U.S. side, many of the derailed cars had jackknifed and came to rest between the tunnel’s reinforcement walls in various positions (Figure 13).

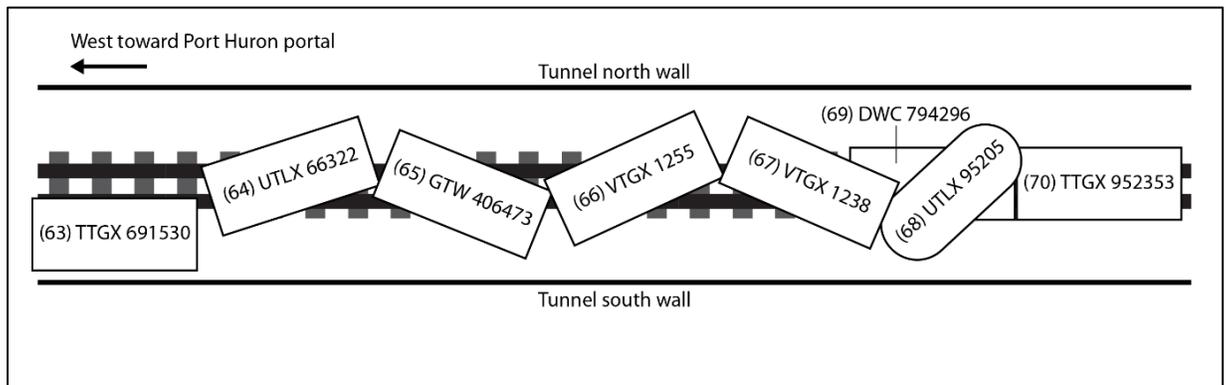
Figure 15. Schematic of derailment within the tunnel between lines 63 and 70 (Source: TSB)

On 01 July 2019, CN contracted Exelon Corporation to conduct a confined-space aerial inspection of the wreckage using a caged drone. The inspection focused on the inaccessible freight cars in the centre of the derailment, between lines 63 and 70 (Figure 15).

- Tank car UTLX 95205 (line 68) came to rest suspended about 4 feet above the tunnel's north reinforcement wall.
- It was situated diagonally across the tunnel, with the leading B-end near the tunnel's south wall, and the trailing A-end near the tunnel's north wall.
- The A-end right side of the head exhibited a large dent but no visible breaches, and the A-end right side car body bolster was bent (Figure 16).
- There was no visible damage to the top fittings, but acid residue was observed on the safety vent.
- The trailing-end stub sill and coupler of covered hopper car VTGX 1238 (line 67) had impacted and punctured the lower left quadrant of the UTLX 95205 B-end tank head (Figure 17).

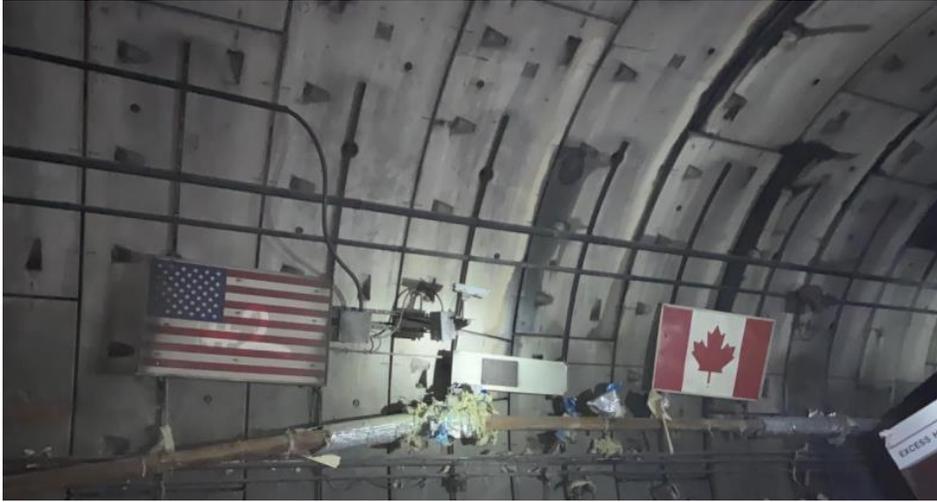
Figure 19. Marker showing the international border between Canada and the United States at Mile 60.63 (Source: Environmental Protection Agency)

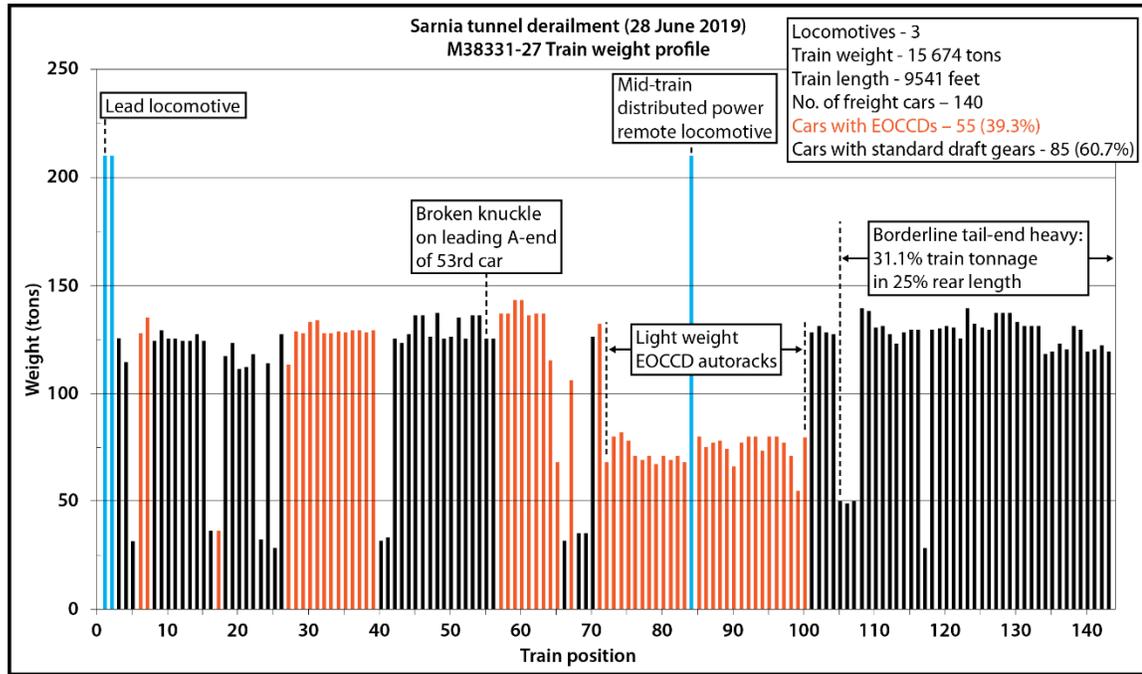
Figure 20. Weight profile of occurrence train (Source: TSB)

The train had 31.1% of its tonnage in the rear 25% of the train (Figure 20), which made the train borderline tail-end heavy, according to CN marshalling rules. Also, the DP remote locomotive placement between line 81 and line 82 did not comply with CN's DP remote locomotive placement criteria. For the train departing Sarnia, according to CN's Train Marshalling Job Aid, the DP remote locomotive should have been placed between lines 114 and 115 of the train.

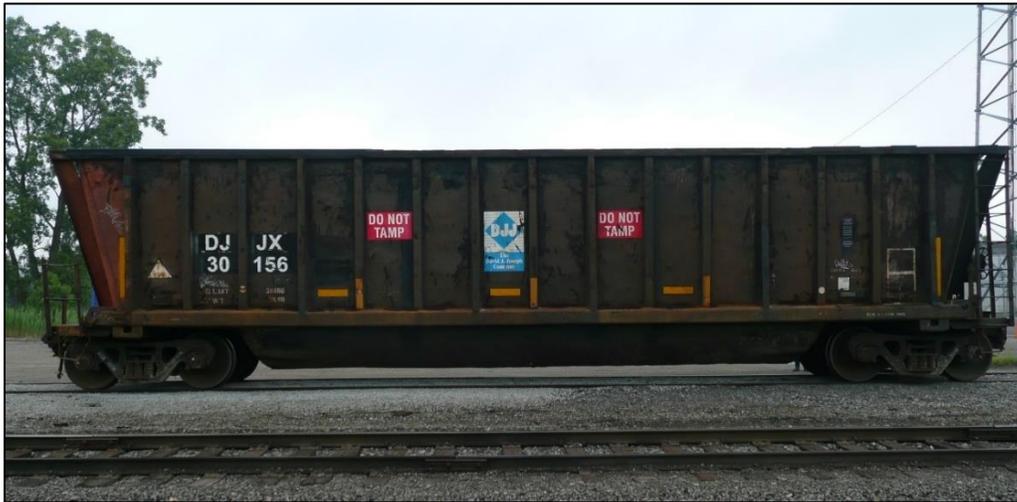
Figure 22. Side view of DJJX 30156 (line 13) bathtub gondola car, which was a car of the same design as DJJX 30478 (Source: TSB)

The 5 DJJX bathtub gondolas of the similar vintage that were removed from head end of the occurrence train following the accident included DJJX 30156 (Figure 22), which was a car of the same design as failed car DJJX 30478 (line 53). Both cars were manufactured in 1978 by Berwick Forge.

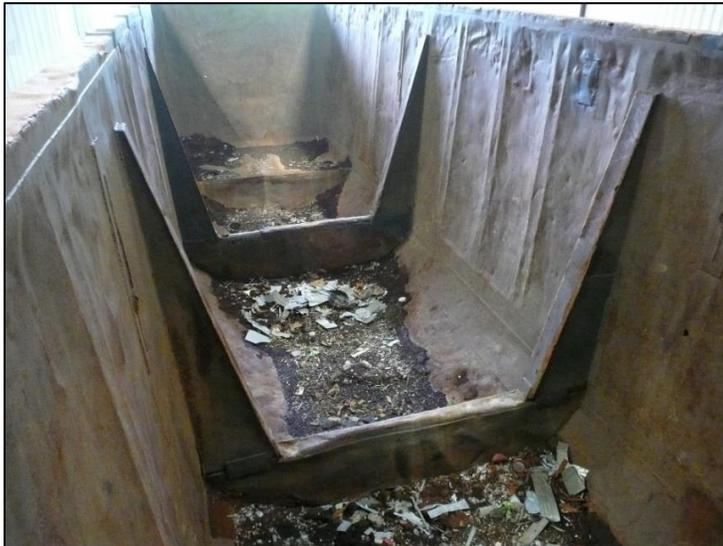
Figure 24. Car DJJX 30156, as modified, with 2 large steel u-channels fabricated inside the car to compensate for the removal of the 2 upper reinforcement crossbars (Source TSB)

was based on the requirements for the design of freight cars as found in AAR Standard M-1001, (*Specifications for the Design, Fabrication and Construction of Freight Cars*) which covers what is considered normal usage. The effectiveness of the modifications, like any reinforcement, will only provide satisfactory service if it is not exposed to an environment that stress the components beyond their inherent strength.

The proposed modification required that the 2 upper reinforcements be removed and replaced with vertical stiffeners while the 2 lower reinforcements were to be enclosed and protected. The modification had the appearance of 2 large steel u-channels (U-channels) inside the car to compensate for the structural change (Figure 24). The modification was also needed to reinforce the parabolic curved bottom sheet (tub) and secure it to the side sills and side sheets of the car.

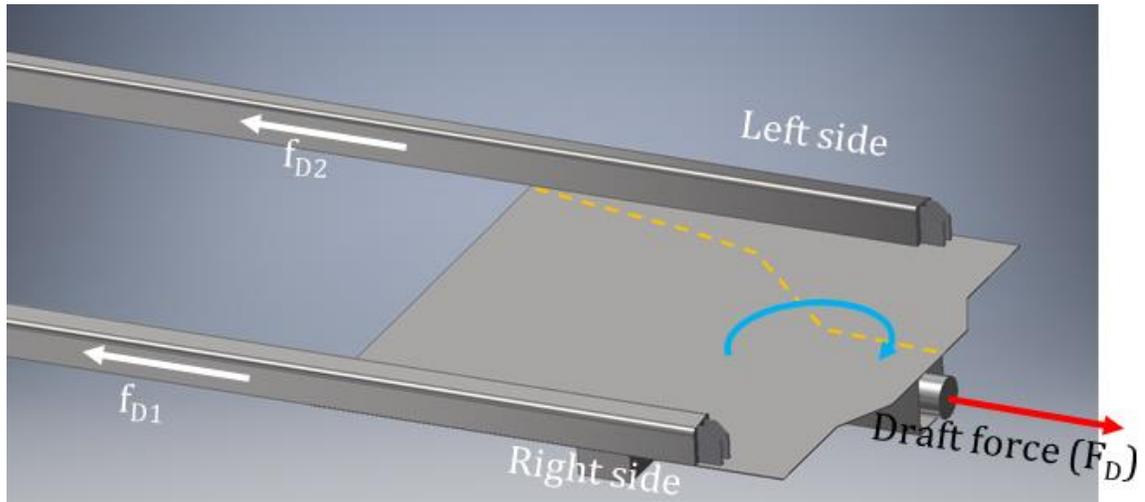
Figure 32. In-train draft force (F_D) acting on the car while the train negotiated the tunnel (red arrow). The blue circular arrow identifies the torque resulting from the applied force. The dotted line shows the observed fracture line. (Source: TSB)

The FEM included the structural defects observed in the A-end of DJJX 30478. FEM analysis determined that the combination of forces acting on the A-end when it was subjected to in-train draft force would produce a large amount of torque to the right of the observed fracture line (Figure 32). In this case, the majority of the platform structure to the right side of the fracture line would be twisted or rotated outward, toward the front and the right side. Since this scenario was not consistent with site observations and the examination of the car wreckage, the FEM analysis concluded that in-train draft forces did not play a role in the A-end structural failure of DJJX 30478.

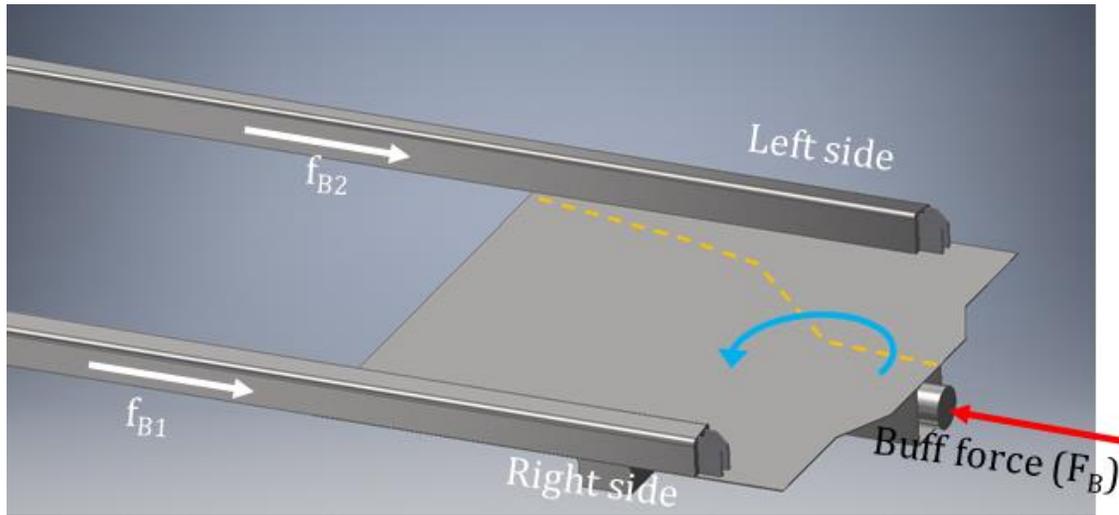
Figure 33. In-train buff force (F_B) acting on the car as the train negotiated the tunnel (red arrow). The blue circular arrow identifies the torque resulting from the applied force. The dotted line shows the observed fracture line. (Source: TSB)

The FEM analysis also determined that the combination of forces acting on the A-end of DJJX 30478 when it was subjected to in-train buff force would produce a large amount of torque to the right of the observed fracture line (Figure 33). In this case, the majority of the A-end platform structure to the right side of the fracture line would be twisted or rotated inward, which was consistent with site observations, the examination of the car wreckage, and the FEM analysis results. This confirmed that the in-train buff force played a role in the A-end structural failure of DJJX 30478.

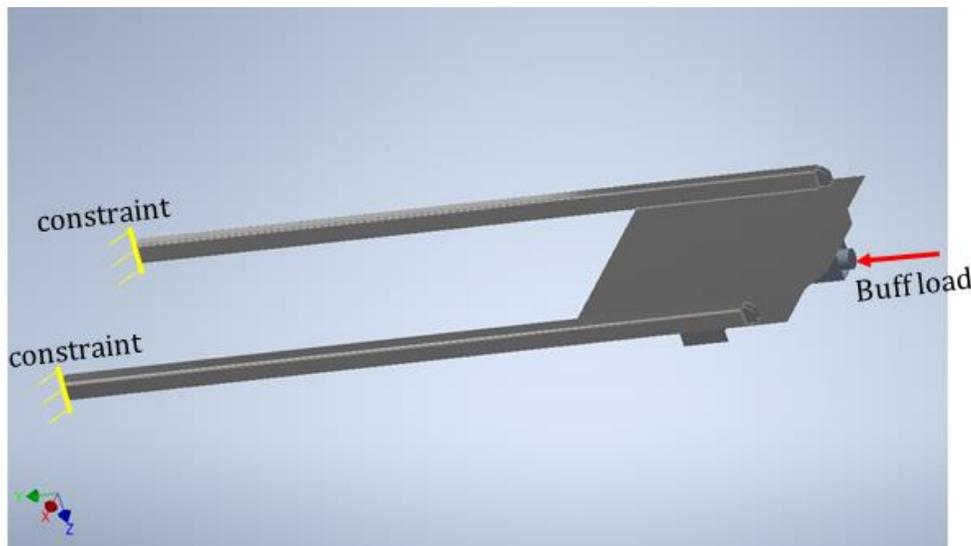
Figure E1. Finite element model of Berwick Forge & Fabricating Corporation bathtub gondola car (Source: TSB)

For the half model shown (Figure E1), the cut-off ends of the 2 side sills were fully constrained (i.e. blocked in longitudinal direction and prevented from being displaced in lateral and vertical direction). A buff force (referred to as a buff load in the model) was applied at the end of the poker, which was inserted into the stub sill, similar to using a poker to apply a buff load during a compressive static load test, as was done at the National Research Council Canada (NRC).

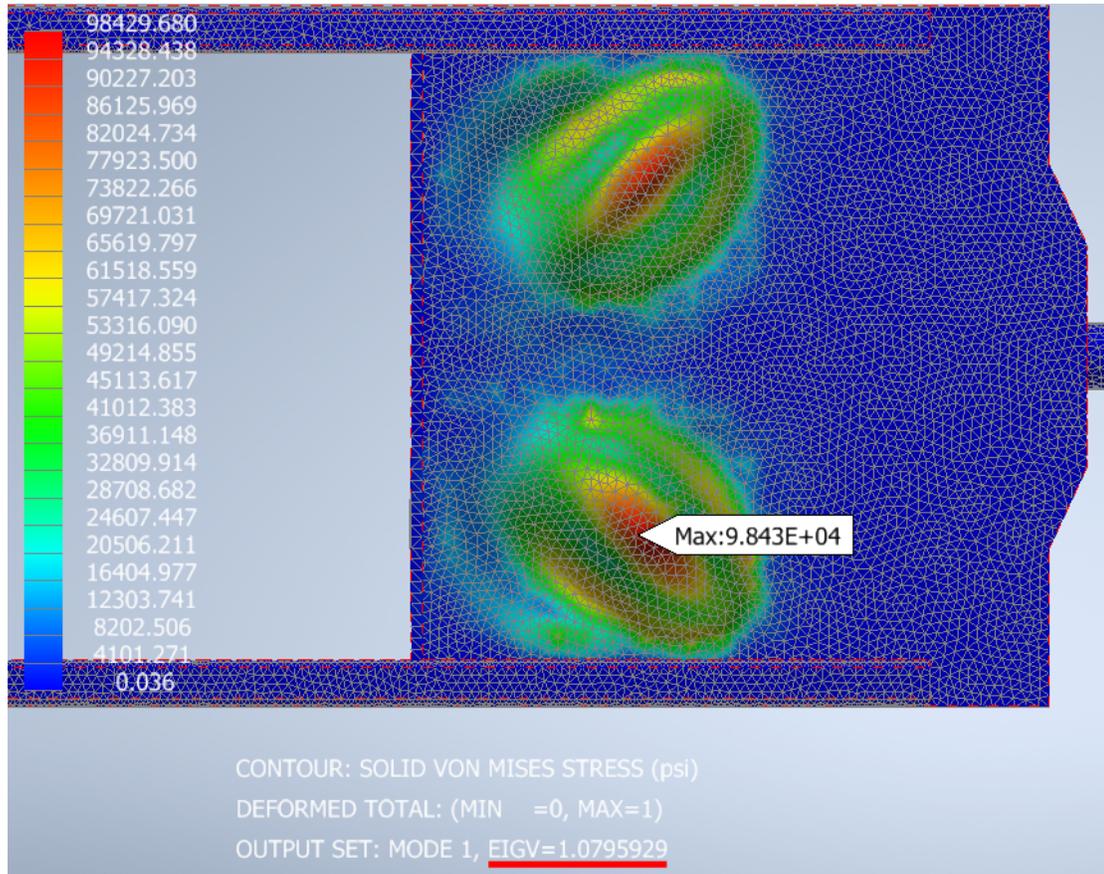
Figure E2. Linear buckling analysis of the platform structure of an intact gondola car (Source: TSB)

First, a model for an intact platform structure of the car end without introducing any defect was analyzed. The result (Figure E2) shows that the output EIGV value (underlined in red) of an intact car is approximately 1.08. The critical buckling load of the intact car is thus calculated to be 1 080 000 pounds of force (i.e. critical buckling load = EIGV value \times applied load = $1.08 \times 1\,000\,000$ pounds of force = 1 080 000 pounds), indicating that the model of an

intact car can take a buff load of 1 000 000 pounds of force without failure,⁴² and failure could occur when the buff load reaches 1 080 000 pounds. The locations of buckles in the shear plate and their orientation are consistent with the result of compression testing at NRC.
