The Washington Metrorail Safety Commission

Safety Audit

of the Washington Metropolitan Area Transit Authority

Audit of Emergency Management and Fire and Life Safety Programs

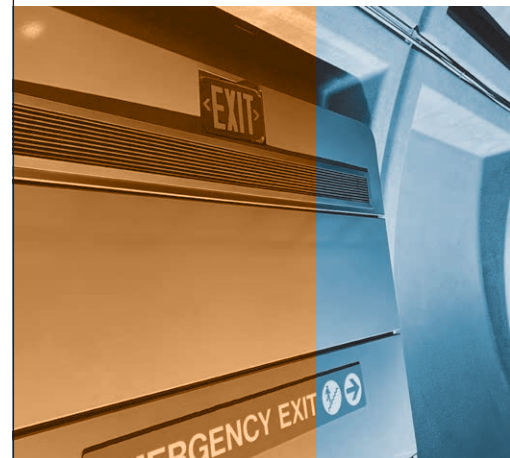
**Emergency equipment
in station medical
cabinets is expired and
covered in dirt.**

Concerning its physical assets, emergency equipment in station medical cabinets is expired and covered in dirt. There is no inspection procedure or responsible party assigned to inspect and maintain this safety equipment. Metrorail does not conduct systematic underground inspections to ensure safe egress and fire and life safety response, and has set minimum tunnel emergency lighting levels that are not compliant with NFPA minimum standards. Metrorail does not consistently inspect and maintain current certification status of all fire extinguishers, particularly those on the roadway. Metrorail does not consistently perform or document all elements of its Fire & Intrusion Alarm System Inspection Preventive Maintenance Instructions.

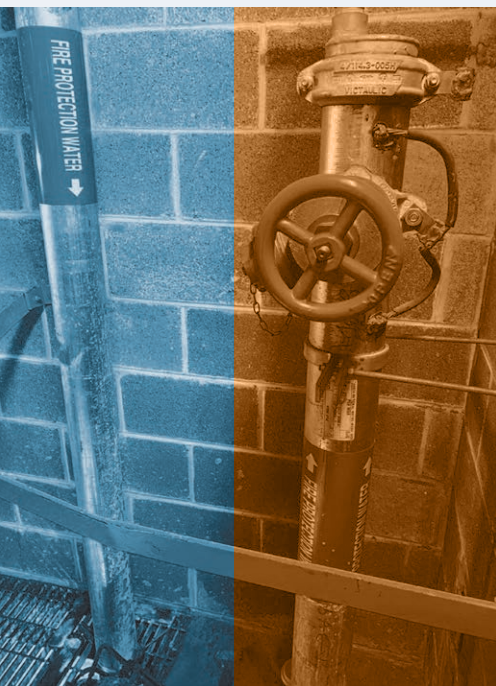
- Site visits identified a good solid barrier around a fire protection pipe in exit stairs at Navy Yard-Ballpark Station's Half Street exit to properly direct people through an exit door.

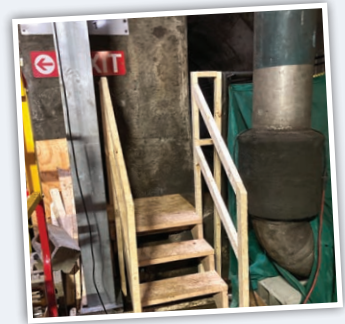
National Fire Protection Association (NFPA) 130 (Standard for Rail Fixed Guideway Transit and Passenger Rail Systems), introducing flammable material into the tunnel environment by placing wooden stairs to temporarily resolve the initial egress issue identified during site visits for this audit.

The WMSC identified this subsequent violation of NFPA 130, and directed Metrorail to remove the untreated wooden stairs, to expedite the construction of permanent concrete or steel stairs that had been removed from final designs despite being in initial drawings created prior to the project award to a contractor, and to ensure that trained Metrorail personnel are present in the area to assist with an evacuation if needed until an adequate egress path is restored. During follow-up discussions on this issue, Metrorail stated that they had sought steel stairs as an immediate temporary mitigation after the WMSC identified and communicated the obstructed egress issue, but they could not procure them within days, so the WMATA Fire Marshal suggested a possible alternative of fire-treated wood. When WMATA could not immediately procure fire-treated wood, project management and safety certification personnel said that they took it upon themselves to decide to install regular wood stairs with a plan to add fire resistant paint several weeks later. The Fire Marshal was not consulted. No other fire and life safety experts, nor the Authority Having Jurisdiction (AHJ) were consulted either, demonstrating continued siloing within the Metrorail organization.

For example, in relation to the Tunnel Ventilation Pilot Project, project staff and Metrorail's safety certification team stated that they installed a hazard – combustible wooden stairs in the tunnel despite the Fire Marshal's instructions that the stairs at minimum had to be made of fire treated wood. The project team and safety certification team stated that they installed the combustible materials, contrary to NFPA 130 requirements and the Fire Marshal's instructions, in part because the Fire Marshal was on vacation when they encountered difficulty acquiring the specified materials, and they did not find it necessary to contact anyone else for guidance.

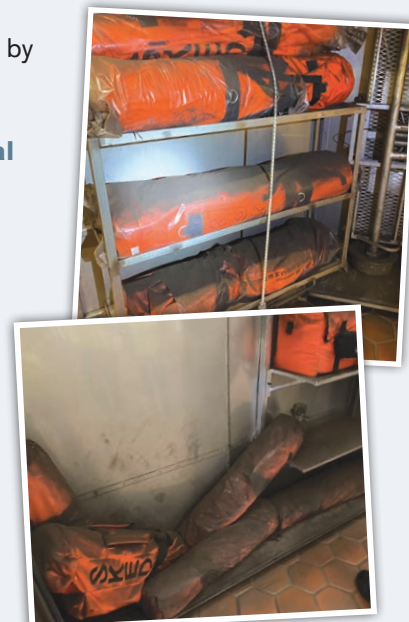
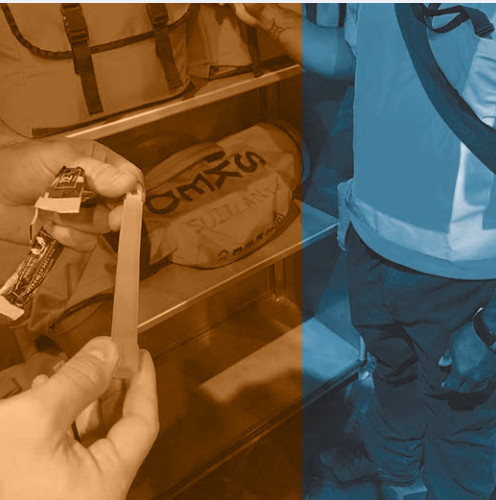
Site visits for this audit identified that the emergency equipment in Metrorail's station medical cabinets is covered in dirt and has expired at each of the stations examined. This includes bags with bandages, Sked emergency rescue stretchers, and glow sticks that are used to help guide customers out of a dark tunnel in an emergency.

The glow sticks, for example, had expired in 2019.

The bags for the equipment in medical cabinets are orange, and would be more visible in low-light conditions if they were not covered in dirt. Gaskets on the cabinets do not appear to create the necessary seal to keep out brake dust and other contaminants and keep supplies clean.

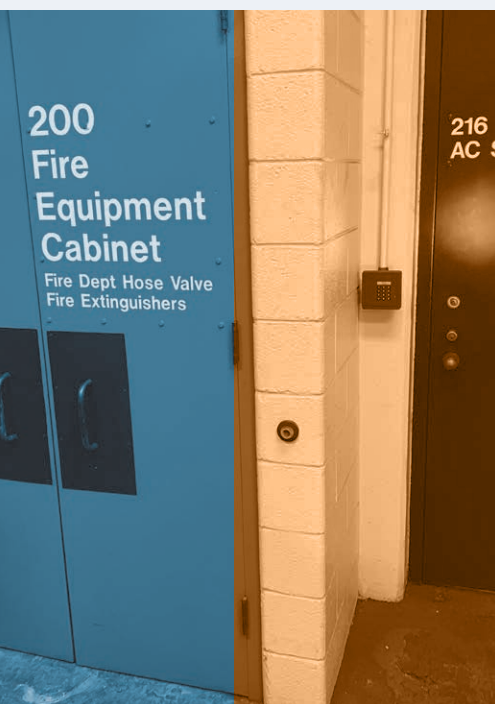
In Room 200 at Anacostia Station, there is not an exit sign posted on any of the multiple doors that workers might take to depart the room, which could lead to workers fleeing into a high voltage area in an emergency rather than using the emergency exit path, which is unmarked.

For example, in Room 200 at Anacostia Station, there is not an exit sign posted on any of the multiple doors that workers might take to depart the room, which could lead to workers fleeing into a high voltage area in an emergency rather than using the emergency exit path, which is unmarked. As with other safety deficiencies identified during this audit, the WMSC raised this immediately with the Metrorail personnel who accompanied the WMSC on that site visit including the Fire Marshal.
