# Management of In-Train Forces: Challenges and Directions

Railroad Safety White Paper

Grady C. Cothen, Jr.

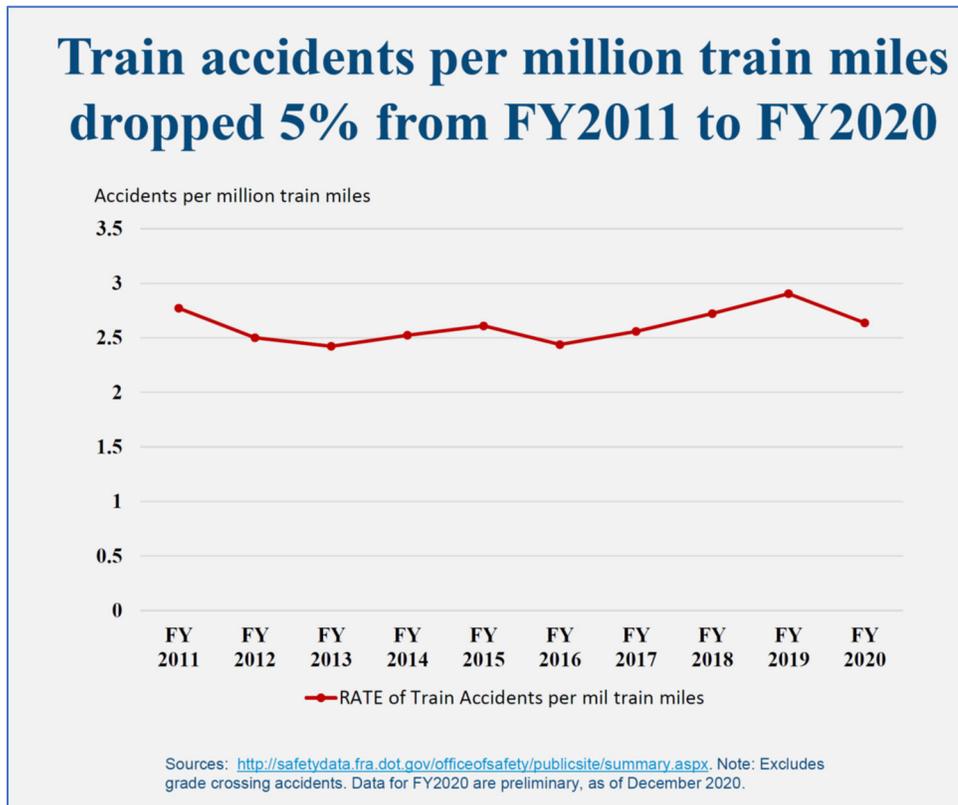
**Figure 1 – Train Accident Rate / All Railroads**

In Figure 1, AAR displays data for Federal fiscal years, which end September 30<sup>th</sup>. It includes all railroads.

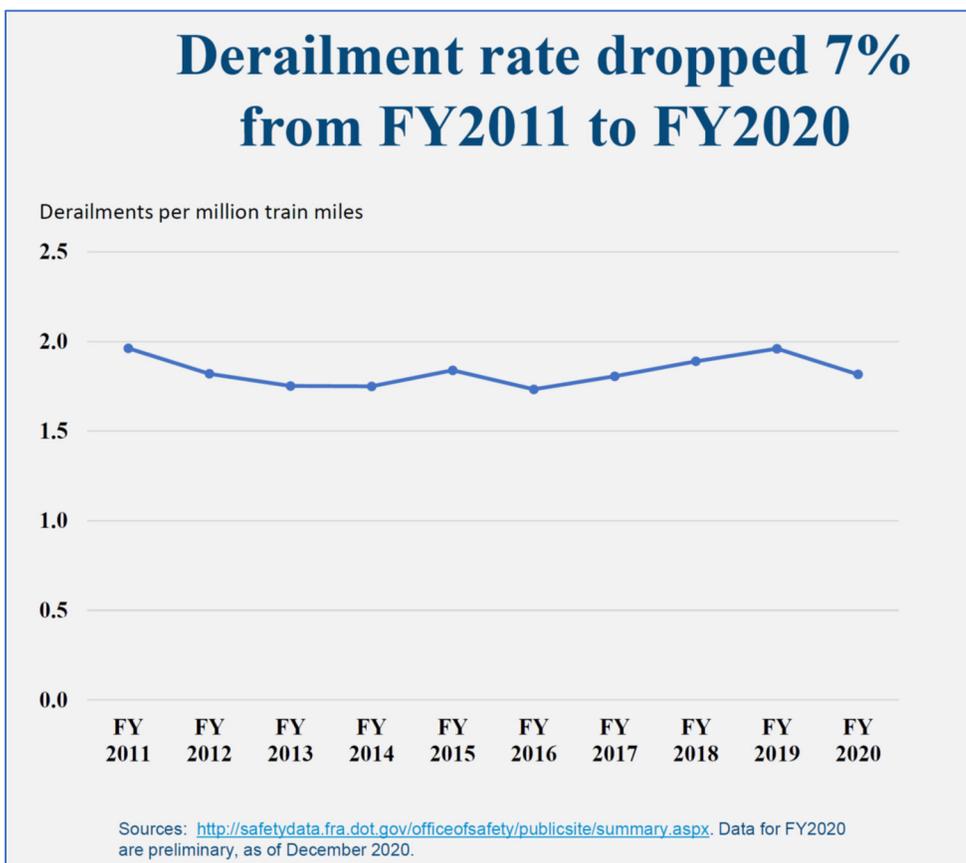
**Figure 2 – Derailment Rates for All Railroads**

Again, this is data for all railroads. It reflects derailments on all track (including yard and main line).

In earlier versions of this paper, we noted that placing a positive spin on these numbers requires accepting that the 2020 results reflect real progress. Let's happily concede that, at 1.90 the derailment rate for FY2021 was better than the derailment rate for FY2020, which was 1.93. Having said that, FY2016 came in at 1.70.<sup>3</sup>

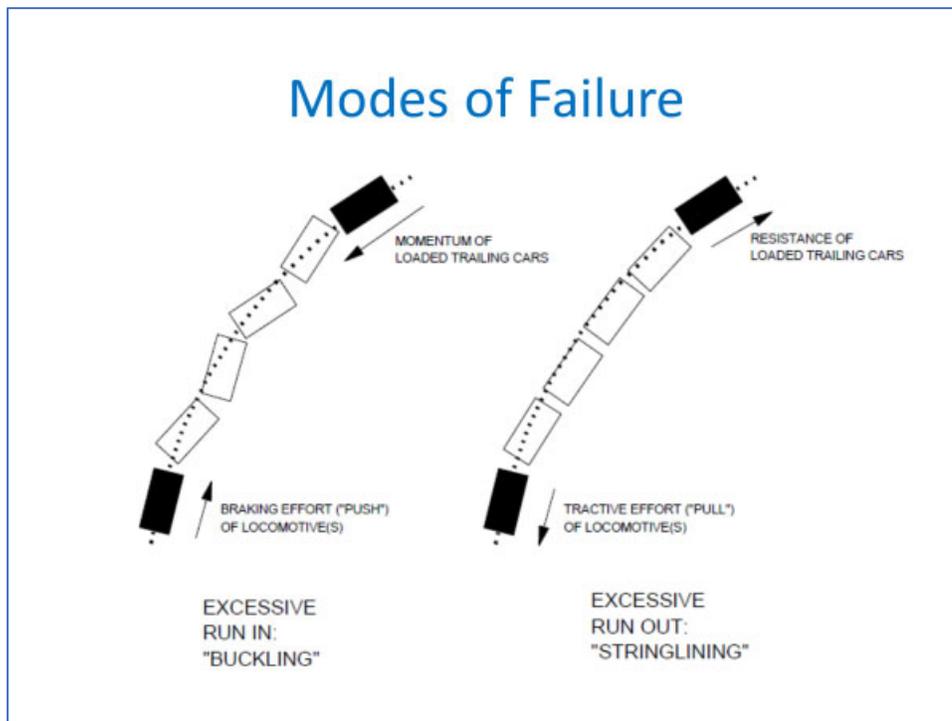
During the author's time at FRA, the agency, with help from the Volpe National Transportation Systems Center, produced a congressional report<sup>11</sup> that describes the kinds of derailments. Here are illustrations from that report:

**Figure 3 – Buckling and Stringlining Illustrated**

These classic derailment scenarios, together with run-away trains, have been staples of railroad operations since the beginning. Note that the modes of failure can result from poor use of motive power, poor braking, or poor train make-up. But other initiating causes, such as wide gage, broken rails, broken wheels, stiff trucks, etc., can set up unfavorable in-train forces; and the severity of the resulting events will increase. Even when an engineer deems it necessary to apply the emergency brake to avoid or mitigate a collision with a tanker truck stuck on the crossing ahead, or children on the track failing to respond to the train horn, the result may be a serious derailment.

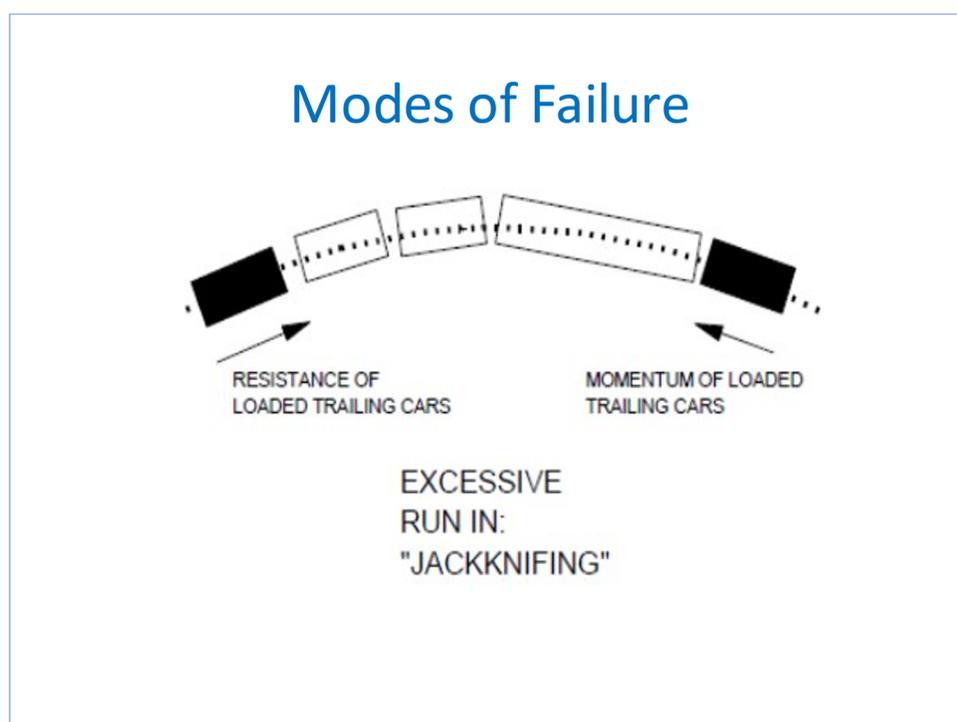
**Figure 4 – Jackknifing Illustrated**

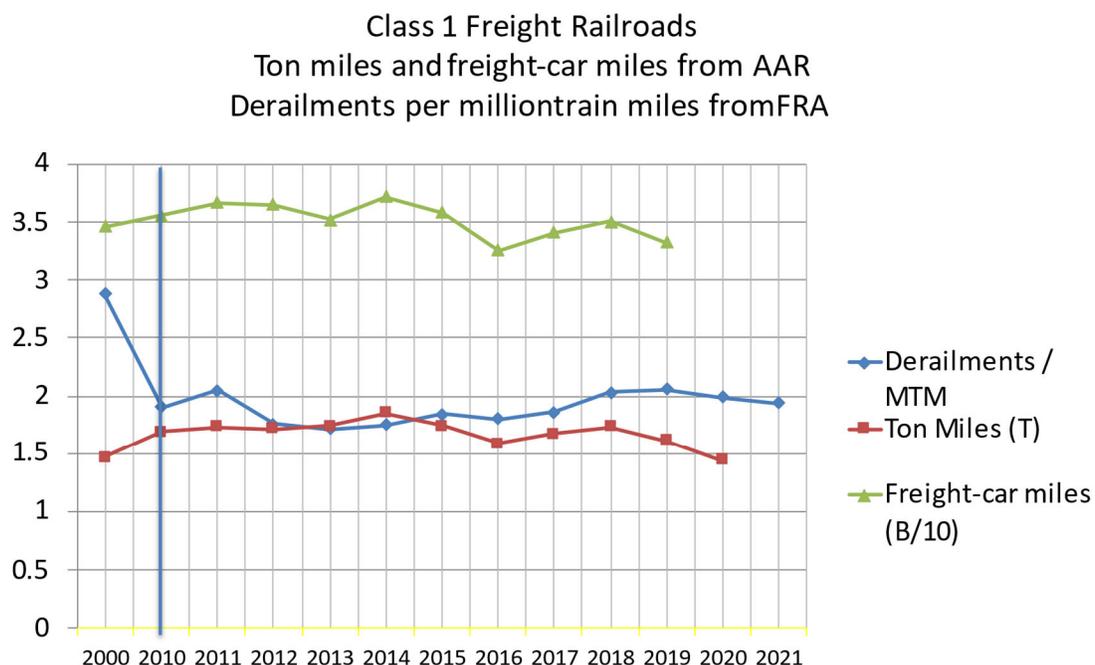
**Figure 5 – Class 1 Freight Railroad Derailment Trends (all tracks)**

Figure 5 data for ton miles and freight-car miles were taken from AAR Fact Books, and the derailments per million train miles were calculated directly from FRA data.<sup>19</sup> Note that this data varies slightly from AAR’s report of FRA data, used in prior versions, perhaps because AAR included all Class 1 railroads (including Amtrak) while the graph above applies to freight railroads only. Temporary increases in coal traffic, and a general recovery of carload traffic, likely pushed ton miles up somewhat in 2021.

There is an ongoing discussion, the resolution of which has not come to the writer’s attention, over what kind of normalizing statistic should be used in an era of very long trains. Figure 5 displays the accidents per train mile metric that both FRA and AAR have used in the past to gauge progress. Running fewer trains yields fewer train miles to serve as the denominator, even if this is being done soundly.

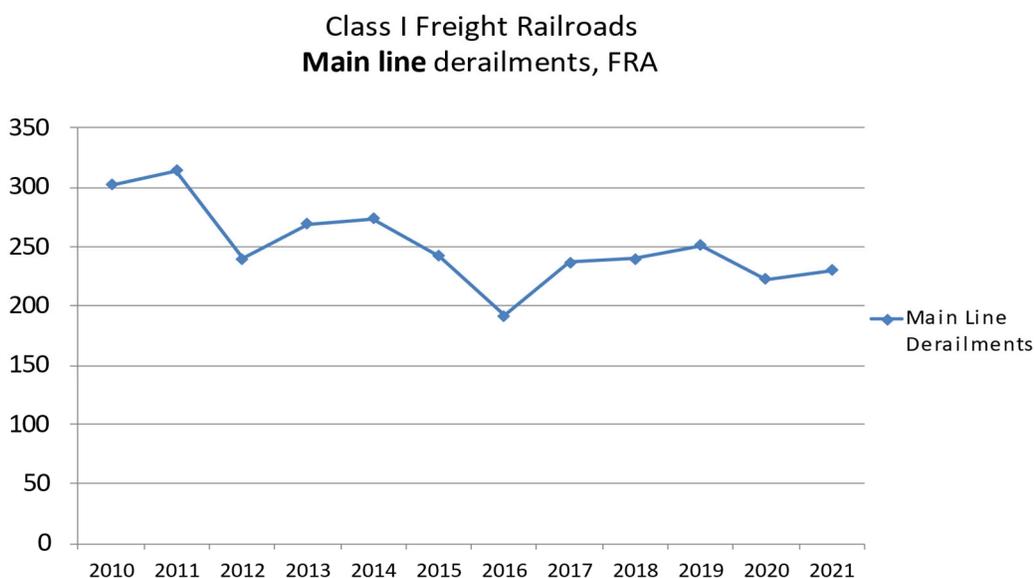
**Figure 6 – Class 1 Main Line Derailments (counts only)**

While running many fewer trains, the major railroads continue to report a steady or increasing number of main line derailments. What is behind this trend? First, “human factor” derailments having been gradually rising, even as track-caused accidents decline steadily. As would be expected with the rise of in-train forces associated with PSR, equipment caused derailments also remain at a significant level—this, despite all of the advances in wayside detection technologies.

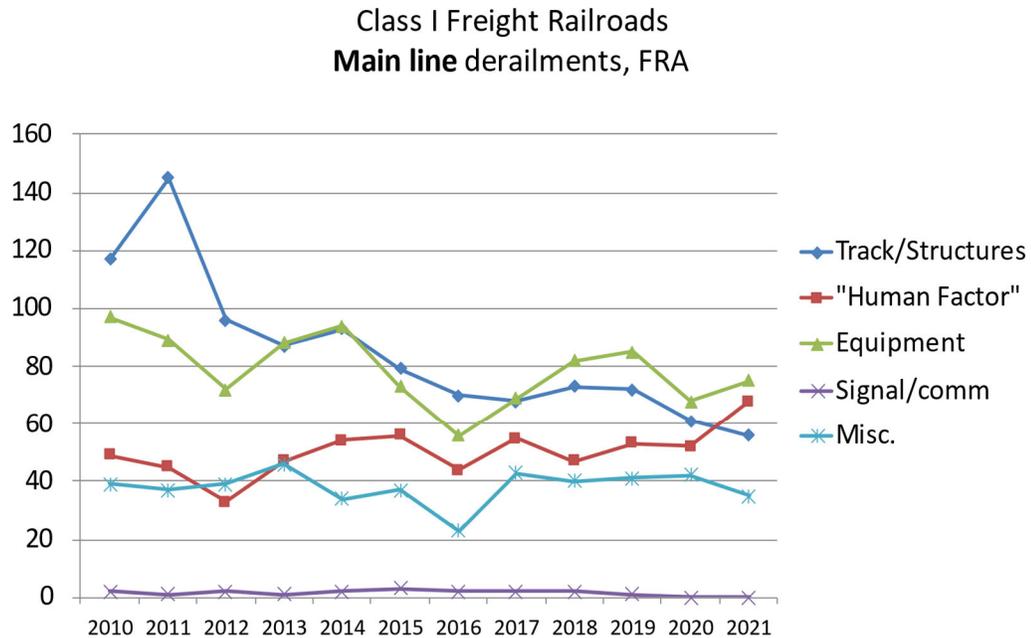
**Figure 7 – Class 1 Main Line Derailments by Cause (counts)**

Figure 7 shows the gradual increase in human factor derailments, even as the number of trains operated has declined steeply. Track accidents continue to decline, but equipment-caused accidents have remained quite persistent. Miscellaneous causes have also shown persistence.

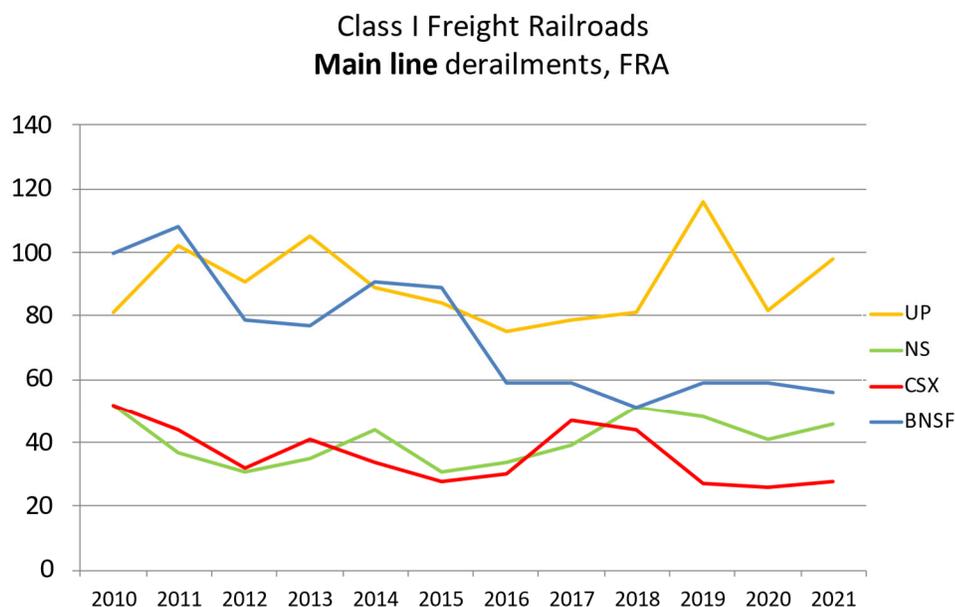
**Figure 8 – Class 1 Main Line Derailments by Major Railroads (counts)**

In Figure 8, note that BNSF is actually the bigger railroad in the west (by volume), but UP is leading in derailments. CSX, which went through a difficult PSR start, now has fewer main line derailment than NS, which is the smaller railroad in the east. These differences look stark when one searches for accidents likely driven by in-train forces (examples abound in Appendix B).

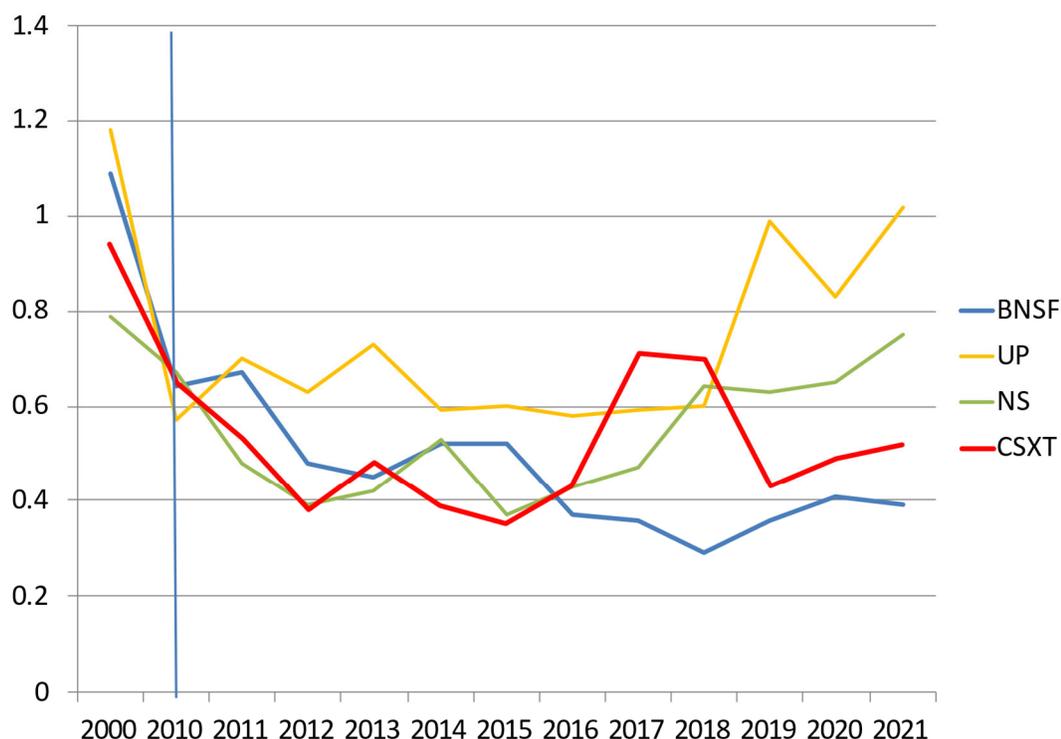
**Figure 9 – Main Line Derailment Rates per Million Train Miles**

Again, Figure 9 data drawn from the FRA web site shows the rate of main line derailments per million train miles.<sup>22</sup> These four railroads account for the majority of trains operated and train miles in the United States. All four railroads have extended their train lengths and tonnages over the past half-decade, although BNSF has done so to a lesser extent.

In Figure 9 above, note that the values for NS and UP are relatively high through 2021. NS faced a hostile takeover bid by investors aligned with CP that ended in April of 2016, but its derailment performance overall seems not to have recovered. Each of the PSR railroads has maintained a low operating ratio while using much of its cash for stock buybacks and dividends. *Review of the granular derailment data for UP and NS, in particular, suggests casual attention to train make-up and the challenges presented for crews drawing very long and heavy trains.* The other major railroads continue to struggle with management of in-train forces, but to a lesser extent.
